**G-05501-R1**  
**April 2005**

**SUBJECT: SAFETY RECALL (CANADA, EXPORT)**  
**FRONT DRIVE SHAFT on 4800 4x4's with FABCO**  
**TC-200 TRANSFER CASES built 6/30/1999 thru**  
**5/8/2002**

*This Recall is the final remedy and supercedes Safety Recall G-03516*

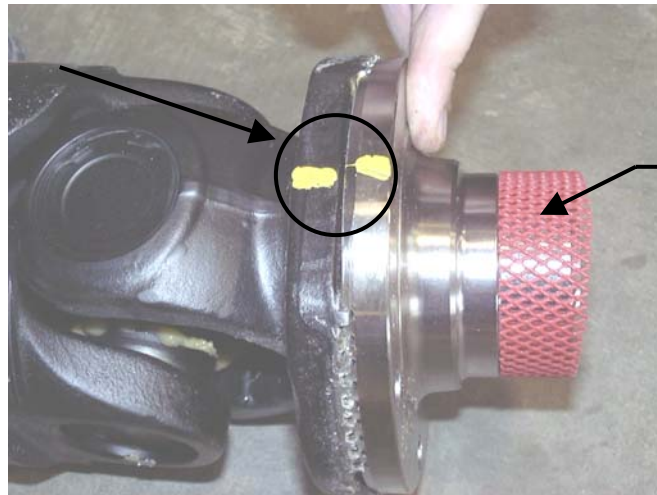
**Figure 1 – Front Axle Side – Small Spline**

Front Axle Flange has  
**SMALL** Diameter  
Splines

Transfer Case Flange  
has **LARGE** Diameter  
Splines

1. Dry fit and lay out the new shaft and flanges to determine which side belongs on the axle side and which belongs on the transfer case side. Mark flange and shaft for ease in installation and proper alignment.

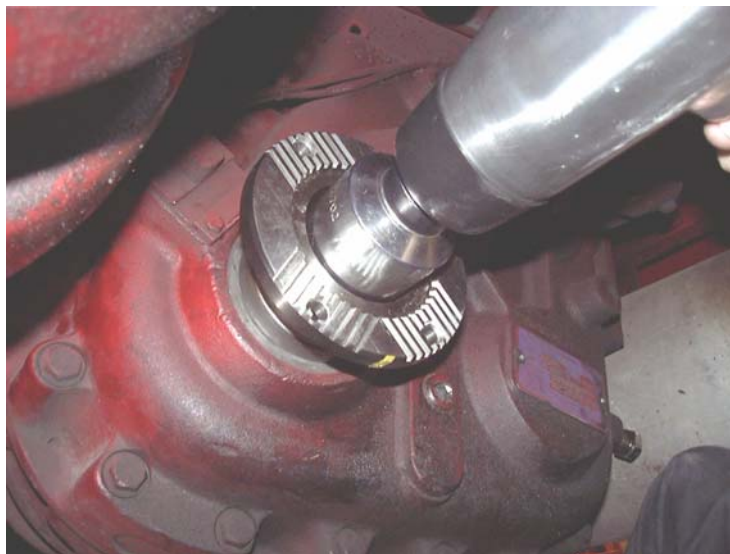
**Figure 6**

**NOTE:** *You will need to use a thin wall socket to properly tighten the nut.*

9. Disengage the transfer case so the output shaft is free to rotate.
10. Install new driveshaft starting with the front axle. **INSTALL SHAFT WITH SLIP JOINT TOWARDS THE REAR OF THE VEHICLE.** Align

mark on flange with mark on shaft. Install and torque bolts to **88-92 LbF-Ft (120-125 Nm)**.

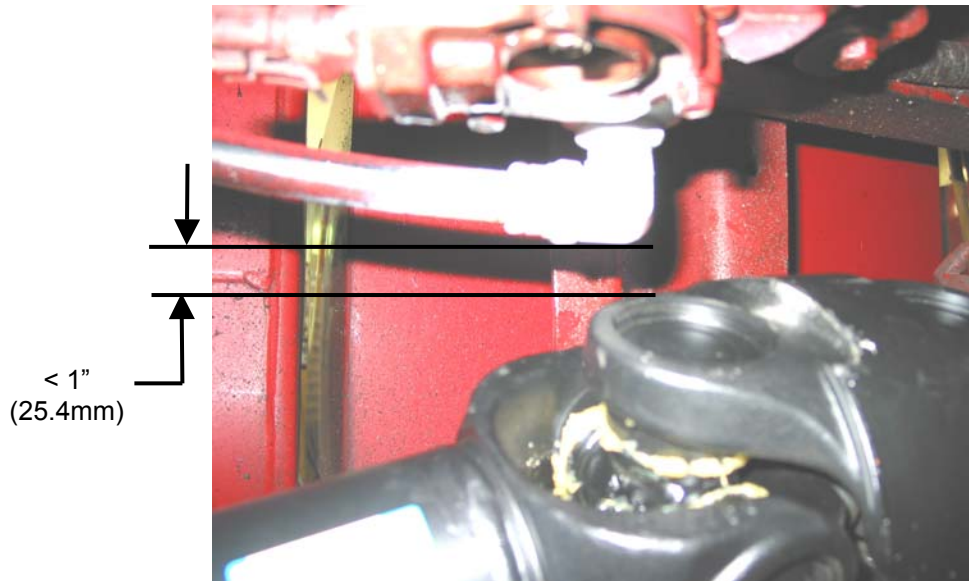
**Figure 8**

13. Some vehicles built with feature code 804EMZ, air dryer relocation, will require the air dryer to be rotated and re-mounted.
14. If the vehicle's air dryer has an output elbow in close proximity (less than 1" [25.4mm]) to the drive shaft (see Figure 8), a rotation is required. Continue to step 16.

15. If the air dryer elbow is not located in close proximity (greater than 1" [25.4mm]) to the driveshaft, then the dryer relocation is not required.
16. Remove the air dryer mounting bolts. Loosen upper air dryer strap bolts.

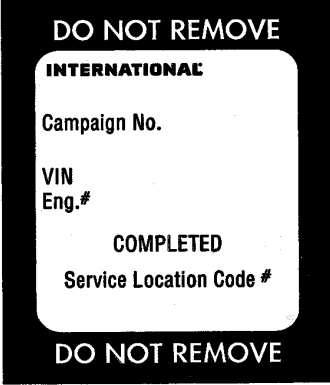
A rectangular label with a black border. At the top and bottom, it says "DO NOT REMOVE" in white capital letters. In the center, there is a white rectangular area with black text. The text includes "INTERNATIONAL" in bold, "Campaign No." followed by a line, "VIN" followed by a line, "Eng.#" followed by a line, "COMPLETED" in bold, and "Service Location Code #" followed by a line.

*Each vehicle corrected in accordance with this campaign **must be** marked with a CTS-1075 Campaign Identification Label.*

Complete the label and attach on a clean surface next to the vehicle identification number (VIN) plate.
