VEHICLE RECALL

G-06510
November, 2006

SUBJECT: SAFETY RECALL (U.S., EXPORT)
**Handrail on certain CE & 3800 School Buses built
between 12/23/1997 and 03/21/2006.**

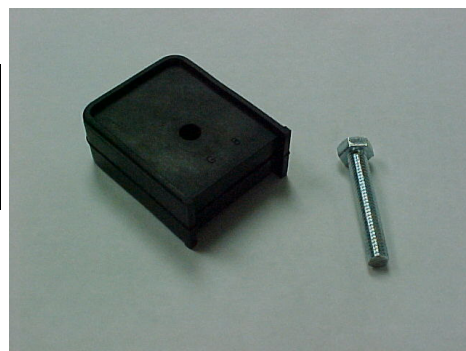
Figure 5 - Kit 8900190R91

436462001
Spacer Rubber
(2 included)

180085 Bolt
5/16-18, 1.75
grade 5 (2
included)
