# **SERVICE MANUAL**

### **DRIVETRAIN FAILURE ANALYSIS**

**s10008, Formerly CTS-5198**

**06/03/1996**

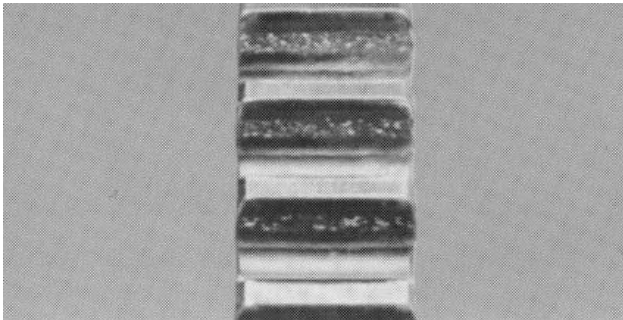
**Figure 3 Pitting and Spalling**

3. Pitting and spalling occurs when gears are run under excessive loads for long periods of time or using the wrong type of lubricant. Contaminated lube will also cause this type of failure (Figure 3).

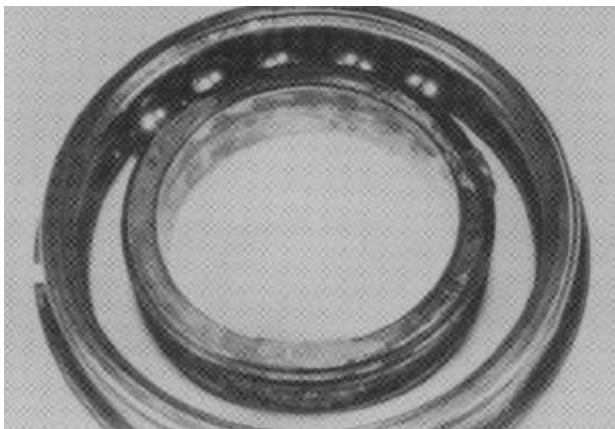
**Figure 5 Sharp Edge Along Inner Race**

1. Torsional vibration can cause the bearing cage to fail, allowing the balls to move and not carry the load evenly. The inner race will have a sharp edge along the edge (Figure 5).

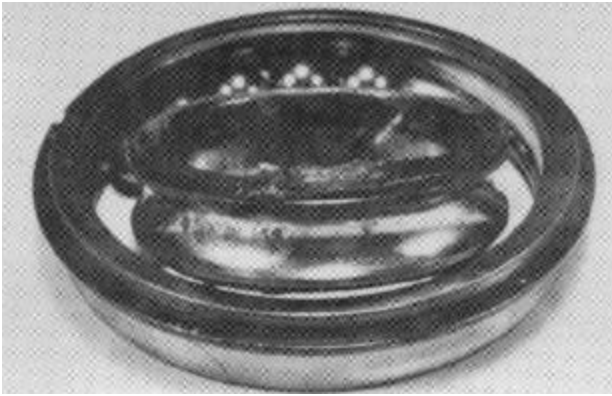
**Figure 6 Inner Race Spalling**

2. Contaminated lubricant will cause inner race spalling (Figure 6).

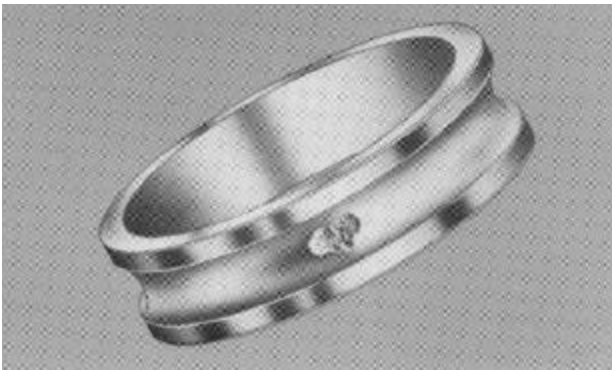
**Figure 7 Flaking or Spalling of Bearing Raceway**

Fatigue is characterized by flaking or spalling of the bearing raceway (Figure 7). Spalling is a granular weakening of the bearing steel which causes it to flake away from the raceway. The rough surface of spalled bearings will produce noise and vibration.

5. Overloading will appear as shown in Figure 7.
6. Misalignment is indicated by offset spalling (Figure 10) or an angular ball path (Figure 11).

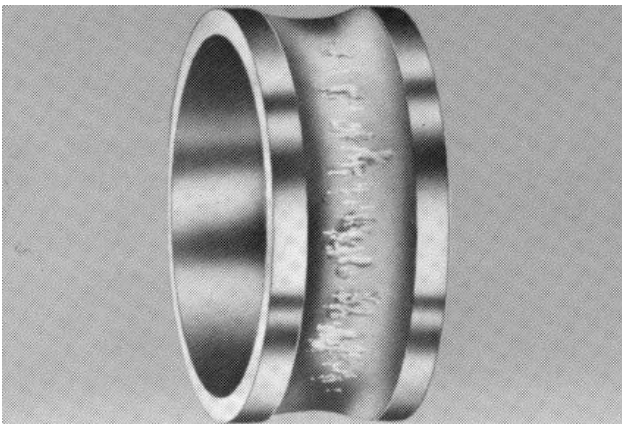
**Figure 8 Spalling of Raceway**

3. Lack of lubricant is characterized by discoloration of the bearing parts and spalling of the raceway (Figure 8).

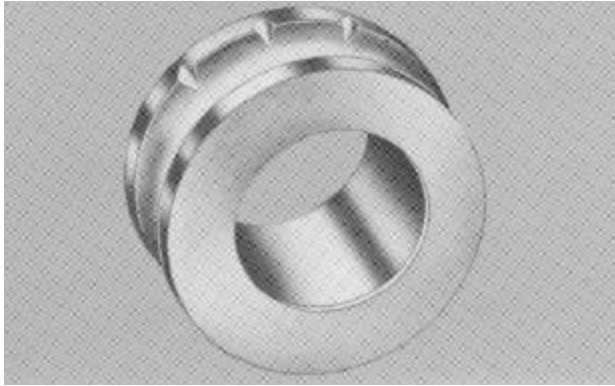
**Figure 9 Brinelling**

4. Improper assembly can cause brinelling (Figure 9). Driving or pressing on one race while supporting the other is the primary cause.

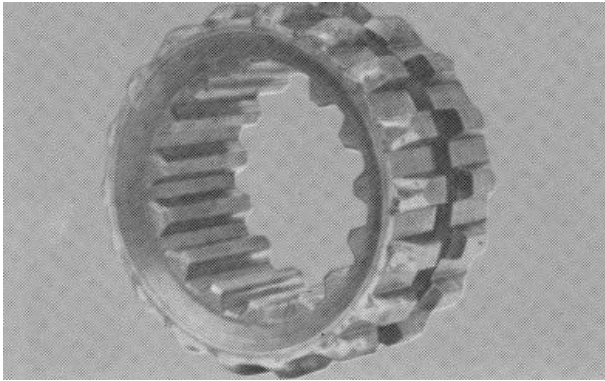
**Figure 12 Damage From Clashing Gears**

Clashing gears while shifting is a common abuse in unsynchronized transmissions. Significant damage can occur by a hard clash shift when gears and collars are forced to engage but the speeds are not synchronized (Figure 12).

1. Improper shifting by drivers who are not familiar with the shift pattern or who have not learned the RPM spread between shifts.
2. Poor clutch release or a dragging clutch will make shifting difficult and will result in damage to gears and collars.
3. The inertial force of rotating gears requires a few seconds to slow down. Forcing a quick shift will result in noise and premature damage to gears and collars.
4. Clashing can also occur in air shifted transmissions. Verify that the correct shift points are being used or the pressure regulator setting is correct.

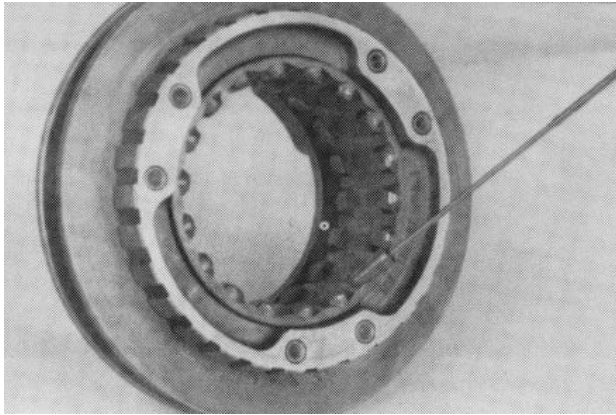
**Figure 13 Rounded Corners on Synchronizer Clutching Teeth**

1. Rounded corners on synchronizer clutching teeth (Figure 13).

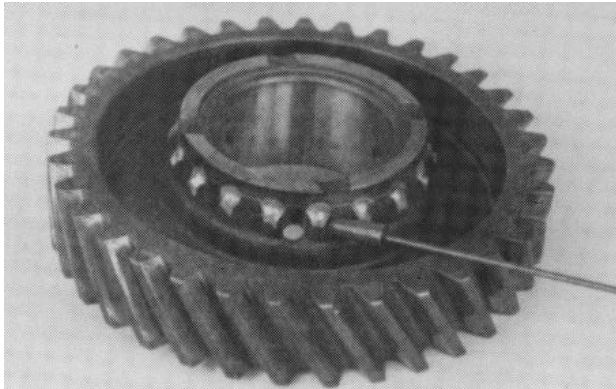
**Figure 14 Worn or Chipped Clutch Teeth**

2. Clutch teeth on gears will become worn or chipped (Figure 14).

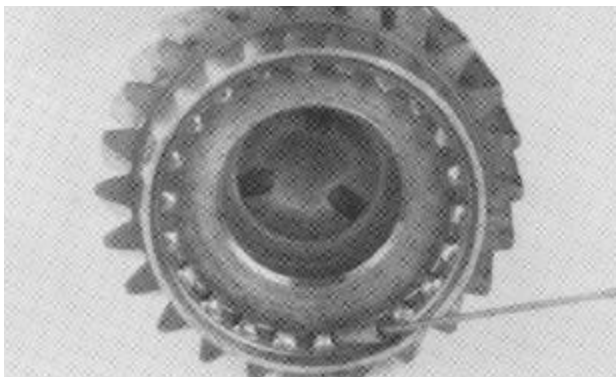
**Figure 15 Rounded Teeth at Gear I.D.**

3. Rounded teeth at the gear I.D. result in gear jumping (Figure 15).

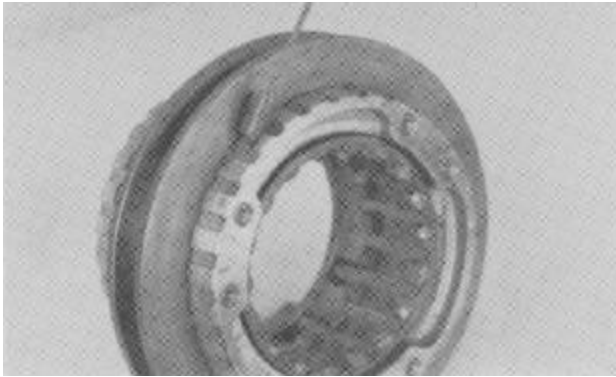
**Figure 16 Synchronizer Rings Imbedded With Metal Chips**

4. The soft brass synchronizer rings will become imbedded with metal chips from the clutching teeth (Figure 16).

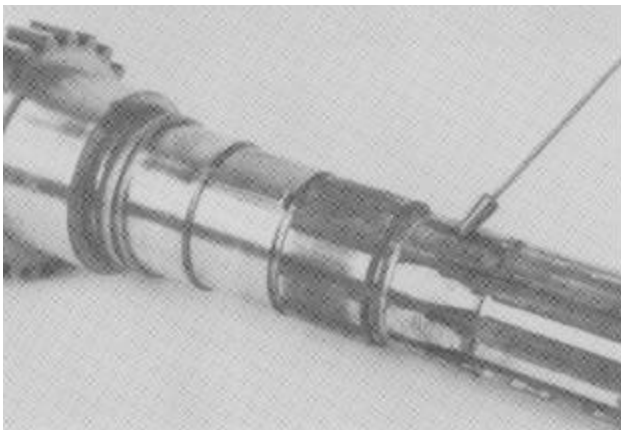
**Figure 17 Mainshaft Seizure of Fourth Speed Fluted Diameter**

1. Mainshaft seizure of the fourth speed fluted diameter (Figure 17).

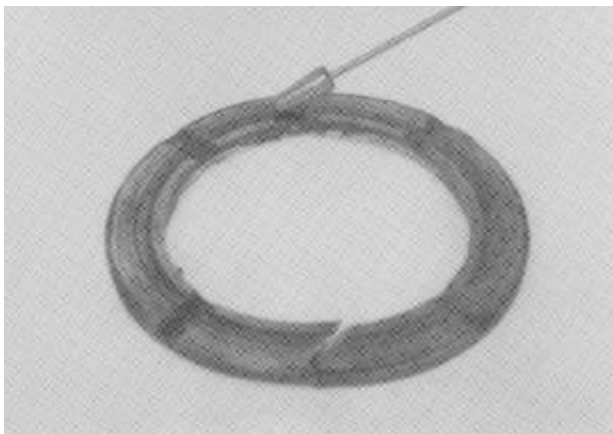
**Figure 20 Washer Seized to Thrust Face of Gear**

4. Washer seized to the thrust face of its gear (Figure 20).

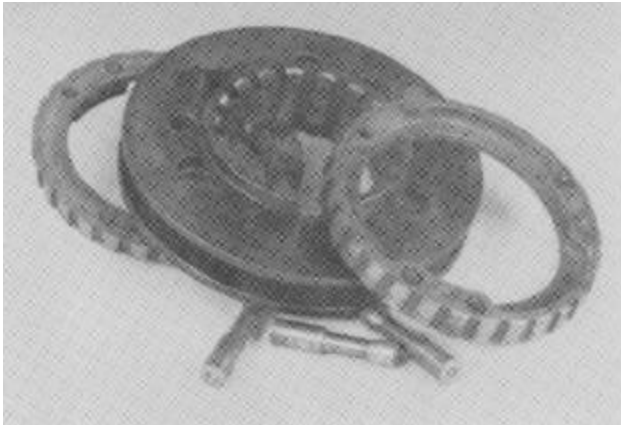
**Figure 21 Broken Synchronizer Pins**

5. Broken synchronizer pins (Figure 21).

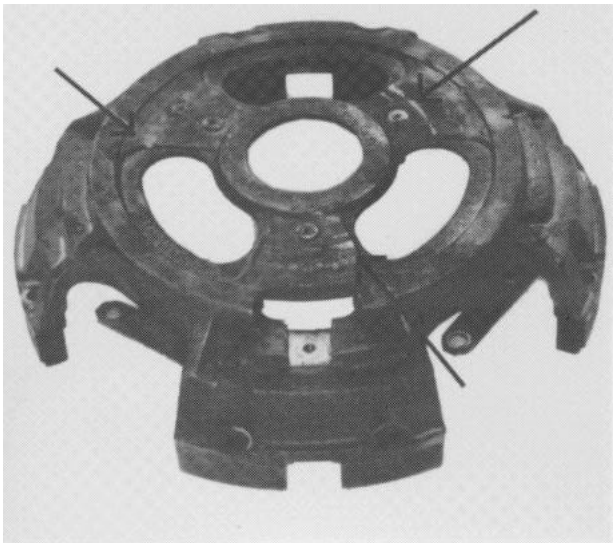
**Figure 22 Outer Surface Wear**

If there is wear on the outer surface (Figure 22), inspect for the following:

1. Linkage adjustment.
2. Worn transmission input bearing cap.
3. Worn or missing clutch brake.
4. Worn wear pads on release bearing housing.
5. Worn release forks tips.
6. Too much material removed from flywheel.

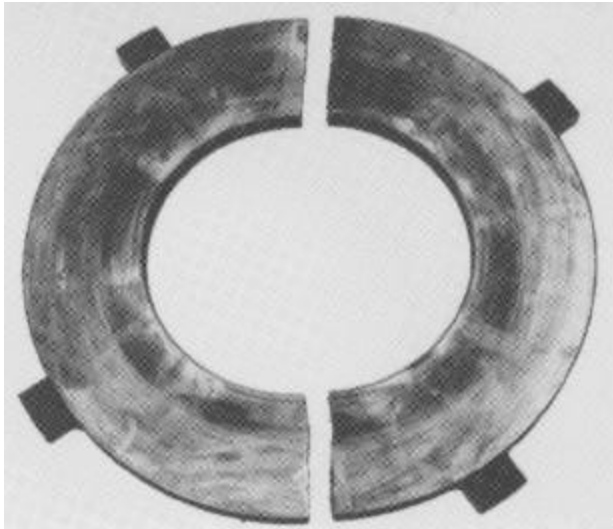
**Figure 23 Cracked Plate**

1. Cracked or heat checked caused by thermo stress due to slippage (Figure 23 and Figure 24). Check the following:

- a. Clutch adjustment.
  - b. Drive pins not square to the flywheel (14").
  - c. Center plate lug clearance (15-1/2").
2. Scored center plate or pressure plate (Figure 25). Small scratches and grooves are normal wear. Large scratches and grooves are due to slippage. Refer to page 13 Step 1 above.

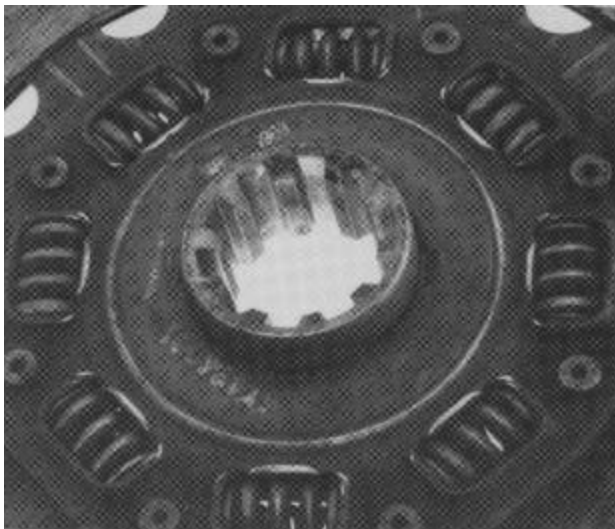
**Figure 26 Cracked Hub**

3. Burnt driven discs are a result of excessive heat due to slippage. Ceramic facing material will flow and eventually separate from the disc. Organic material will separate from the disc due to bonding agent failure. Burnt discs can result from:
  - a. Lack of free pedal.
  - b. Constantly riding the clutch pedal.
  - c. Partial unloading of a clutch due to a binding linkage system.
  - d. Worn driven discs.
4. Driven disc to release retainer interference is the result of incorrect adjustment. The linkage was adjusted to compensate for wear rather than the internal adjusting ring. This can cause cracked hubs in the rear disc and a cracked pressure plate from the heat generated (Figure 26).

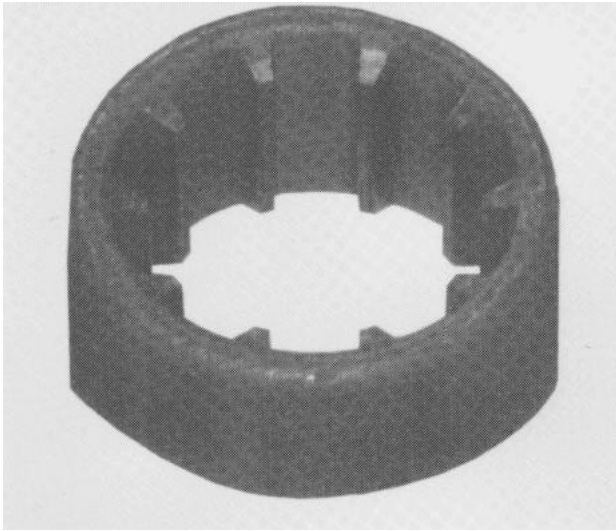
**Figure 27 Worn Splines**

5. Rigid disc splines excessively worn or disc cracked. The cause of worn splines is usually due to torsional vibration or misapplication (Figure 27). A cracked disc hub (Figure 28) can be caused by the following:

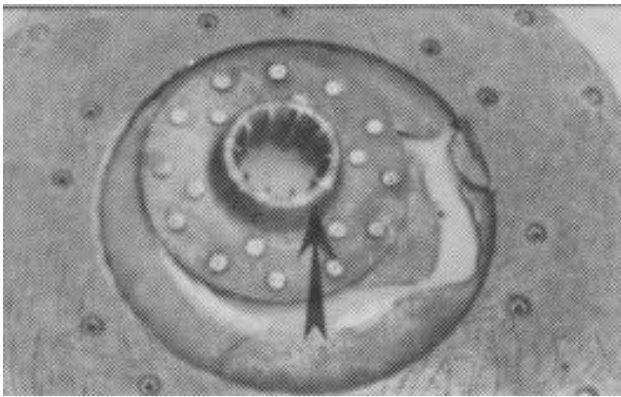
**Figure 28 Cracked Disc Hub**

- a. A severe shock load.
  - b. Misalignment between the transmission clutch housing and the engine housing.
  - c. Misapplication - a rigid disc should not have been used.
  - d. Torsional vibration from the engine.
  - e. Excessive flywheel runout.
  - f. The transmission was hung in the disc unsupported during installation.
6. Cracked damper cover (Figure 29) can result from:

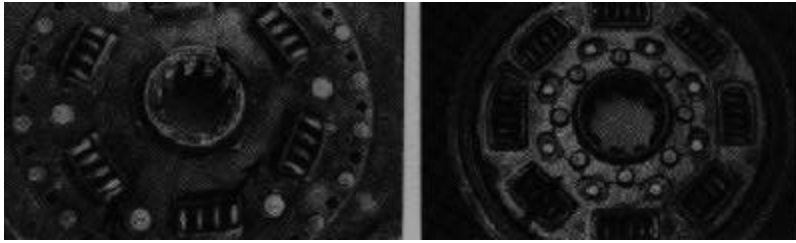
**Figure 29 Cracked Damper Cover**

- a. Forcing the transmission input shaft into the driven disc hub during installation.
  - b. Allowing the transmission to hang unsupported in the driven disc hub during installation.
  - c. Misalignment between the engine housing and the transmission clutch housing.
7. Broken or missing damper springs may result from severe shock loads or excessive torsional vibration from the engine over the design limit of the damper (Figure 30).

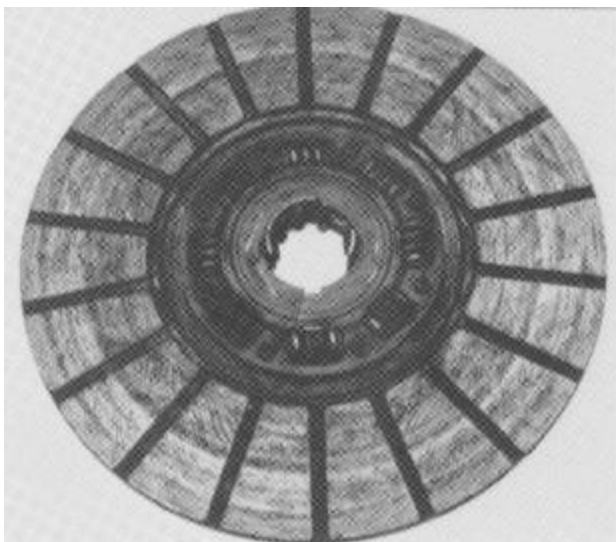
**Figure 31 Cracked Driven Disc Damper Hub**

8. Driven disc damper hub cracked due to severe shock load or powertrain torsional vibration (Figure 31).

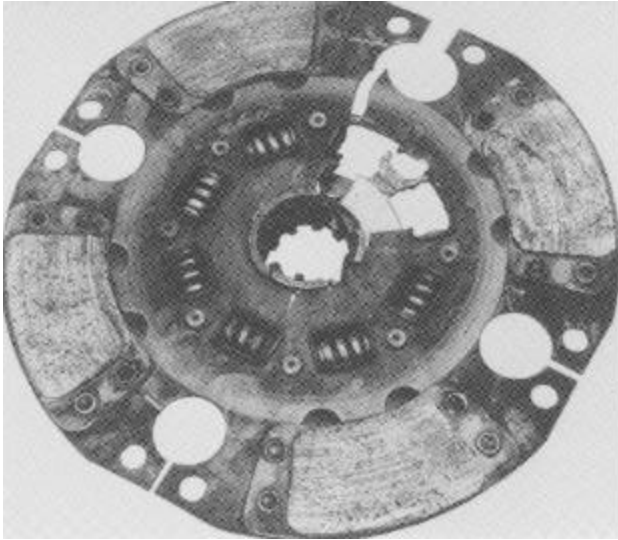
**Figure 32 Cracked or Broken Driven Disc**

9. Cracked or broken driven disc due to a severe shock load (Figure 32).

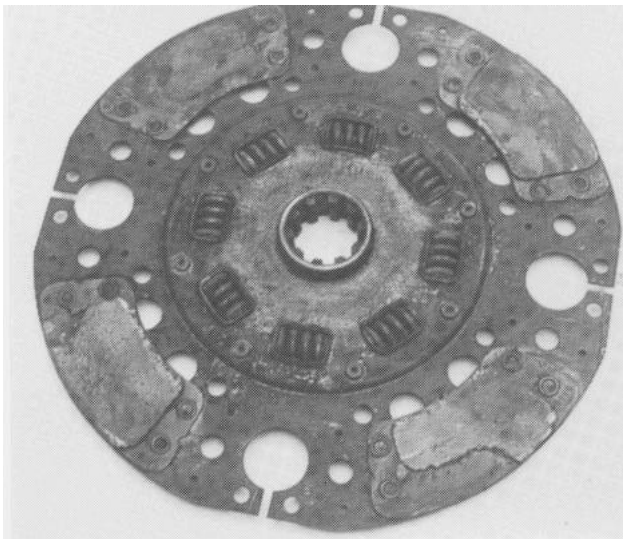
**Figure 33 Damaged Facings**

10. Facings separate from the driven disc and the pressure plate, center plate and flywheel show severe damage caused by excessive slippage (Figure 33).

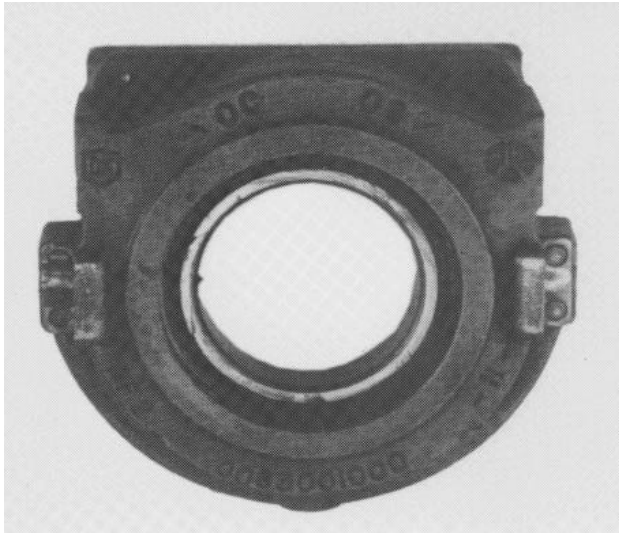
**Figure 35 Uneven Wear on Housing Wear Pads**

- a. Lack of periodic lubrication (does not apply to sealed bearings).
  - b. Failure to fully release or riding the clutch pedal.
  - c. Failure to use the recommended lubricant.
2. Uneven wear on housing wear pads is caused by worn or damaged cross shaft bushings or cross shaft (Figure 35).

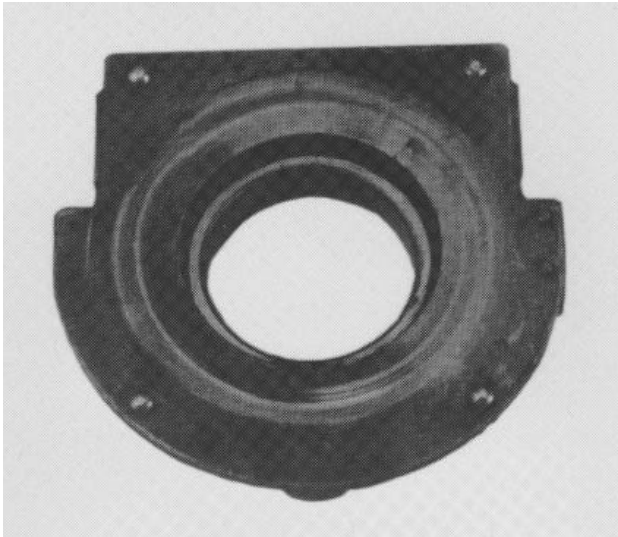
**Figure 36 Excessive Housing Cover Wear**

3. Excessive housing cover wear can be caused by a linkage system out of adjustment or driver shift technique (Figure 36).

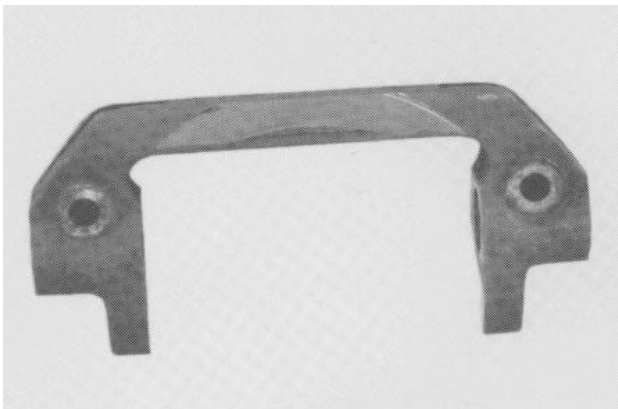
**Figure 37 Release Fork Bridge Contacting Cover Assembly**

1. Release fork bridge contacting the cover assembly (Figure 37). Inspect for the following causes:

- a. Worn clutch brake.
  - b. Broken or missing clutch brake.
  - c. Worn or incorrect transmission bearing cap.
  - d. Excessive wear on release bearing housing wear pads.
  - e. Excessive wear on release fork fingers.
  - f. Incorrect linkage adjustment.
  - g. Incorrect release fork.
  - h. Machined too much material from the flywheel.
2. Worn fork fingers (Figure 38).

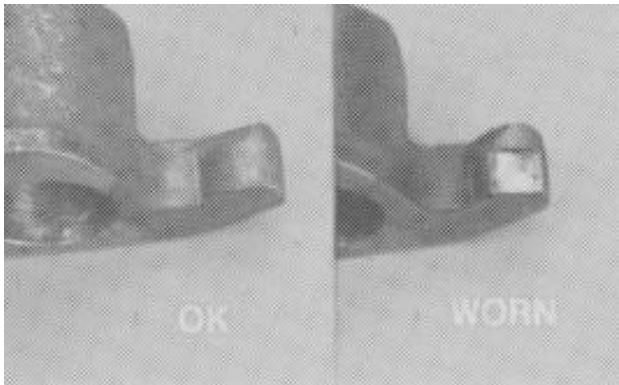
**Figure 38 Worn Fork Fingers**

- a. Failure to maintain free pedal.
- b. Driver abuse by riding the clutch pedal.

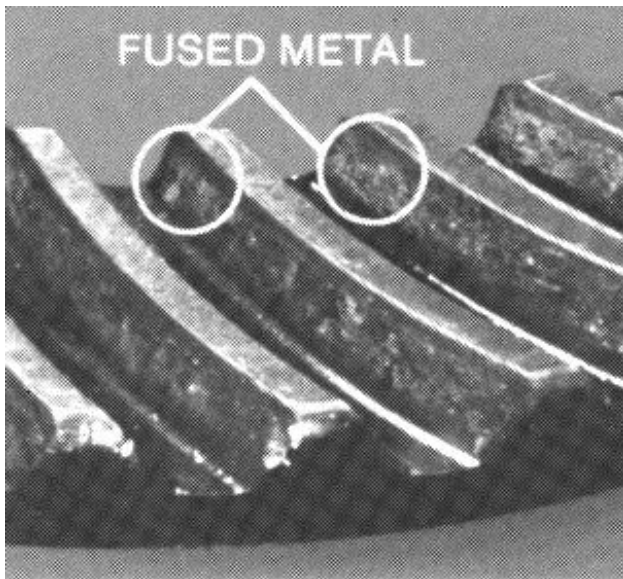
**Figure 39 Gear Teeth Surface Fused**

1. Gear teeth surface fused. A charred appearance indicates an overheated condition. Metal lifted off the pinion and fused to the ring gear teeth (Figure 39). This is due to lack of lubricant.

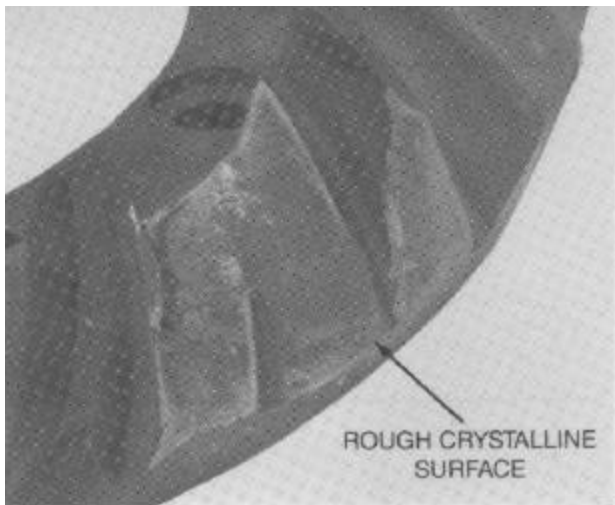
**Figure 40 Shock Load**

2. Shock load. Teeth as shown in Figure 40 were in mesh with the pinion and were subjected to an instantaneous shock load. The fracture is rough and looks crystalline.

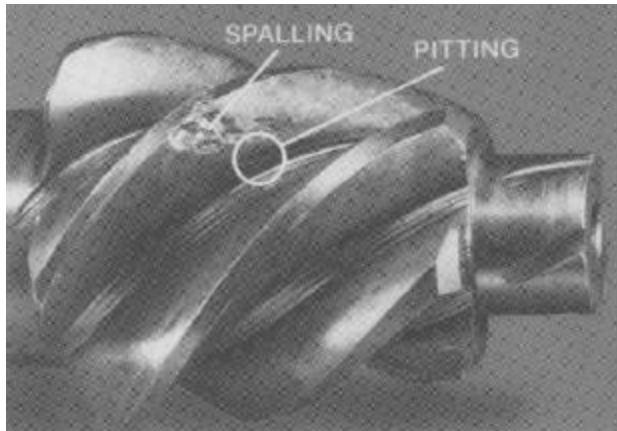
**Figure 41 Spalling and Pitting**

3. Spalling and pitting. Flakes of metal have broken off the tooth surface to create a spalled condition (Figure 41). This failure started with pitting at the tooth root and advanced to spalling at the tooth working surface. It is usually caused by continuous overloading.

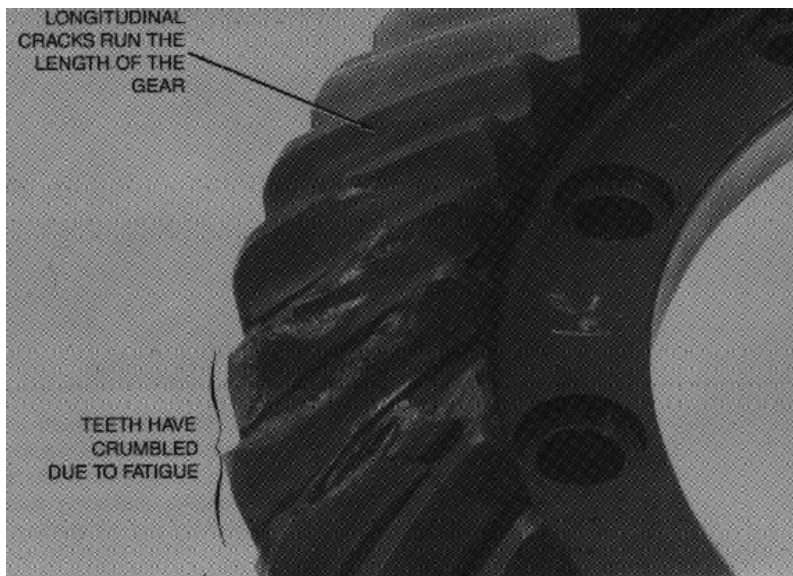
**Figure 42 Flank Cracking**

4. Flank cracking. This type of fatigue failure will first develop cracks that run the length of the tooth face. Once the cracks appear, the metal between them begins to flake away and failure occurs rapidly (Figure 42).

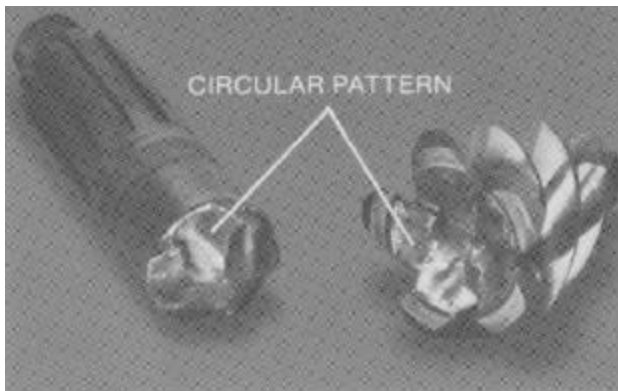
**Figure 43 Drive Pinion Fatigue Failure**

5. Drive pinion fatigue failure. A torsional and bending force caused the pinion in Figure 43 to fail. The failure was probably due to operational overloads or a shock load.

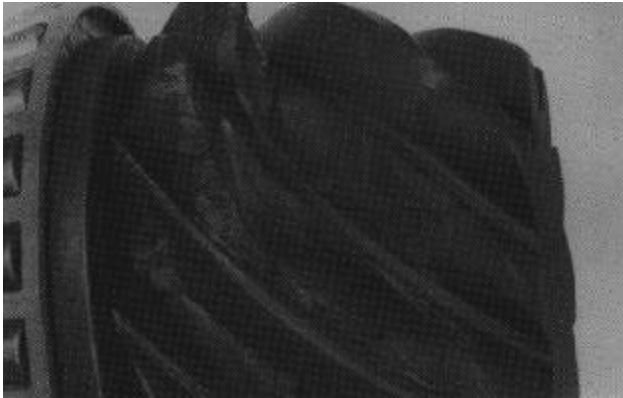
**Figure 44 Root Beam Fatigue**

6. Root beam fatigue. Figure 44 shows typical root beam bending fatigue beach marks at the roots of all damaged teeth. If the remaining teeth are in good condition, the probable cause was a shock load.

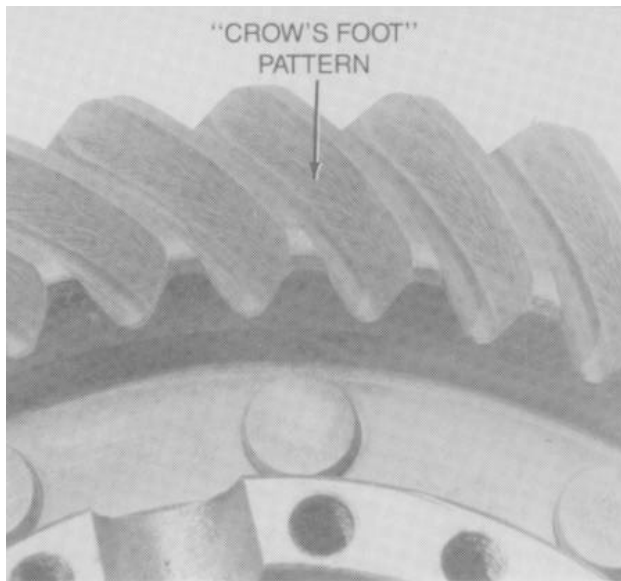
**Figure 45 Crows Foot Pattern**

7. Crows foot pattern. This pattern on gear teeth is characteristic of wear caused by improper lubricants or lubricants with depleted additives (Figure 45).

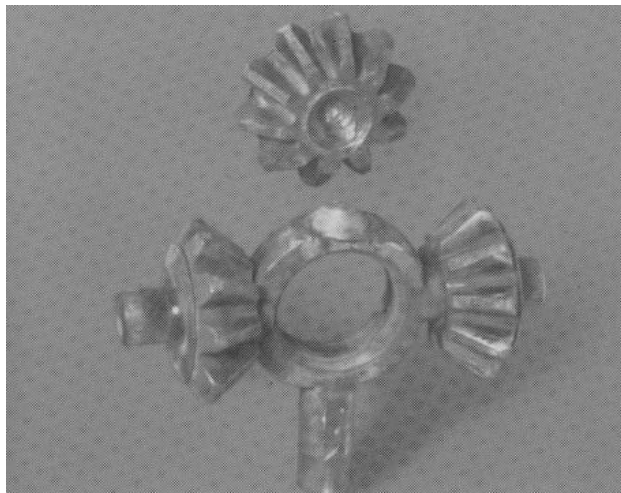
**Figure 46 Spinout Failure**

1. Spinout failure. This type of failure is caused by excessive wheel spinning. Heat developed by the excessive speed of the differential gears will break down the lubricant film and metal to metal contact occurs. The pinion can weld to the cross and the cross will break (Figure 46).

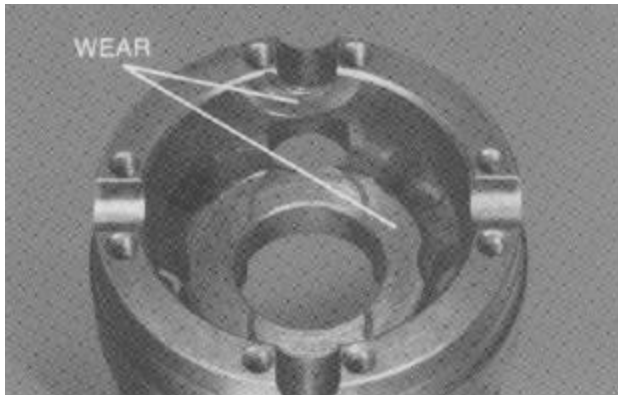
**Figure 47 Differential Case Worn and Scored**

2. Differential case worn and scored. Excessive spinout or low lubricant level can cause scoring and wear at case surface which contacts the thrust washers (Figure 47).

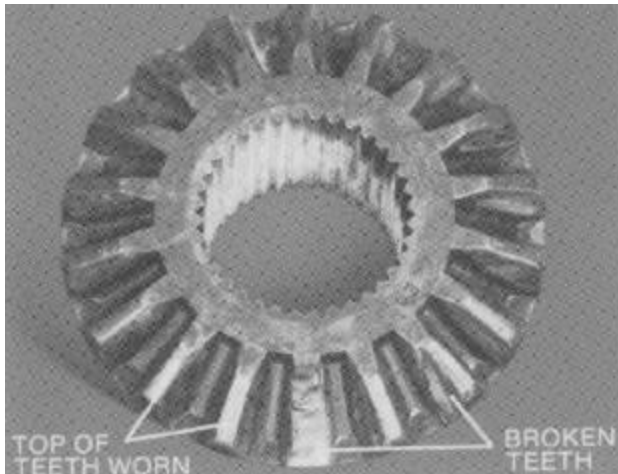
**Figure 48 Broken and Worn Teeth on Side Gear**

3. Teeth on side gear broken and worn. This failure is caused by contaminated lubricant. A part failed, contaminated the lubricant, then caused tooth wear and fracture (Figure 48).

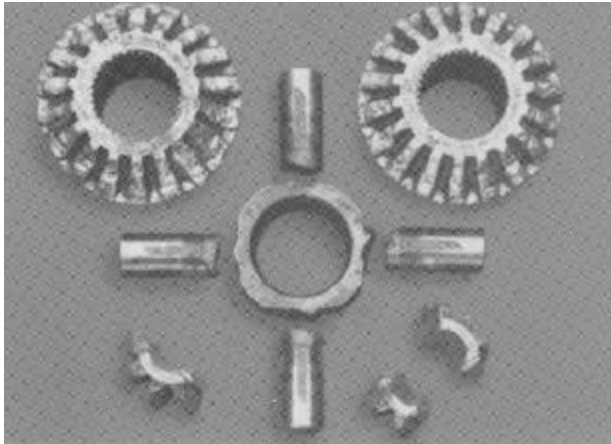
**Figure 49 Differential Shock Failure**

4. Differential shock failure.
  - a. A severe shock load fractured the cross and pinion gears. Continued operation damaged the side gear teeth (Figure 49).

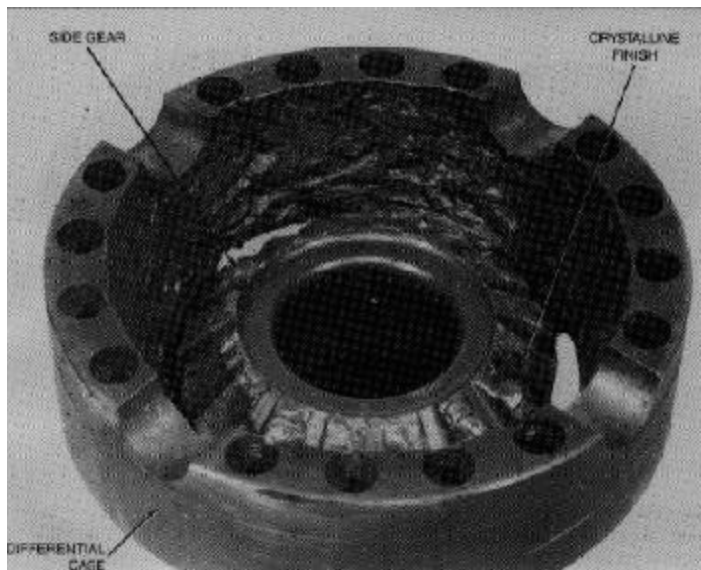
**Figure 50 Teeth Missing in Side Gear**

- b. Inspection of the inner case shows the side gear with its teeth missing (Figure 50). The gear teeth are extremely marred from the metal ground into them. The fractures show a rough crystalline appearance typical of an instantaneous shock load failure.

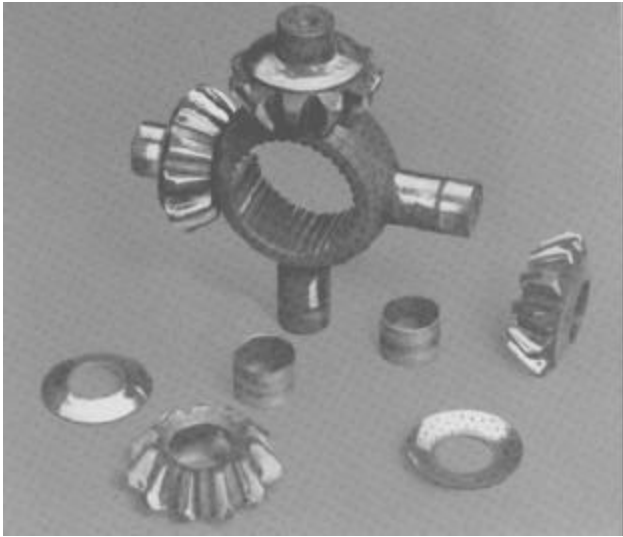
**Figure 51 Excessive Differentiation**

- a. The components in Figure 51 show the effect of excessive differentiation. The cross is worn and scored, bushings are scored and thrust washers are worn. The side pinion teeth are worn and chipped and the cross shows irregular shaped splines.

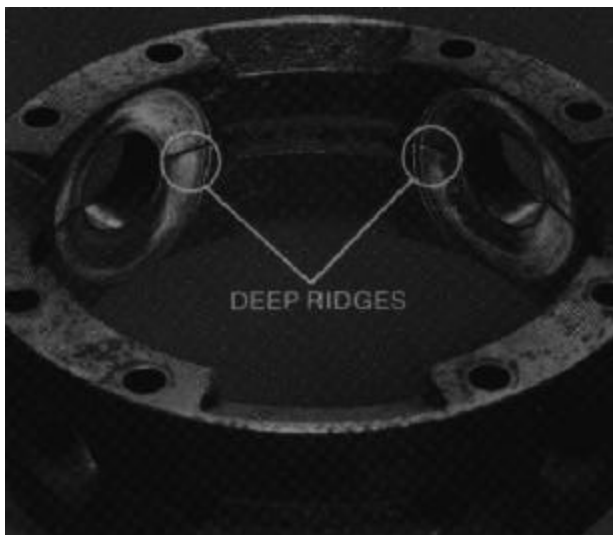
**Figure 52 Worn Case Thrust Washer Surface**

- b. Case thrust washer surface worn (Figure 52). Metal to metal contact caused this wear pattern in the case wall. The deep ridges at the edge of the pattern requires case replacement.

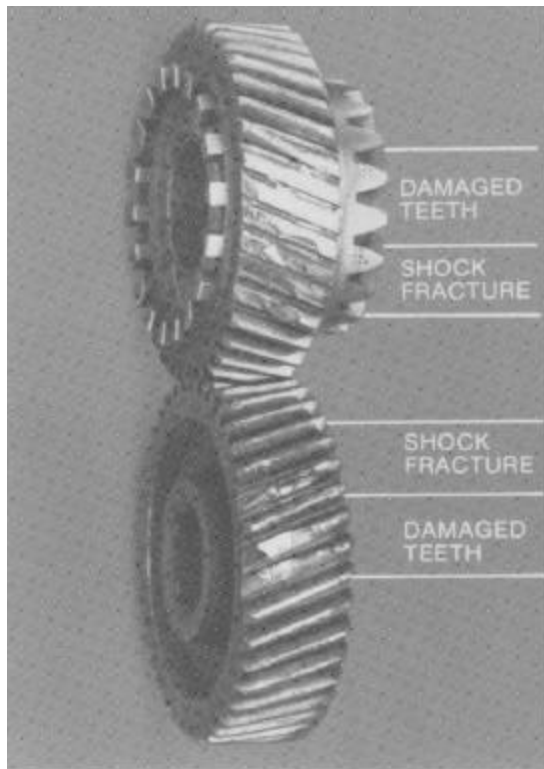
**Figure 53 Damaged Teeth Due to Shock Impact**

1. Damaged teeth due to shock impact. One sudden shock impact fractured the engaged teeth of these two gears. The adjacent teeth were damaged by metal pieces (Figure 53).

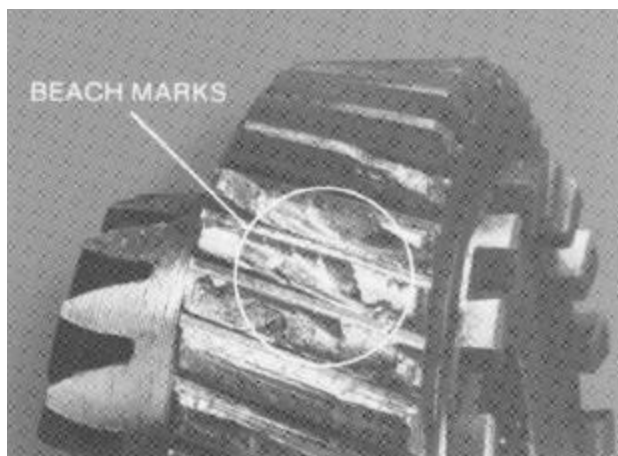
**Figure 54 Broken Gear Teeth From Fatigue Failure**

2. Broken gear teeth from fatigue failure. A shock load to the gear teeth in mesh produced cracking of the case hardened tooth surface. Continued loading resulted in a progression of fractures as evidenced by beach marks (Figure 54).

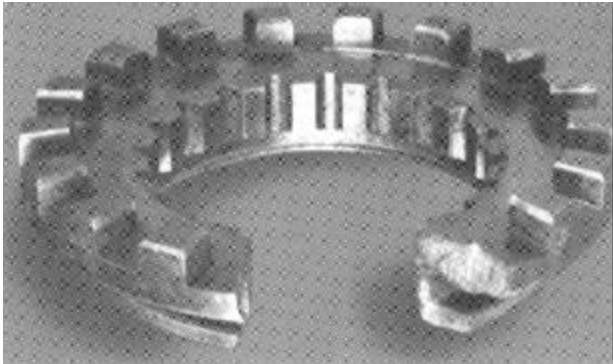
**Figure 55 Broken Sliding Clutch**

3. Broken sliding clutch. An instantaneous shock load created the rough surface pattern on the fracture (Figure 55). This can be caused by trying to engage the inter-axle differential lockout while the wheels are spinning.

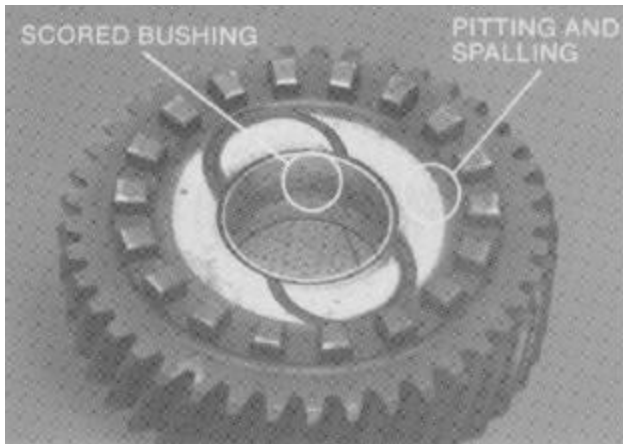
**Figure 56 Gear Bushing Scored**

4. Gear bushing scored. Contaminated lubricant with fine particles caused scoring. Some pitting and scoring has occurred on the gear thrust washer surface (Figure 56).

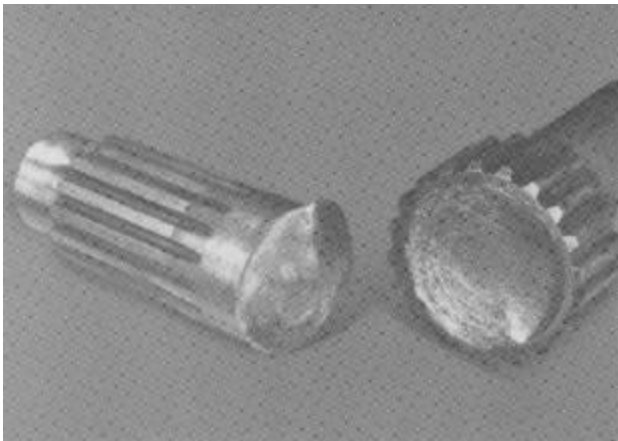
**Figure 57 Input Shaft Broken**

5. Input shaft broken. Multiple shock loads produced the flat, rough break of this input shaft (Figure 57). It can be caused by abusive truck operation, incorrect use of inter-axle differential lockout or abusive clutch operation.

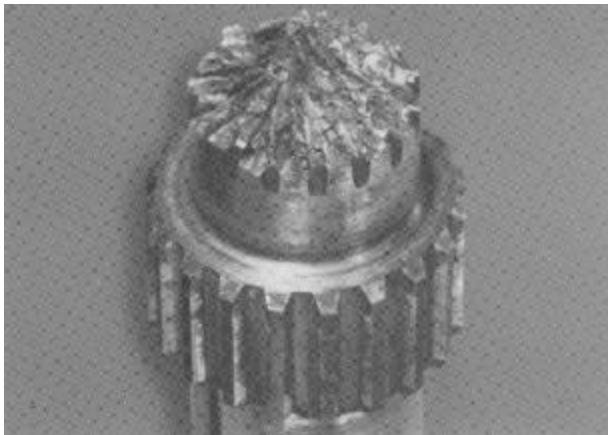
**Figure 58 Input Shaft Torsional Fatigue Failure**

6. Input shaft torsional fatigue failure. The shaft surface initially cracks from an extremely high load. The cracks progress to the center of the core under normal operation until the shaft fails (Figure 58).

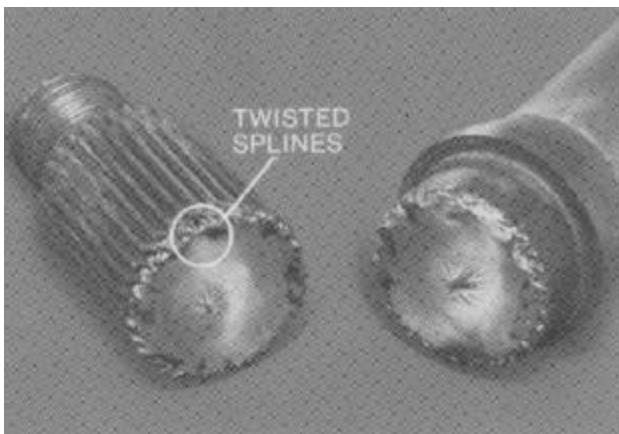
**Figure 59 Output Shaft Torsional Shock Failure**

7. Output shaft torsional shock failure. This is the result of a shock load and can occur in a single impact (Figure 59). The direction of spline twist will indicate whether the vehicle was moving forward or in reverse.

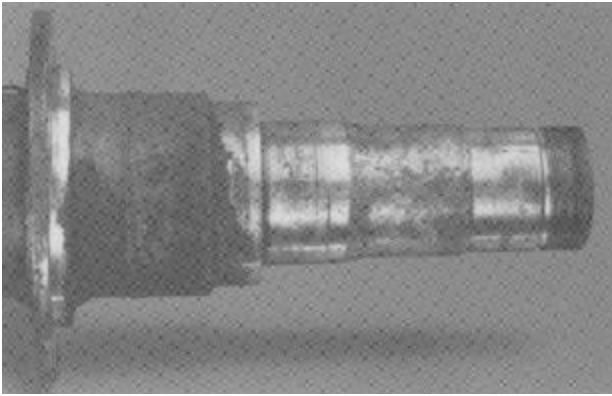
**Figure 60 Worn and Scored Spindle**

1. Worn and scored spindle. Lack of lubricant is the cause of scored or worn spindles. Contamination will create a combination of metal to metal abrasive action. The bearing can seize and the inner cone will turn on the spindle causing a scored condition (Figure 60).

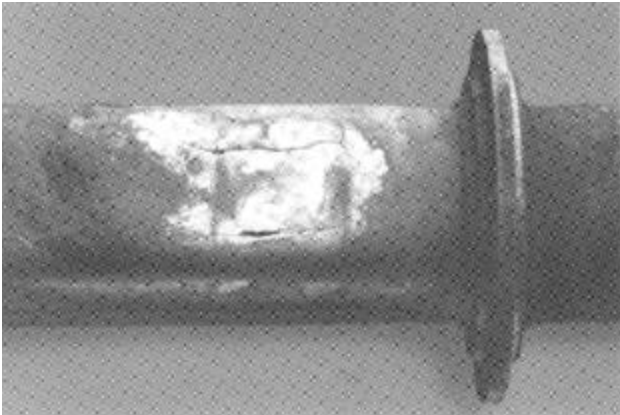
**Figure 61 Cracks at Spring Pad Area**

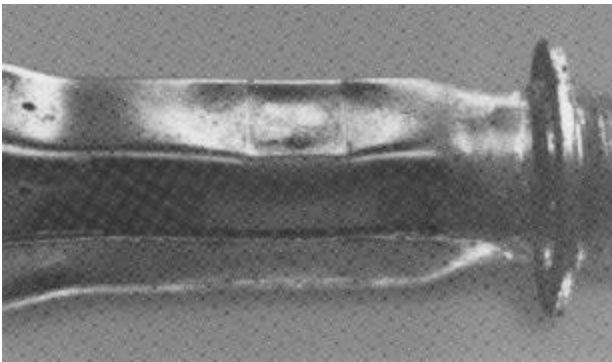
**Figure 62 Axle Housing Crushed in Spring Pad Area**

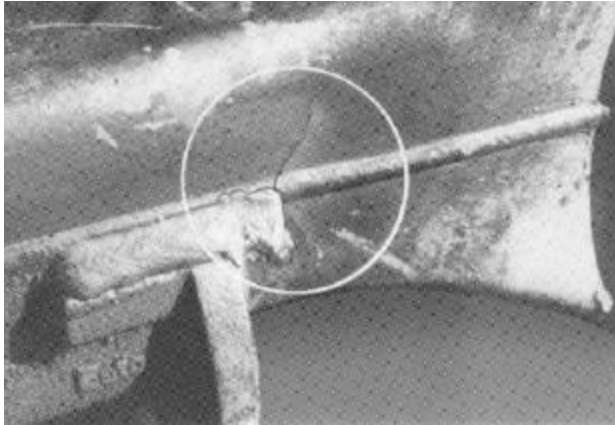
**Figure 63 Axle Fatigue Cracks at Weld**

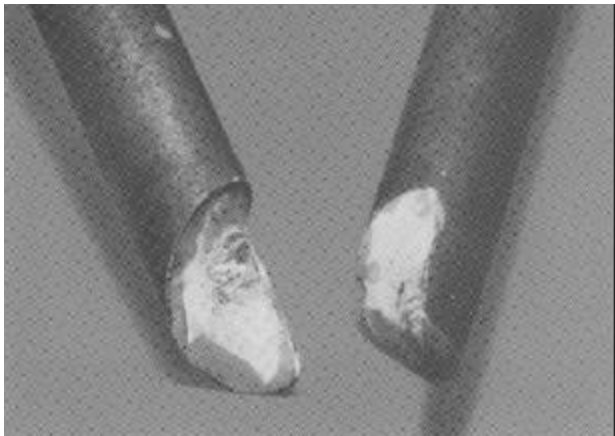
**Figure 64 Axle Shaft Failure**

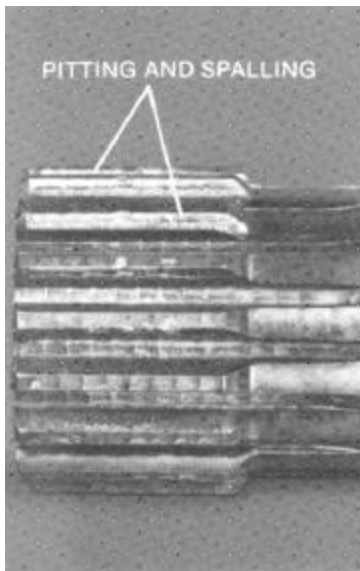
**Figure 65 Pitting and Spalling**

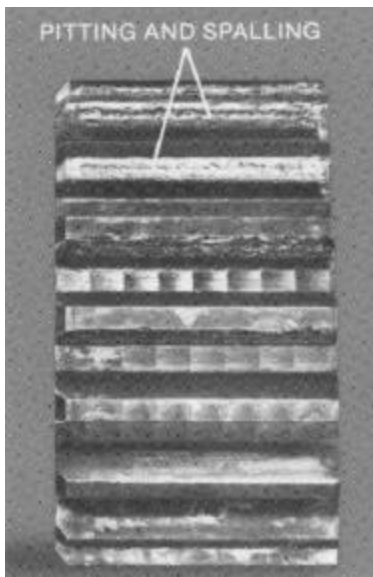
**Figure 66 Pitting and Spalling**

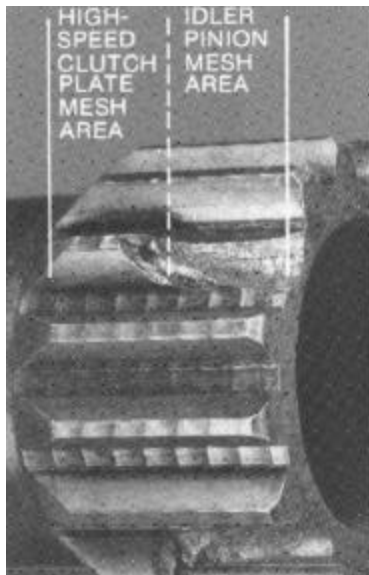
**Figure 67 Broken Teeth on Sliding Clutch Gear**

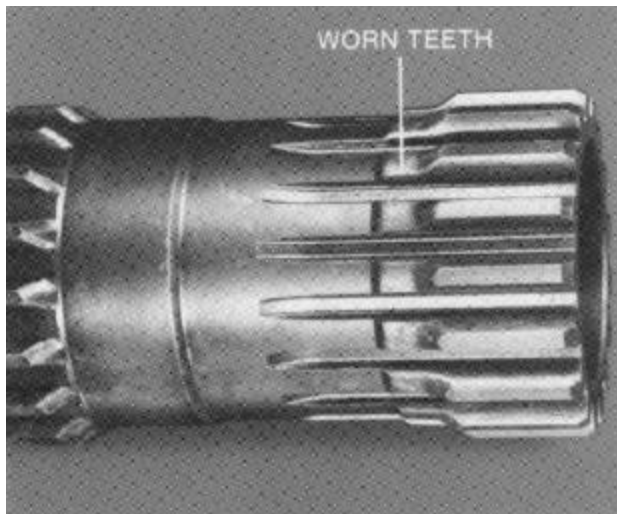
**Figure 68 Excessive Wear to Sliding Clutch Gear**

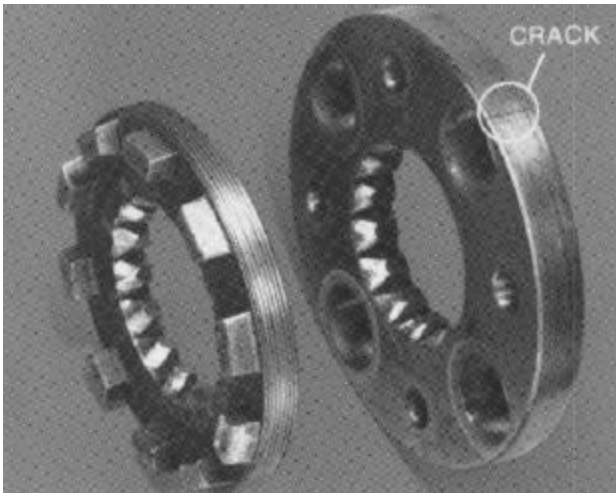
**Figure 69 Excessive Wear to Sliding Shifting Plates**

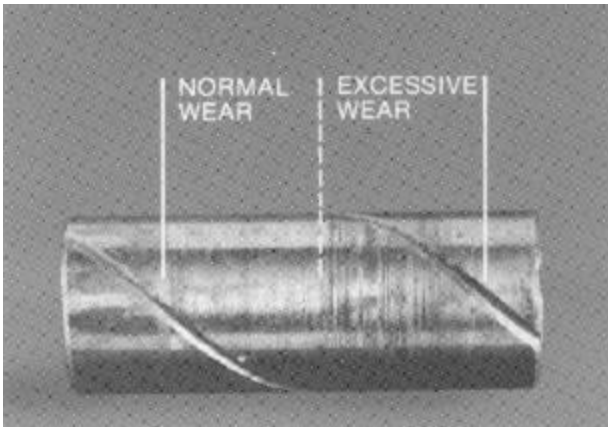
**Figure 70 Normal and Excessive Wear on Idler Pin**

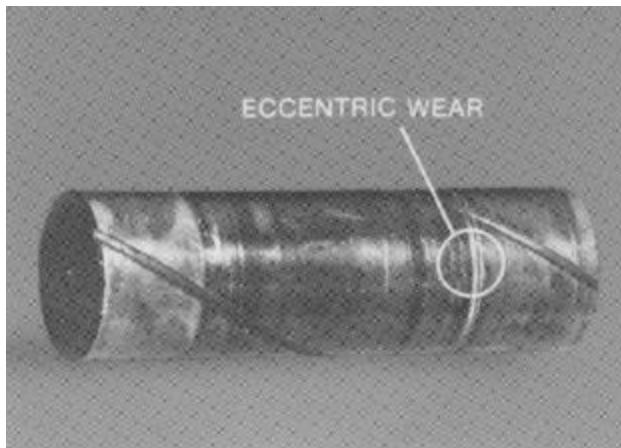
**Figure 71** Scored and Worn Idler Pin

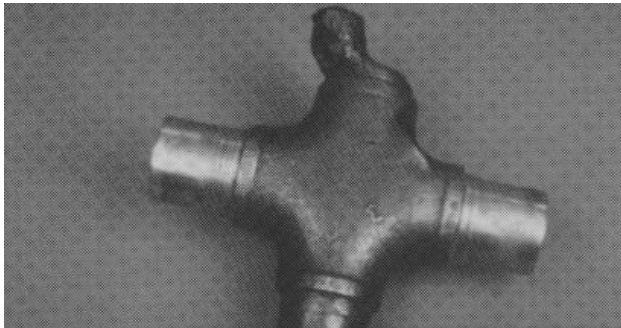
1. Burned U-joint cross (Figure 72):

**Figure 72** Burned U-Joint Cross

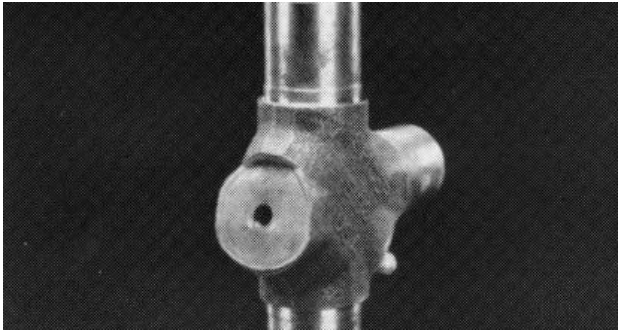
**Figure 73 Fractured U-Joint**

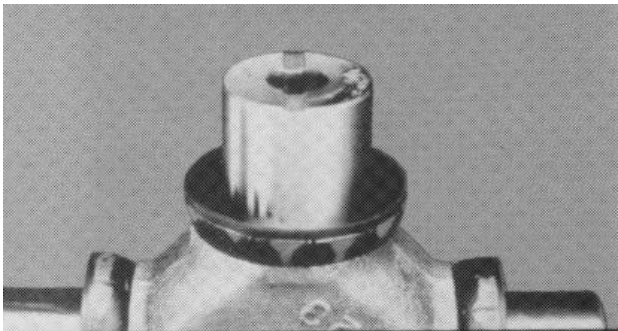
**Figure 74 End Galling**

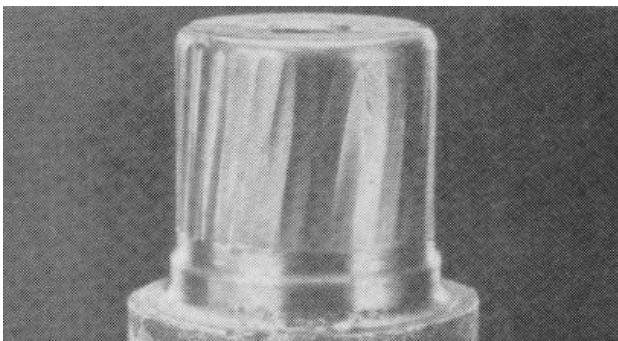
**Figure 75 Brinelling**

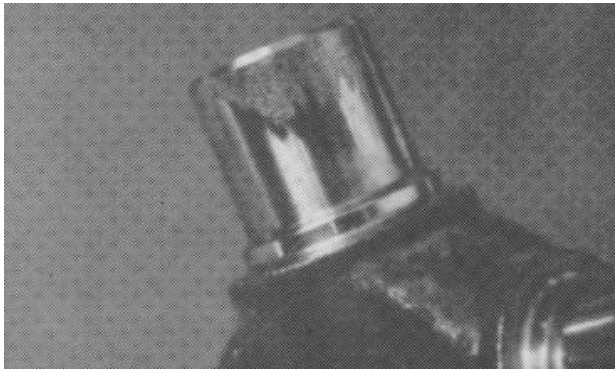
5. Spalling (Figure 76):

**Figure 76 Spalling**

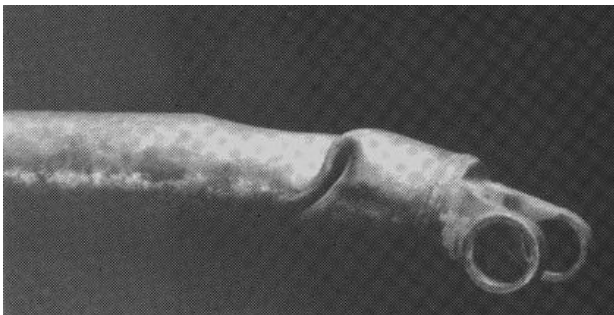
**Figure 80 Bent Tubing**

1. Bent tubing (Figure 80):

- a. Excessive torque.
- b. Axial shock load.
- c. Improper service procedures.

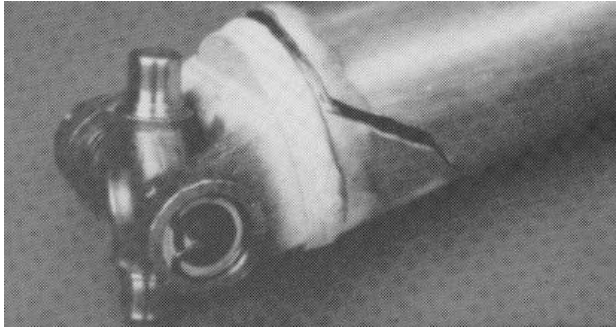
**Figure 81 Broken Weld**
