Authorized Field Change

AFC G-06917

Subject: Leaking Fuel Line on VT 275 Engines

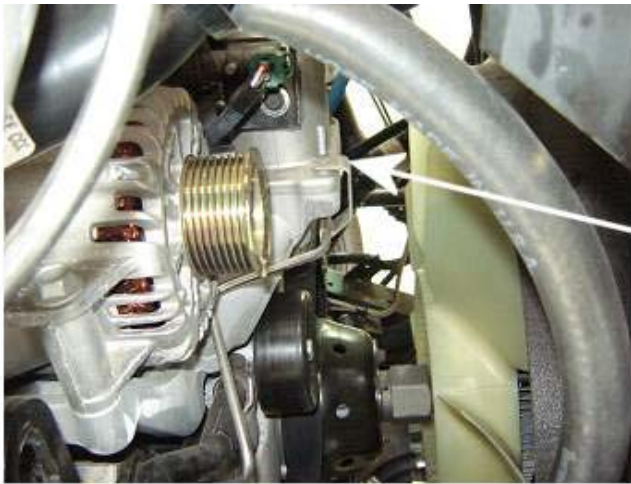
Remove support
bracket retaining nut
and remove fuel line

1. Loosen fan belt and slip it off the alternator.
2. Loosen fuel line clamp retaining nut on front of the engine. Fuel line is slotted so it will slide off of the stud.
