# Authorized Field Change

AFC G-07909

**Subject:** Leaking Fuel Line on VT 275 Engines

Model: W42

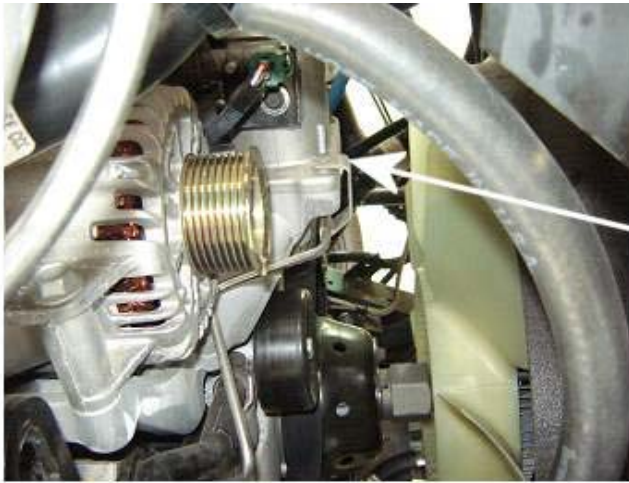
1. Loosen fan belt and slip it off the alternator.
2. Loosen fuel line clamp retaining nut on front of the engine. Fuel line is slotted so it will slide off of the stud.

Remove support  
bracket retaining nut  
and remove fuel line

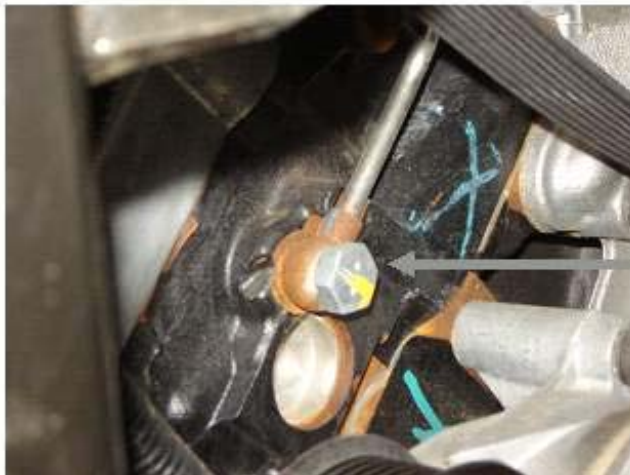
3. Remove banjo bolt from right cylinder head and discard copper seals.

Remove banjo bolt from right  
head

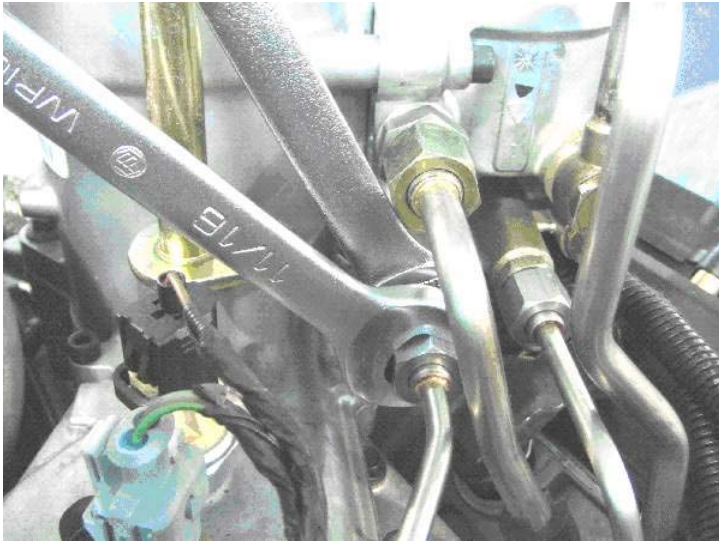
4. Loosen fuel line from filter housing using two wrenches, remove support bracket retaining nut and remove fuel line and discard.

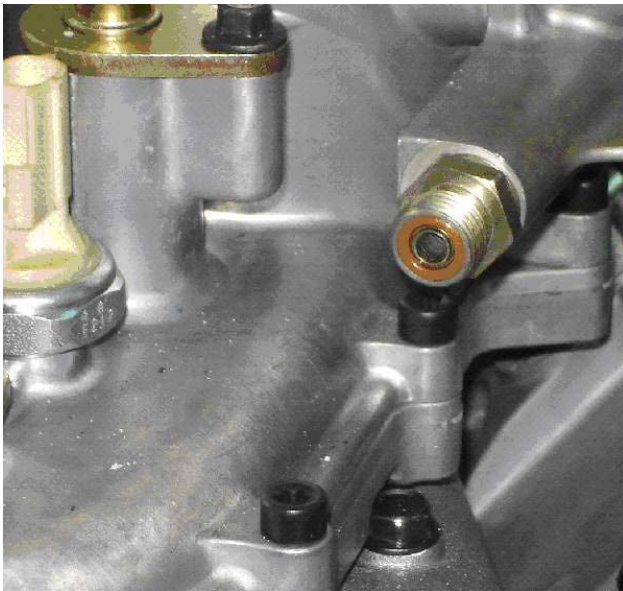
5. Inspect O-ring in fuel filter for damage and replace if needed. **NOTE: O-ring is included in the kit.**

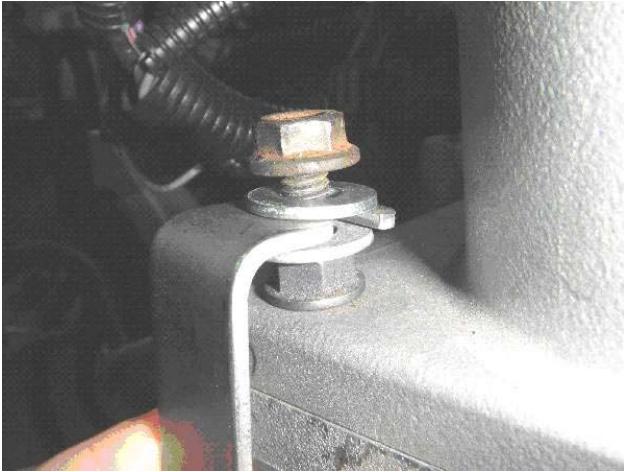
6. Install two washers (Included in kit) and nut on to support bracket stud.

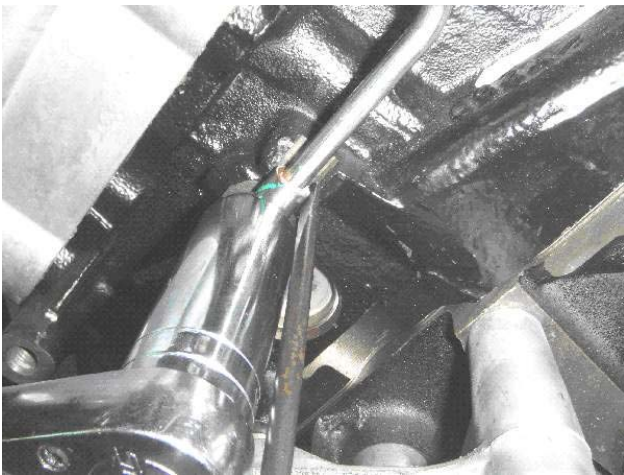
7. Install fuel line so the support bracket is located between the two washers.
8. Install new copper seals (included in kit) on banjo bolt and install hand tight.
9. Install fuel line to the fuel filter housing and hand tighten.
10. Torque banjo bolt to 38 Nm (28 lbf-ft) while holding screwdriver between banjo fitting and tabs on head.

**NOTE – Make sure screwdriver is on banjo fitting and not on fuel line.**

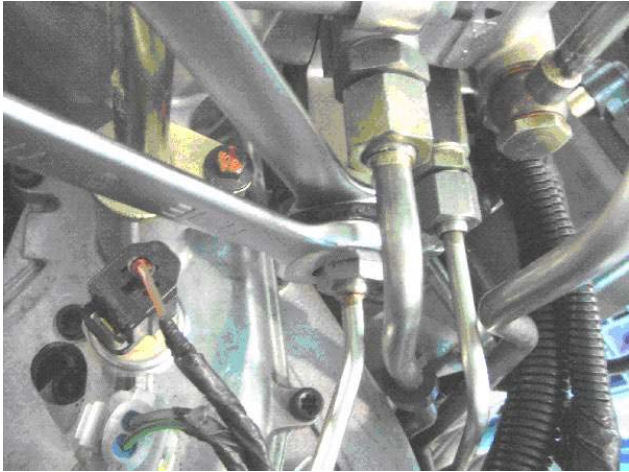
11. Tighten fuel line to fuel filter housing using two wrenches. Torque value is 25 Nm (18 lbf-ft)

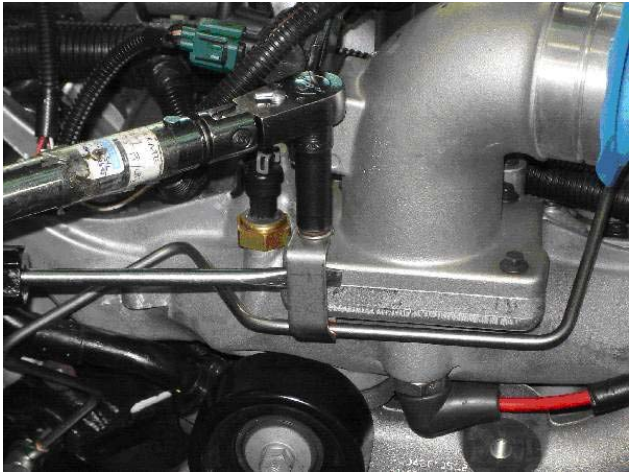
12. Torque support bracket nut to 11 Nm (96 in-lbs) while holding fuel line in place.

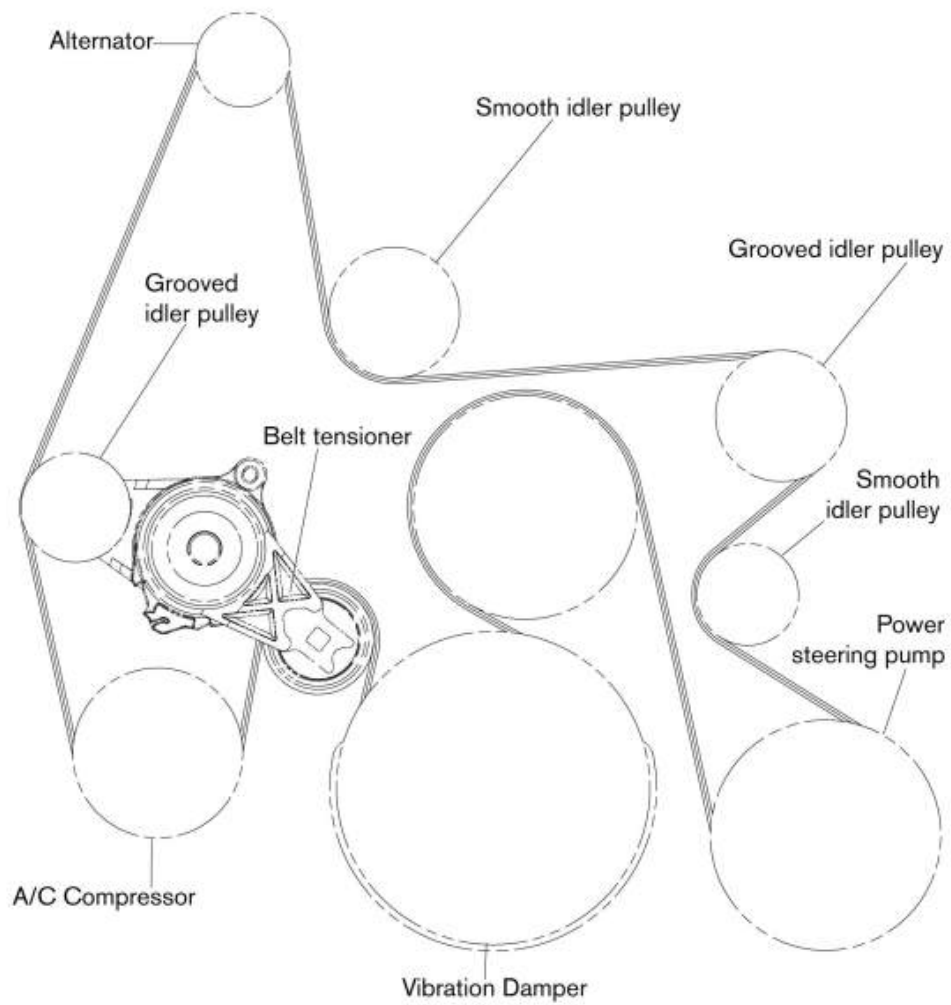
13. Install fan belt on to alternator making sure routing is correct and the tensioner lock is released.
