# Authorized Field Change

AFC 05915

**Subject:** The Engine to Dash Harness used with Caterpillar and Cummins Engines in Certain International® 7000, 8000 HPV Models Built Between May 18, 2001 and April 28, 2005 may have a Missing Harness Connector Seal

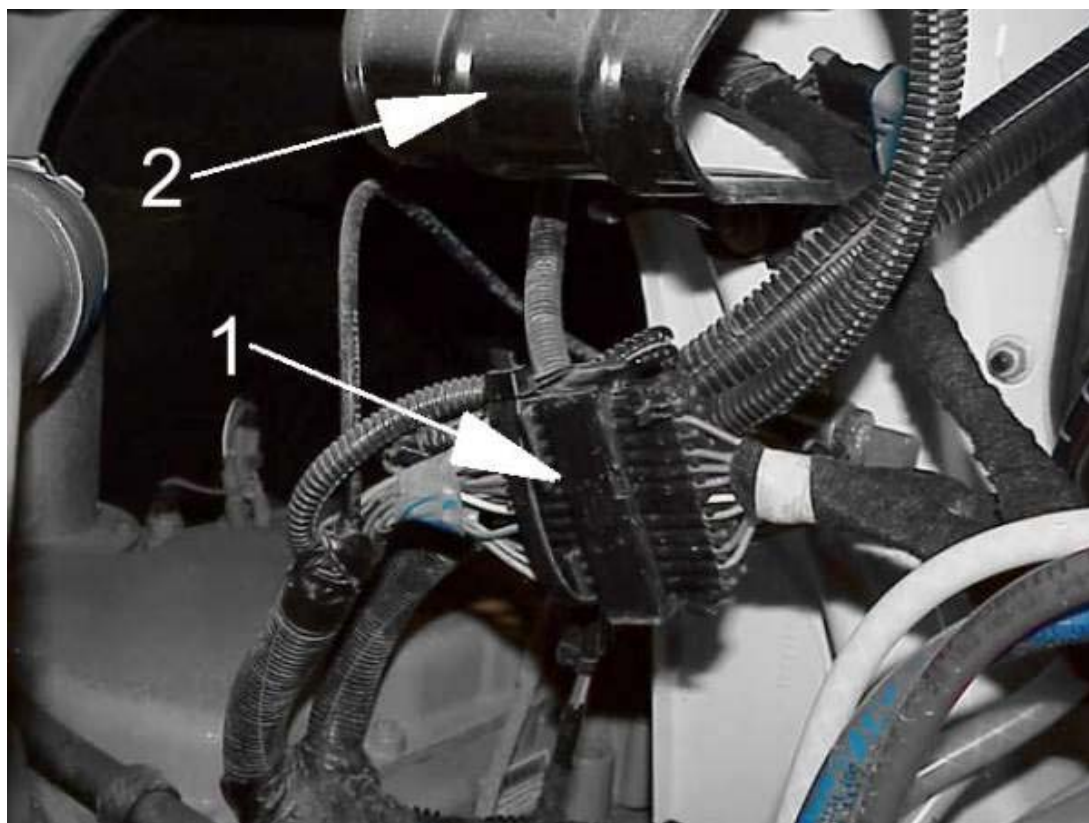
**Figure 1** Location of 4103 Connector

1. 4103 Connector
2. Windshield Wiper Motor Bracket

1. Locate the engine to dash harness connector 4103, on the driver side of the engine and near the windshield wiper motor bracket (Figure 1). Cut tie straps as needed.

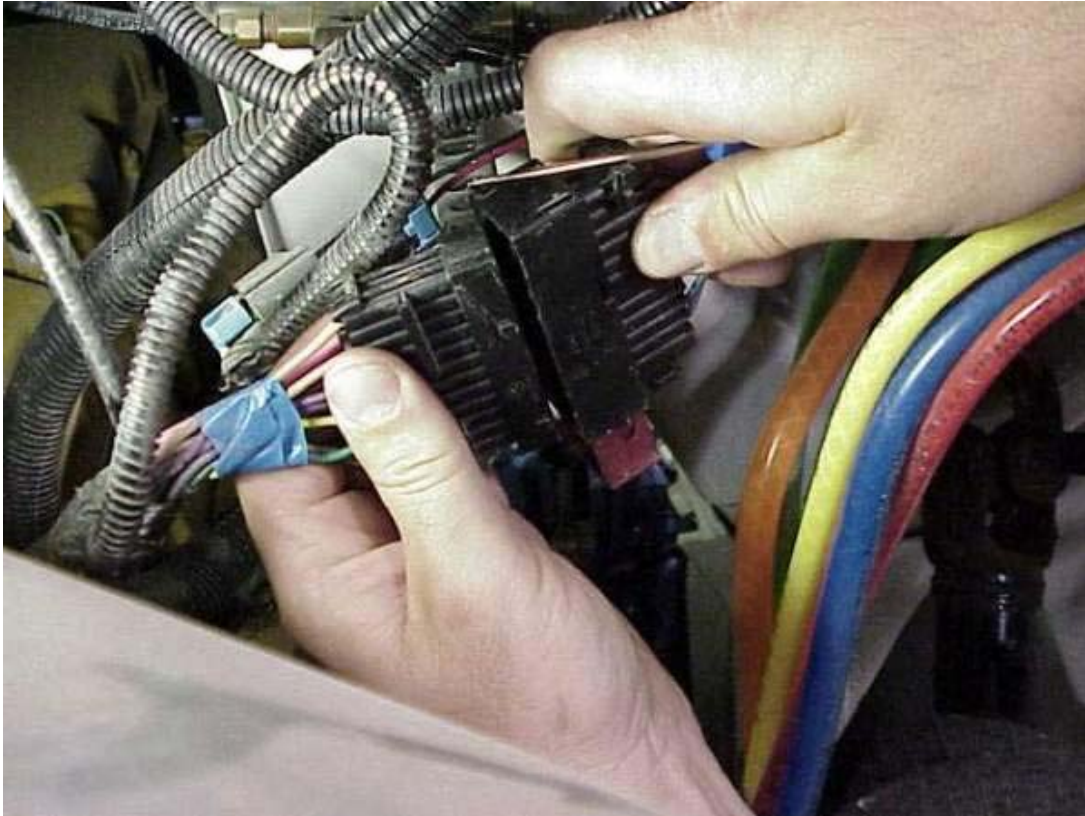
**Figure 2 Disconnect Harness Connector 4103 (Do Not Pry)**

### 2. Disconnect harness connector 4103 (Figure 2).

Do not try to pry the connector “red” lock to separate the connector:

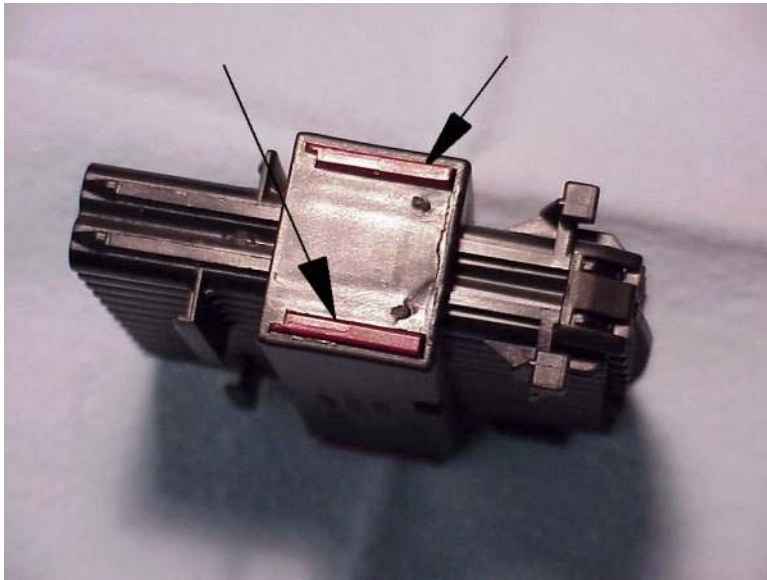
**Figure 3** Release Lock Tabs at Arrows

- Apply pressure to the two (2) lock tabs (Figure 3) until a clicking sound is heard.
- Slide the lock out to release the connector halves (Figure 4, Item 2)
- To re engage the connector lock, press on the lock tab (Figure 4, Item 1) and slide the lock into the connector.

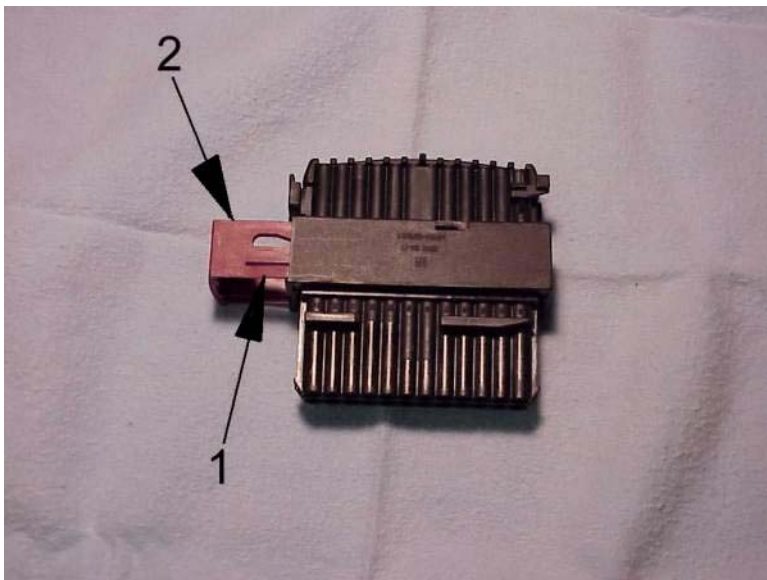
**Figure 4** Connector Lock

1. Release tab to re engage lock
2. Connector lock

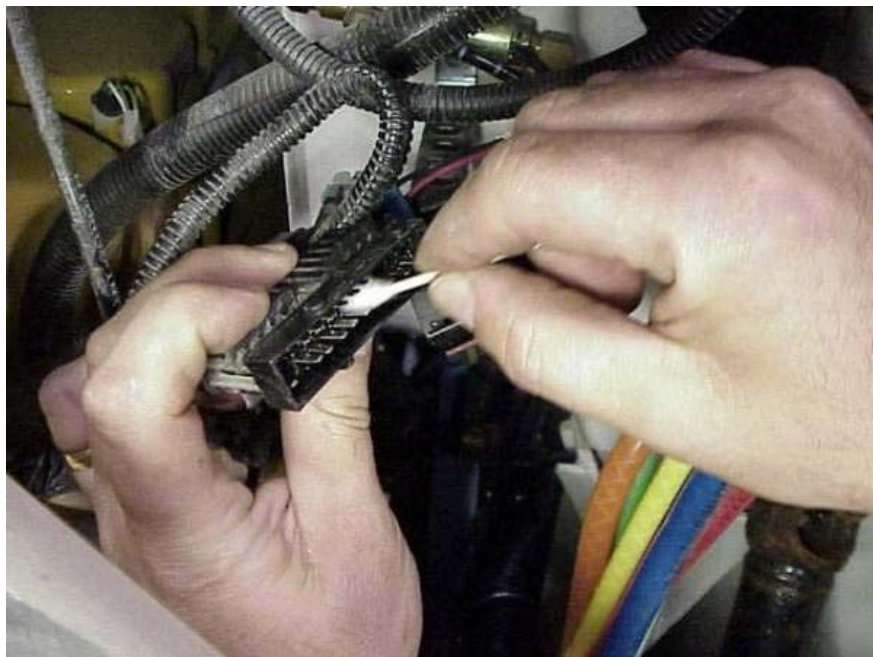
There are different levels of corrosion that can appear on the connector pin. The pins might exhibit a dark green or blue color corrosion. With this condition the engine harness will need to be replaced. If the connector pins exhibits a light green corrosion the pin will need to be cleaned and inspected for dark spots on the connector pin.

**Figure 5 Clean Connector Pins**

3. Inspect the connector pins for corrosion. If there are **no more** than three (3) connector pins with corrosion, spray the connector pins with Ecoline Contact Cleaner from the kit following the instructions on the aerosol can. Use a Q-Tip or equivalent to remove all evidence of corrosion (Figure 5). Re-inspect the pins that were cleaned of corrosion and look for dark spots. If dark spots are present replace up to (3) pins, on both the male and female side of the connector.

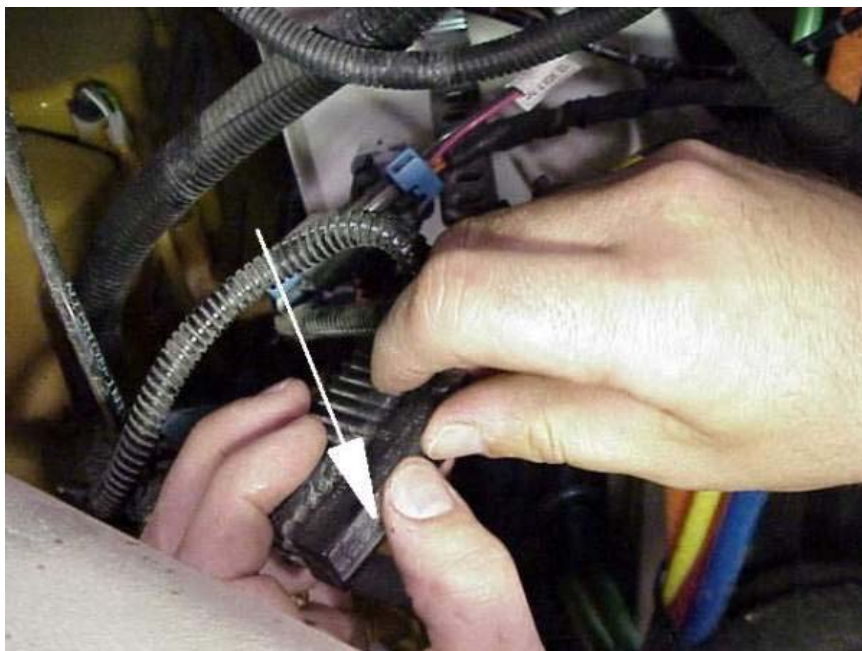
**Figure 6 Install Connector Seal (Arrow)**

- When the connector is dry, spray the connector pin with RID-OX Contact Enhancer from the kit following the instructions on the aerosol can. Wipe off excess spray on the outside surface of the connector.
- Replace the corresponding female pins on the dash harness side of the connector.
- Install the connector seal from the kit (Figure 6).
- Reconnect the connector and replace tie straps that were cut.
- Start the engine and check for proper operation.

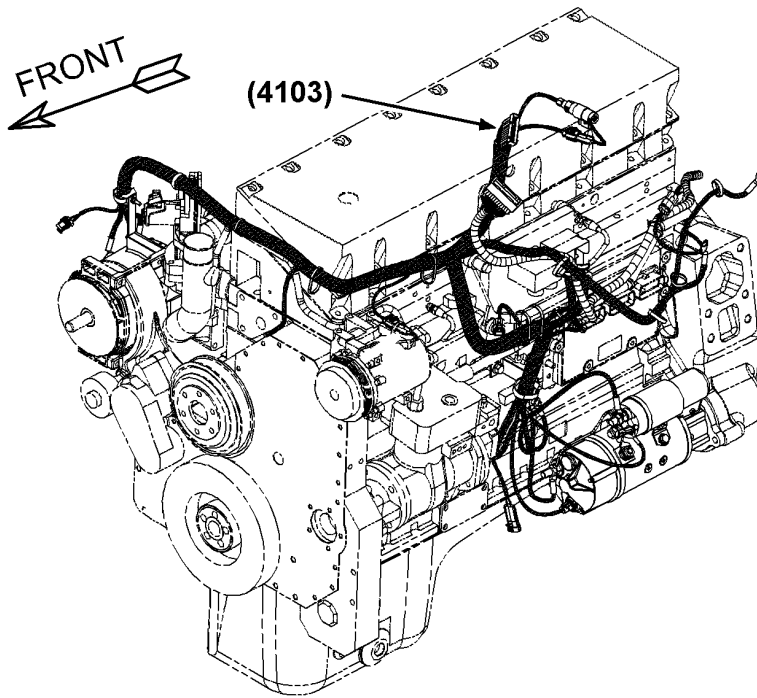
**Figure 7 Cummins Engine Harness Routing and Location of 24 Pin Connector (4103)**

4. Disconnect the battery negative cable and ECM ground.
5. Remove the passenger side engine splash shield.
6. Remove driver side fender extension.
7. Remove charge air cooler intake hose.
8. Disconnect the fan clutch assembly air line.
9. Disconnect crankcase ventilation breather assembly.
10. Disconnect fan clutch solenoid valve air line at solenoid.
11. Referring to Figure 7, Cummins , or Figure 8, Caterpillar, overlay the new engine harness on the existing harness. Beginning at one end of the old harness start disconnecting the harness connectors and connect the equivalent connectors on the replacement harness. Cut tie straps as needed and take note of the location. Continue working along the old harness to disconnect harness connectors and connect the equivalent connectors on the new harness.

12. Replace the female pins on the dash harness side of connector 4103 that correspond with the corroded male pins.

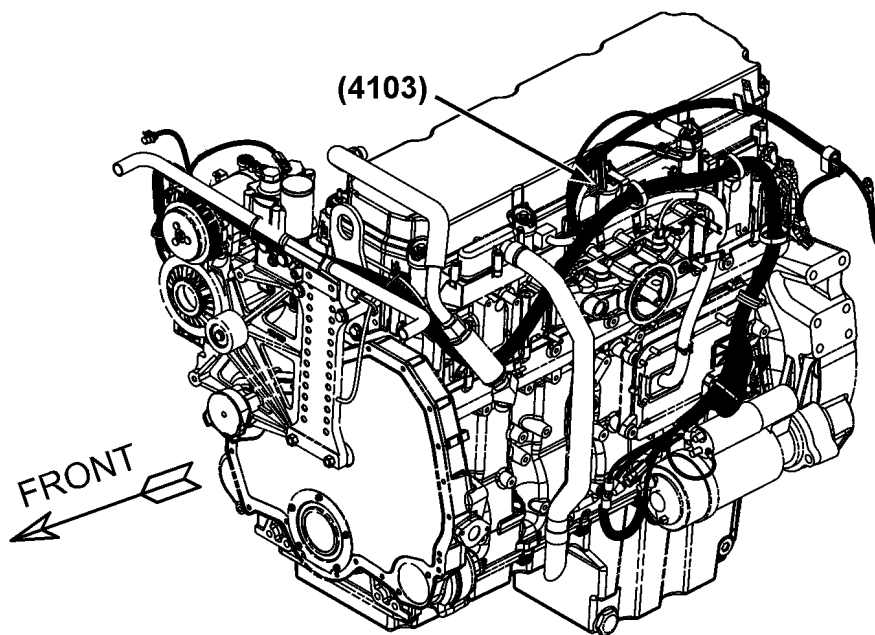
**Figure 8 Caterpillar Engine Harness Routing and Location of 24 Pin Connector (4103)**

13. Re-install / connect components following Steps 4 through 10 in reverse order.
14. Start the engine and check for proper operation.
