SERVICE PROCEDURE

G-07507

SUBJECT: SAFETY RECALL (U.S.)

**AUXILIARY POWER UNIT on certain 9000 Models
built 7/20/2006 thru 3/19/2007**

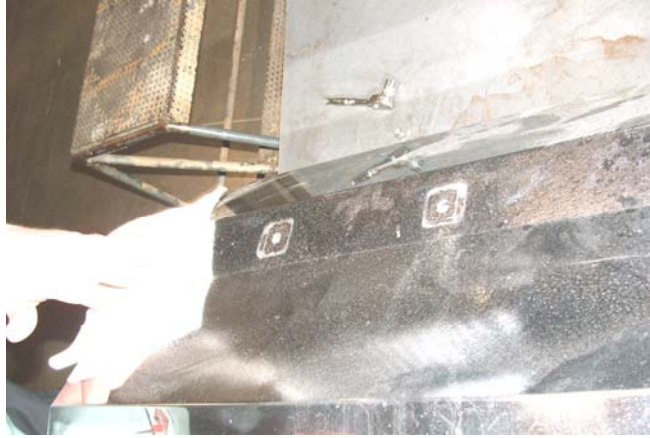
Figure 2

3.0 Remove handle from cover and clean entire label application surface.

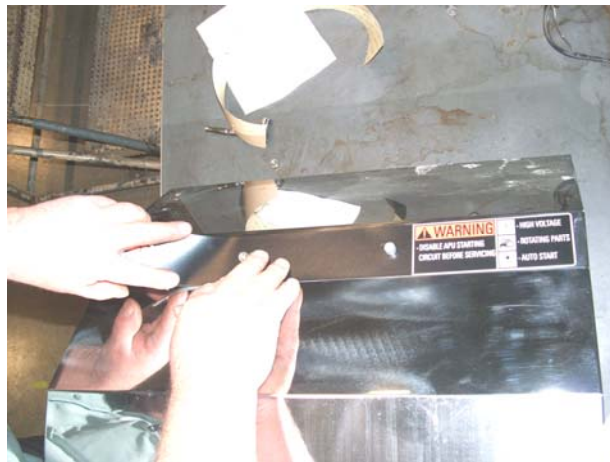
Figure 3

4.0 Install long warning label. Ensure holes in label line up with handle mounting holes in cover.

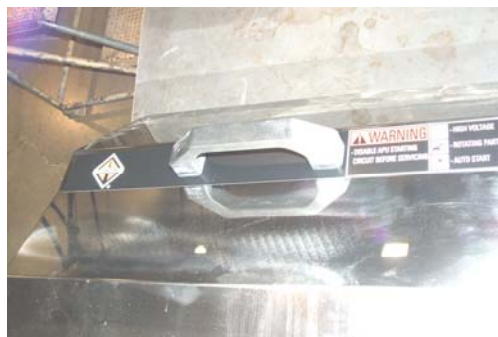
Figure 4

5.0 Re-install cover handle.

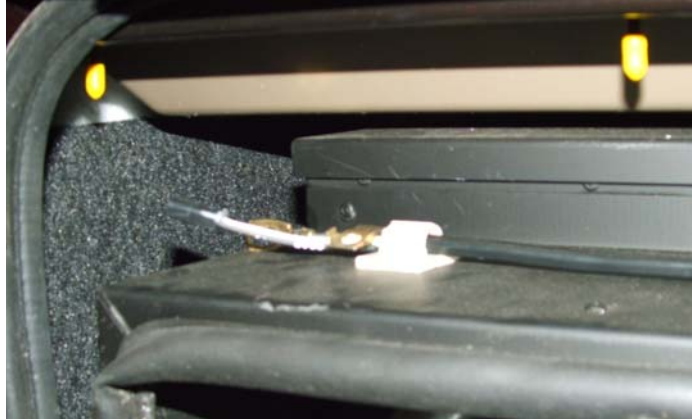
Figure 12

15.0 Some vehicles may have the passenger luggage door release cable and miscellaneous electrical connectors secured to top of HVAC unit. Please remove from top of HVAC unit and secure these cables out of the way.

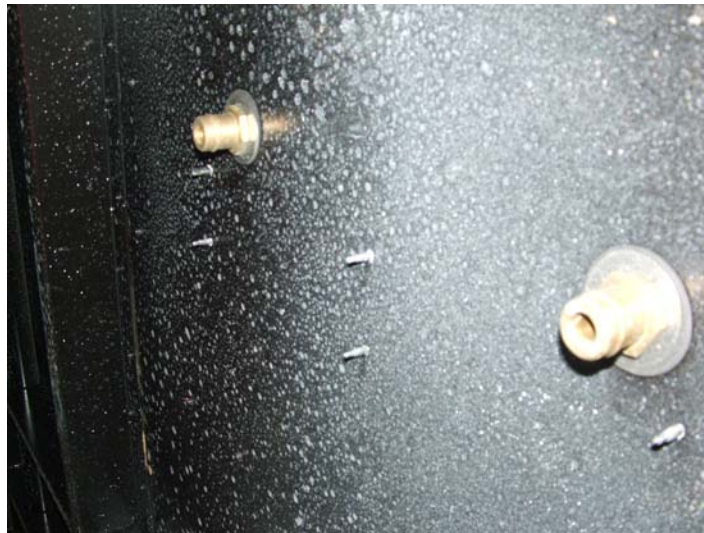
17.0 Remove HVAC drain fittings from underside of sleeper. Save hardware, it will be re-used on new HVAC unit.

Figure 13 – Looking up at underside of Sleeper Floor (HVAC fittings)

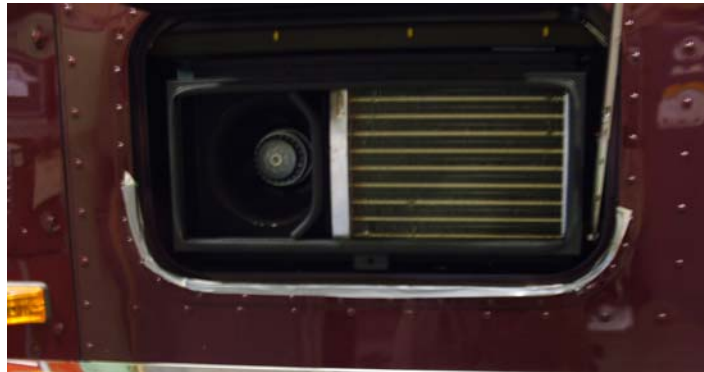
Figure 14

18.0 Protect exterior surface of cab while extracting HVAC unit.

NOTE: It is not recommended to use duct tape directly on painted surface. An initial layer of standard masking tape, then a layer of duct tape was used for Figure 14.

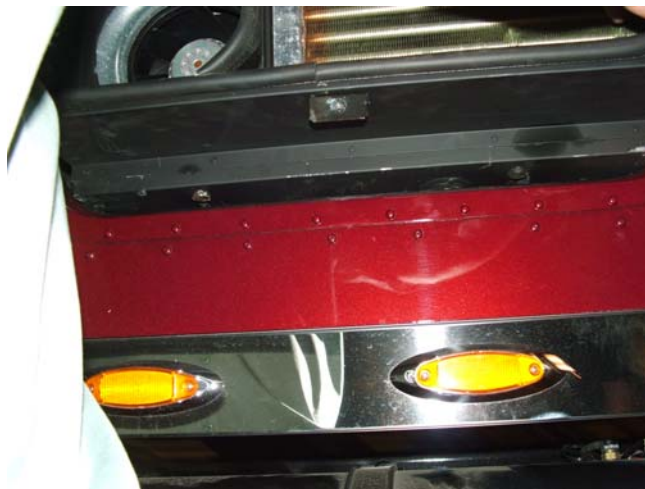
Figure 15

THE HVAC UNIT WEIGHS 135 LBS (62KG) AND IS HEAVIEST TOWARDS ITS REAR, OR ELECTRICAL CONNECTORS.

19.0 Slide HVAC unit gently out of luggage door.

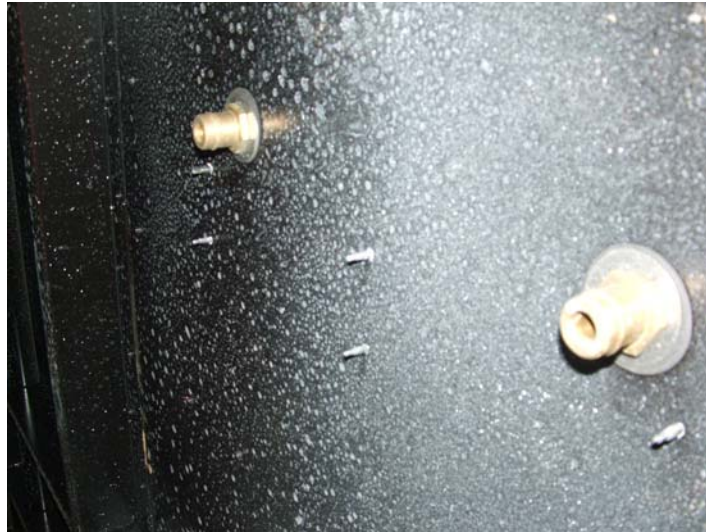
Figure 16

21.0 Re-install underfloor cab drains while HVAC unit is loose.

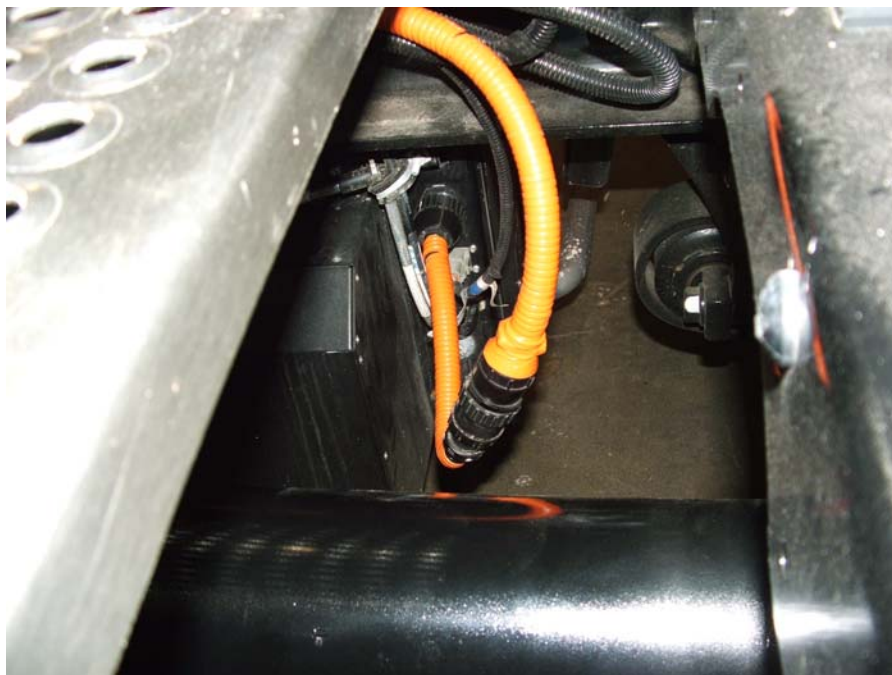
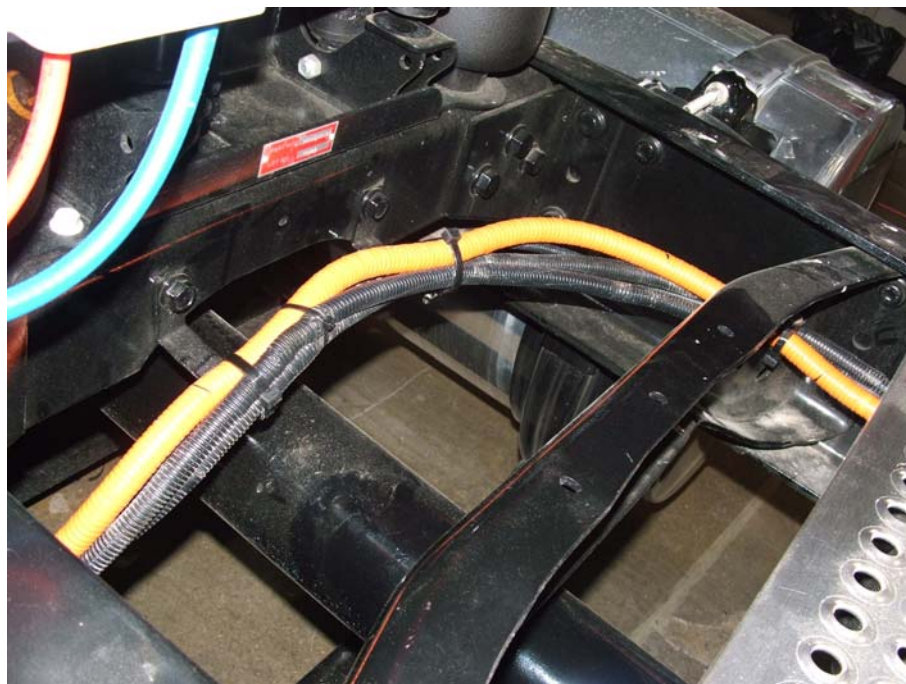
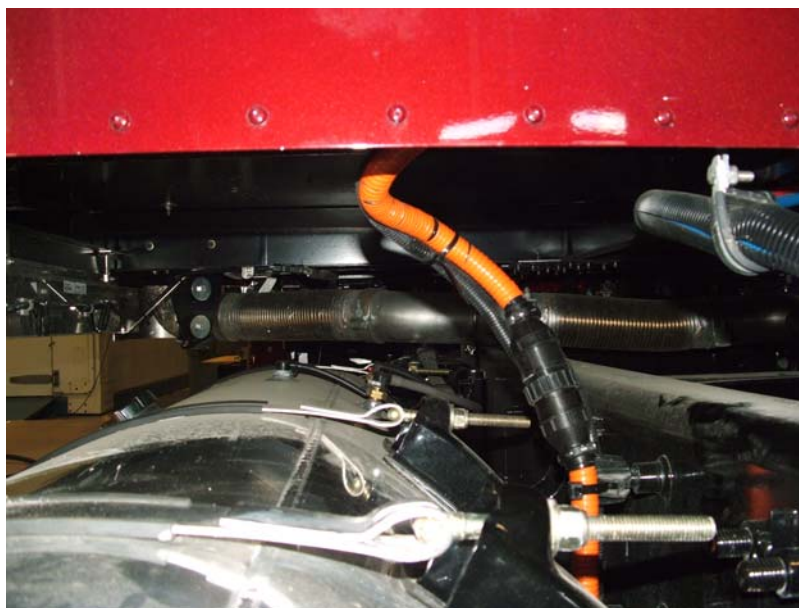
23.0 Install $\frac{3}{4}$ " orange loom from the kit on the main power cable between the engine/generator and cab floor **over** existing cable.

Figure 18b – Loom Installed

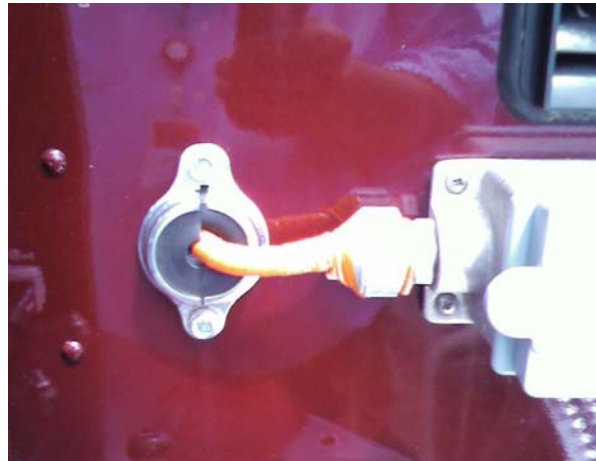
Figure 19

24.0 Install 3/8" loom on power outlet box supply cable on back of cab.

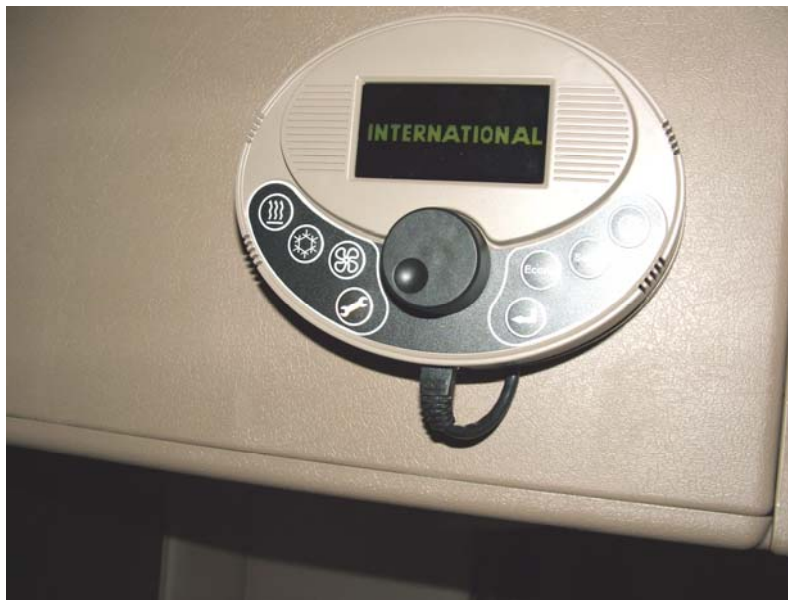
Figure 22

27.0 Install new bunk control panel, tighten screw and re-attach connector.
