IC Corporation

SAFETY RECALL 06510

The handrail on the courtesy shield by the left entrance door does not meet the guidelines in the NHTSA handbook for door entrance and handrail design.

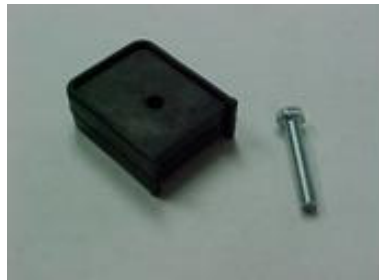
Figure 5 - Kit 8900190R91

180085 Bolt
5/16-18, 1.75
grade 5 ZND
(2 included)

Part Number	Description	Quantity
8900190R91	Left Entrance Door Handrail repair kit (contains P/N 436462001 Spacer Rubber (2 ea) and P/N 180085 Bolt 5/16-18, 1.75 grade 5 ZND (2 ea))	1
