# **Authorized Field Change**

**AFC G-06905**

**SUBJECT: Warning labels on air intake and air cleaner housing may be missing or not visible on certain CE, RE, and PT bus models built at the Conway, Arkansas Bus Assembly Plant before 11/28/2005.**

**APPLIES TO: Various CE, RE, PT (sold to Bluebird) bus models built before 11/28/2005.**

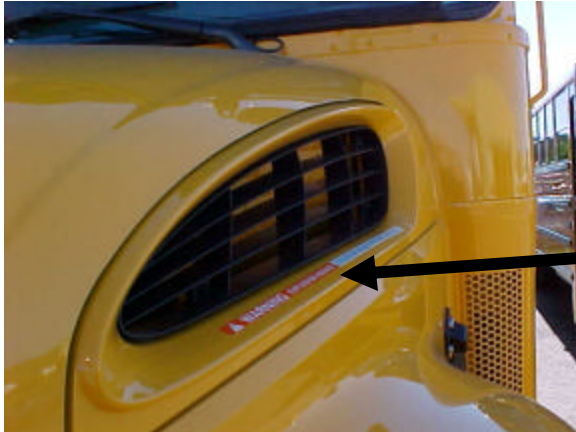
**Placement for: CE - Model PB105 & PT - Model PB015 with Bluebird Body**

*Apply this label if your CE bus has an I6 engine with a grid heater (feature code 12WSZ) installed.*

Decal should be installed at the location indicated by the arrow.

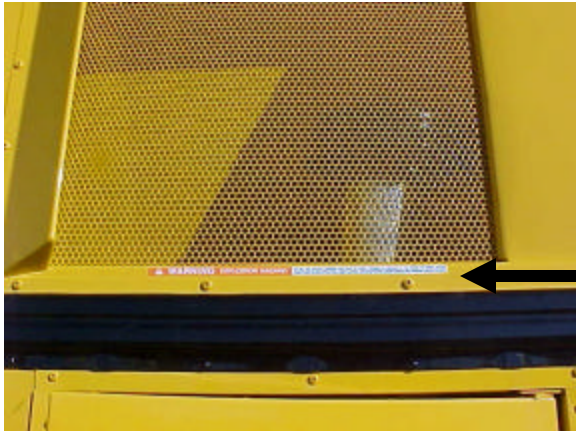
**Placement for: RE – Models PB305, RE300, GD395, GC395**

*Apply these labels if your RE bus has an I6 engine with a grid heater (feature code 12WSZ) installed or a V8 engine.*

Decal should be installed in this area just below the air intake screen. The air intake for the I6 is on the left side (driver's side) and on the right side with V8.

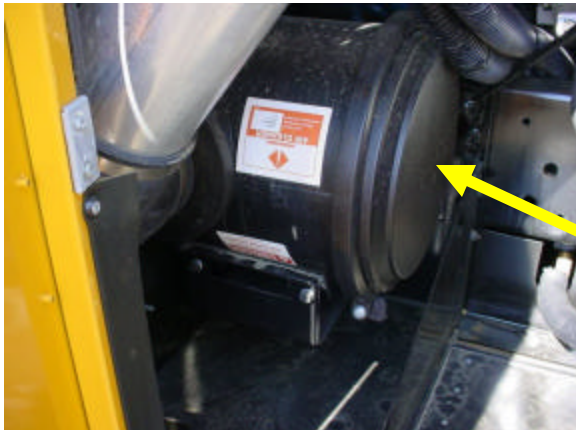
Existing label on RE with I6 may be upside down or facing down. Apply new label (shown below) on end of air cleaner so that it is always visible.
