Authorized Field Change

AFC G-05901

Subject: Check Electrical System Light Stays On, Without Fault Codes Registered, on Certain HPV Models Built Between September 1, 2004 and September 29, 2004

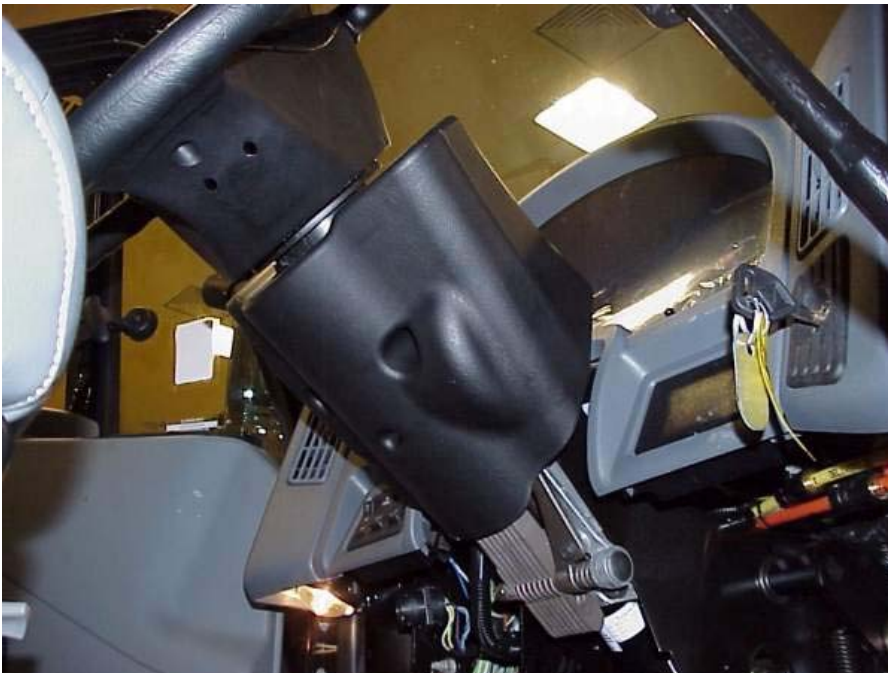
Figure 1 Remove Steering Column Lower Cover

1. Disconnect the negative cable and ECM ground from the battery.
2. Remove fasteners and the steering column lower covers (Figure 1).

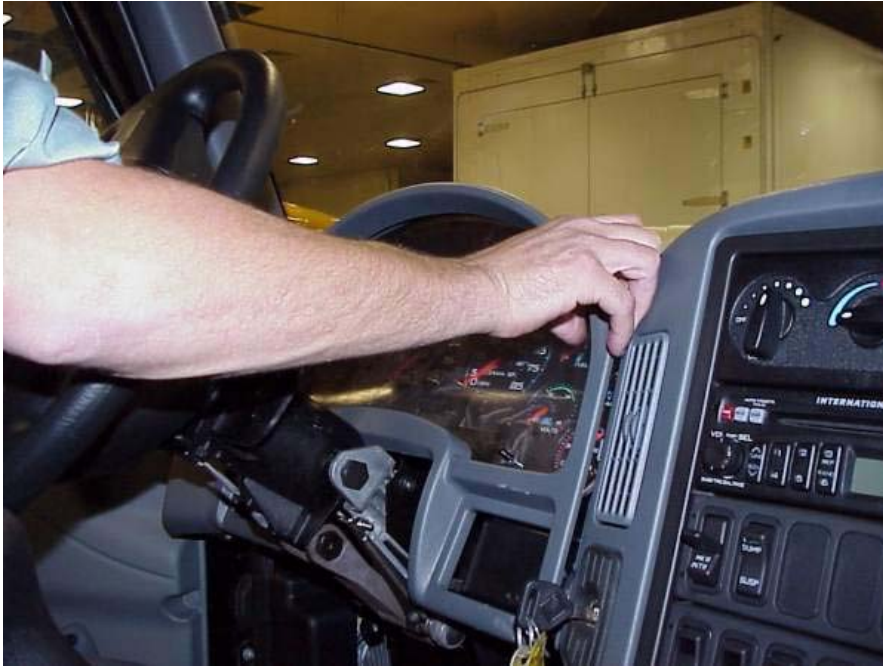
Figure 2 Remove Cluster Dash Panel

3. Remove fasteners and the instrument cluster dash panel (Figure 2).

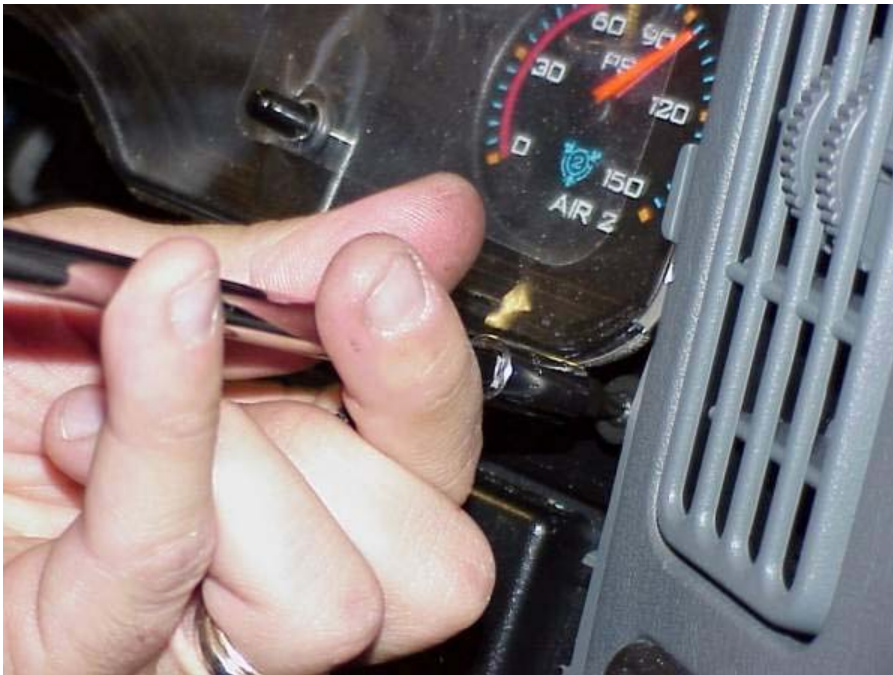
Figure 3 Remove Instrument Cluster Fasteners

4. Remove fasteners from the instrument cluster (Figure 3) and move the instrument cluster from the dash to gain access to the harness connector (Figure 4). Remove the instrument cluster.

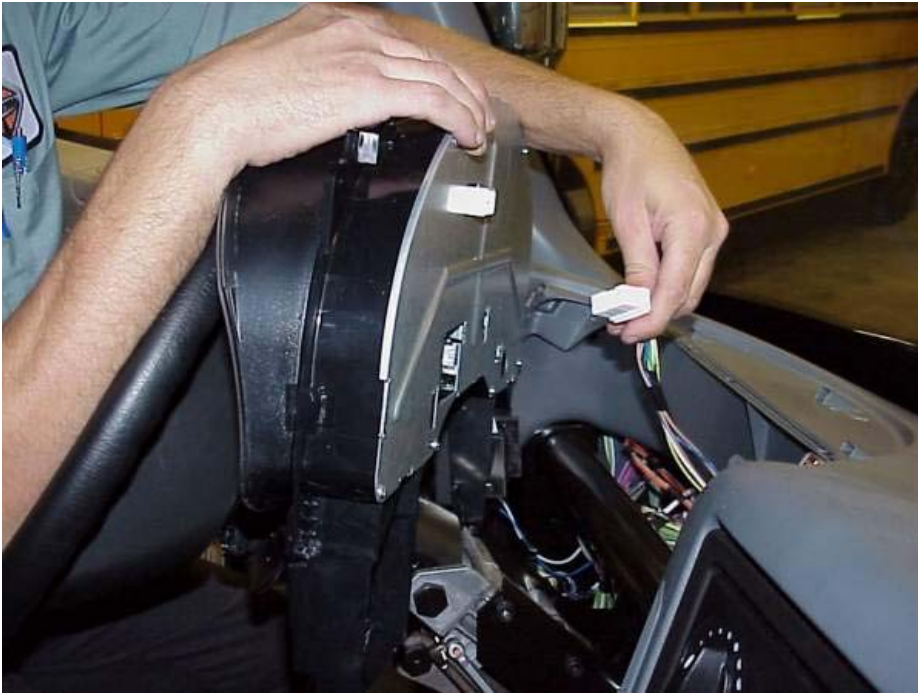
Figure 4 Disconnect Instrument Cluster Harness Connector

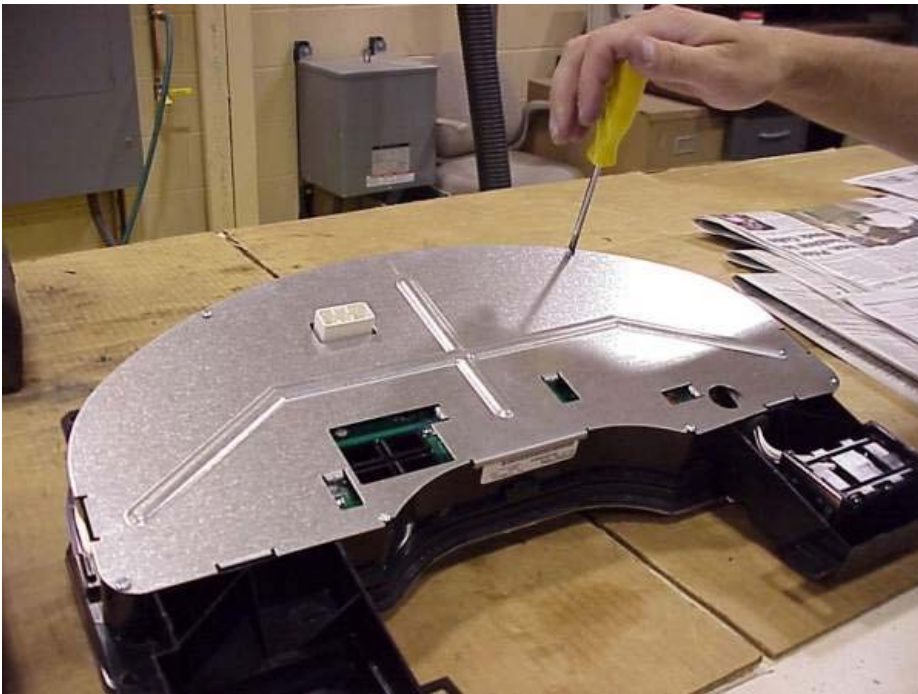
Figure 5 Remove Fasteners from Rear Cover

5. Place the instrument cluster face down on a protected work surface.
6. Remove the fasteners from the rear instrument cluster cover (Figure 5). Remove the cover.

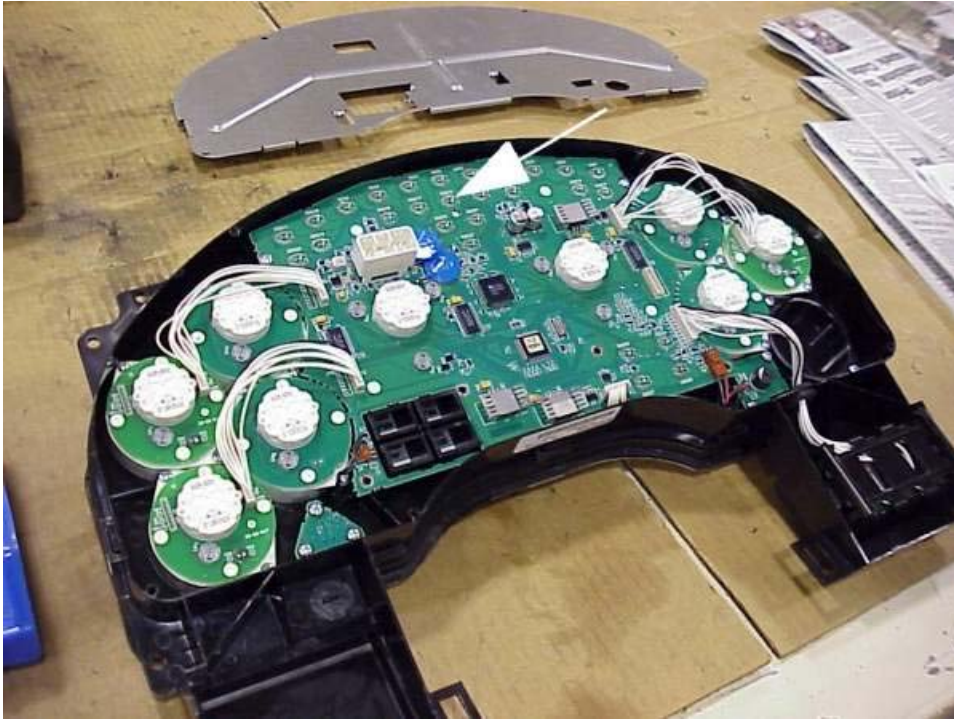
Figure 6 Locate the Check Electrical System Light (Arrow)

7. Locate the Check Electrical System light, identified as SDS16 on the circuit board (Figure 6).

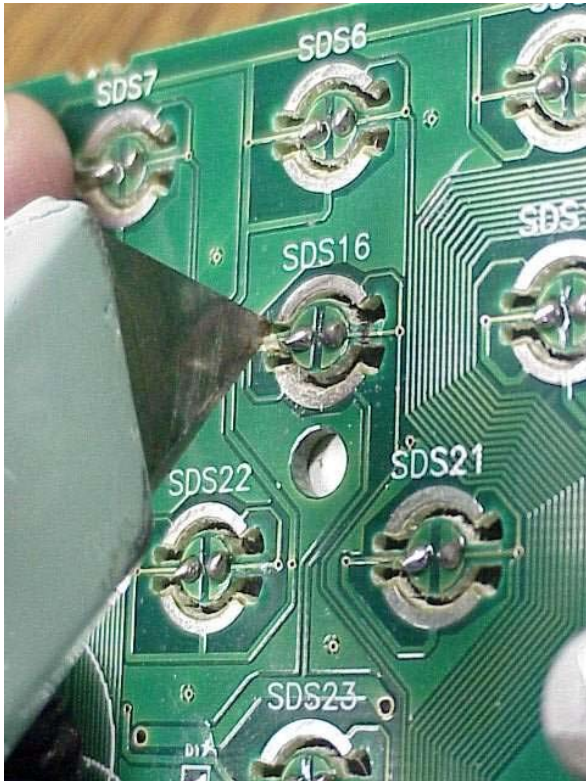
Figure 7 Cut Bridge

8. The lights are supported by two bridges to the circuit board. Use a sharp knife and cut through one of the bridges (Figure 7).

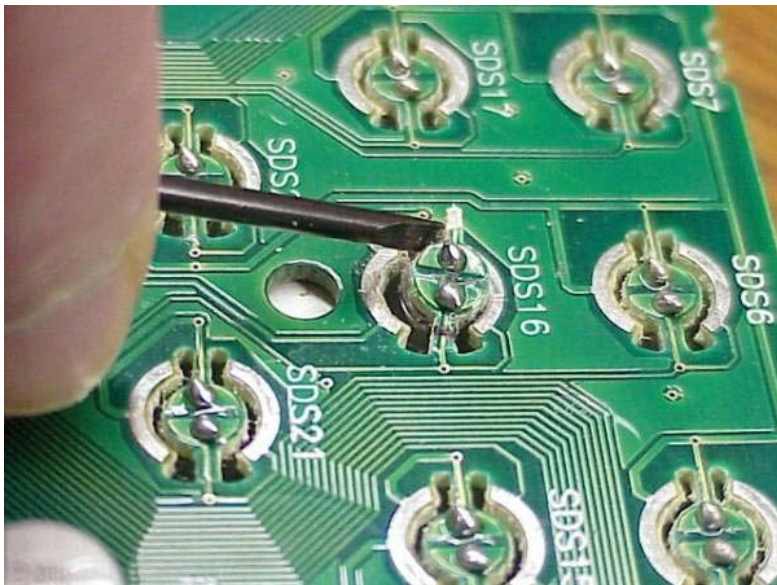
Figure 8 Pry Lamp Above Circuit Board Surface

9. Use a small blade screwdriver to pry the lamp above the circuit board surface (Figure 8).

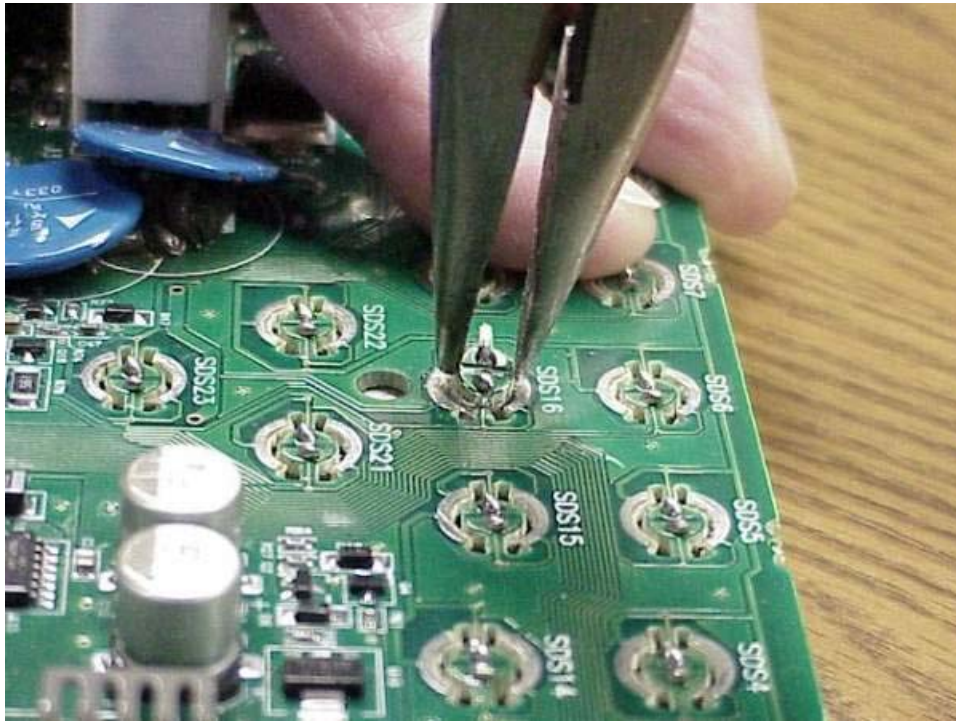
Figure 9 Remove Lamp

10. Grasp the lamp with long nose pliers and carefully twist the lamp out of the circuit board (Figure 9)
