# VEHICLE RECALL

G- 05516-R1

## SUBJECT: SAFETY RECALL (U.S., EXPORT)

**SPECIALTY MANUFACTURING CO. 5 Series Electric Stop Arms on certain 3800 chassis, and CE, FE, and RE School Buses built between 01/07/2002 and 06/22/2005**

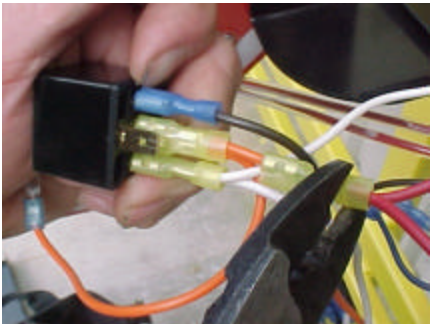
<p>9. Using a flat blade screwdriver, carefully pry the micro switch plate upwards. CAUTION-bushing may break and snap ring will make a loud noise when released. Discard the snap ring and bushing.</p>	<p>10. Remove all wires from micro switch assembly. Black heater wire remains with assy.</p>

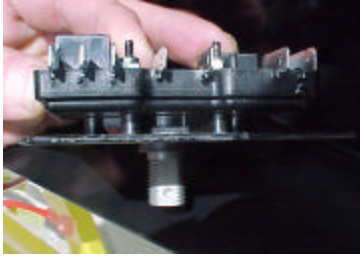
16. Install new 005150 module into position as shown above. Timing mark **MUST** be facing toward the direction of the blade. (Ex. If blade is fully extended, timing mark must be turned to front of unit). Push module shaft through lower hinge hole. Fasten with (2) 11/32" hex nuts from original micro switch assy.

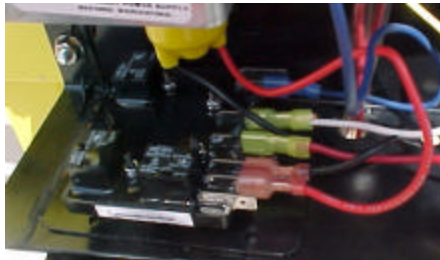
17. Connect +12VDC & GROUND per schematic.

18. Secure with 3/4" nut.

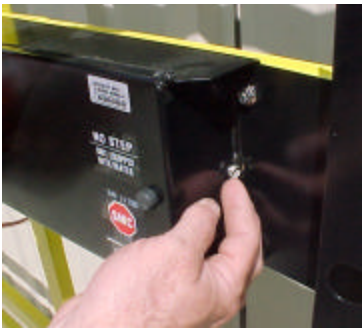
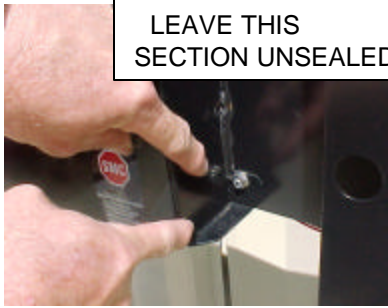
<p>20. Replace cover. Secure with (2) screws. Reseal both ends of the crossing arm cover with RTV. <b>IMPORTANT! – DO NOT</b> seal approximately 1” of the lower right side of the box. This provides an additional drainage location.</p>	<p>21. Test the stop arm assembly to make sure it functions correctly.</p>
<p><b>If further help is needed, contact the engineering department at Specialty Manufacturing</b></p>
