# ***SERVICE PROCEDURE***

**G-07504**  
**March 2007**

**SUBJECT: SAFETY RECALL (MEXICO, EXPORT)**  
**AIR BRAKE TUBING on 4300 and 4400 tractors built**  
**6/21/2004 thru 2/21/2007**

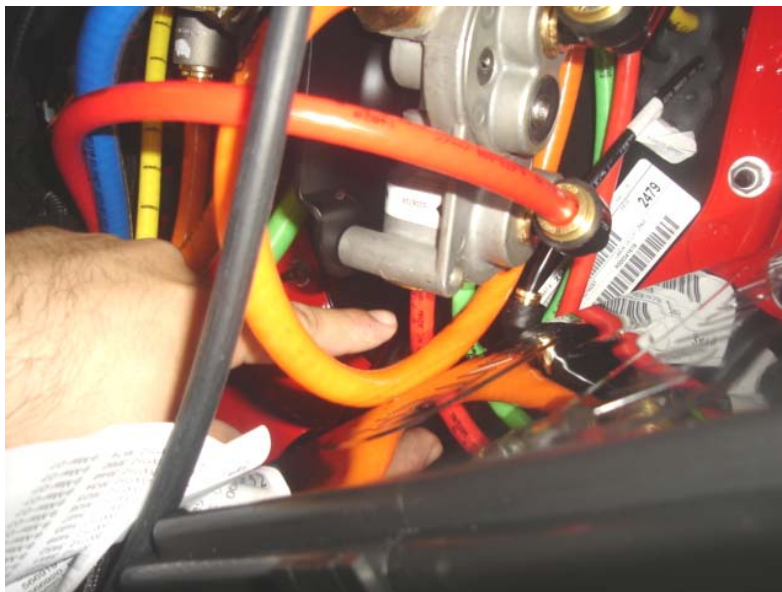
**Figure 1**

1. Drain the vehicle's air tanks by repeatedly depressing the brake pedal or opening the tank drain valves.
2. Open vehicle hood. Locate and remove the single 3/8" OD RED air brake tube located on the bottom side of the TP-5 Tractor Protection Valve, mounted on the driver's side of the firewall.

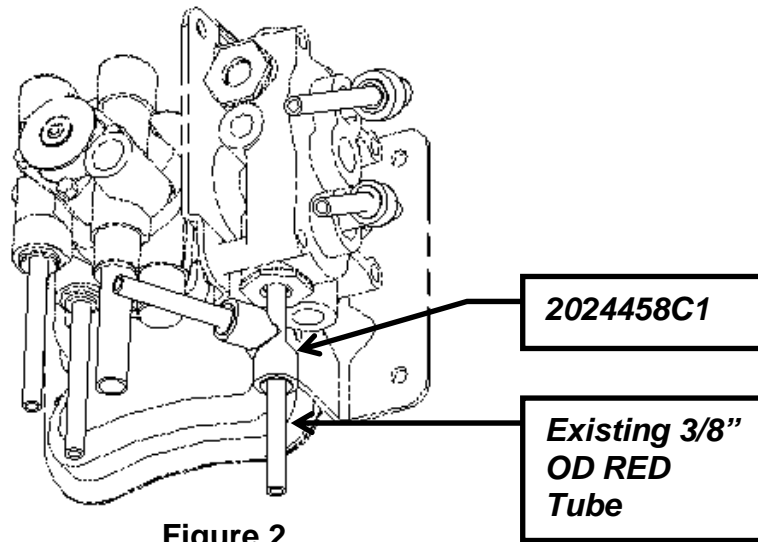
**Figure 2**

3. Install quick connect tee (2024458C1) into port where single 3/8" OD RED tube was located.

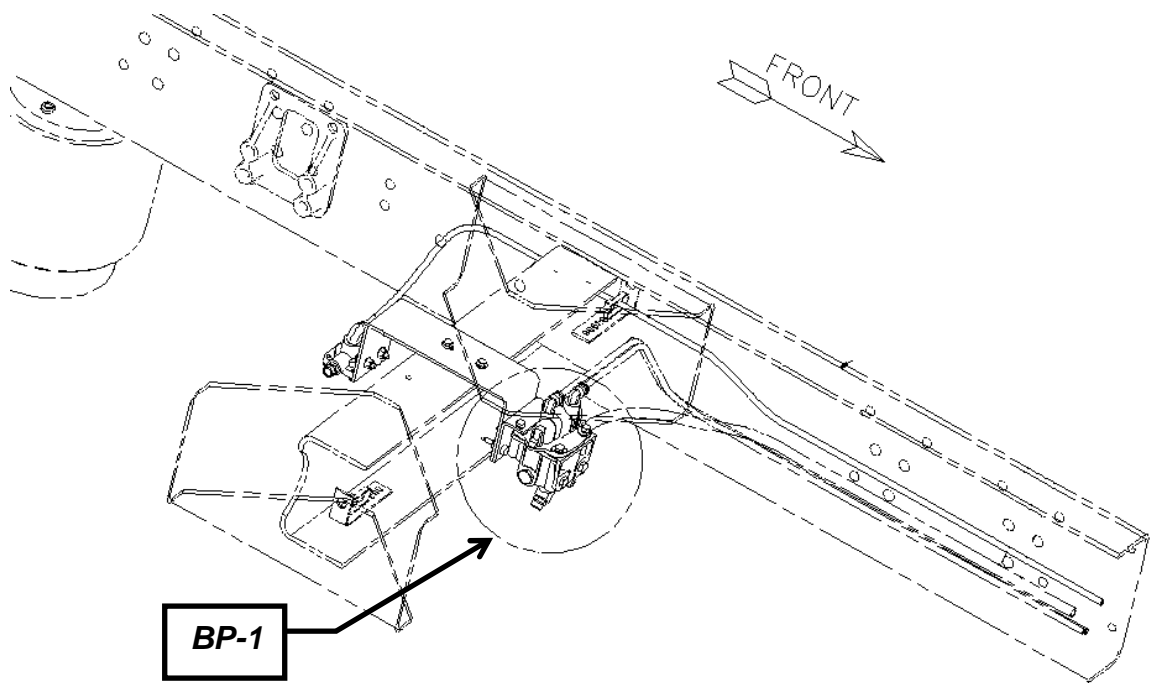
**Figure 3**

4. Locate the BP-1 Bobtail Proportioning valve on the rear frame cross member.

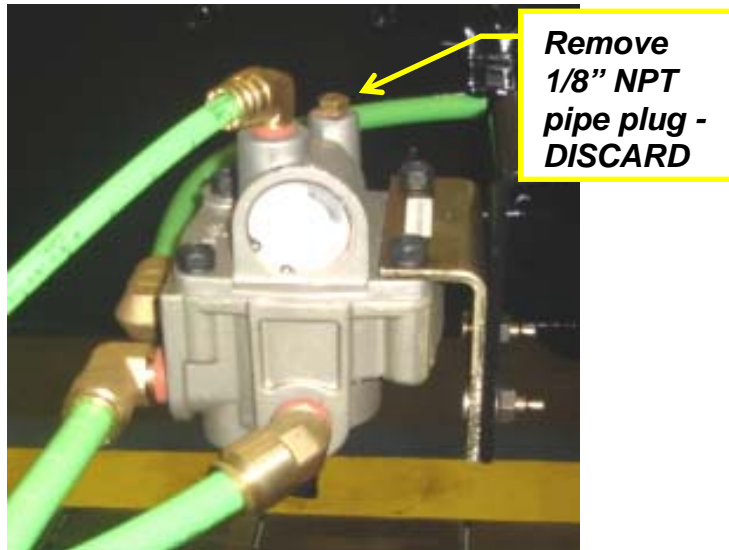
**Figure 4**

5. Remove 1/8" NPT plug from BP1 valve.

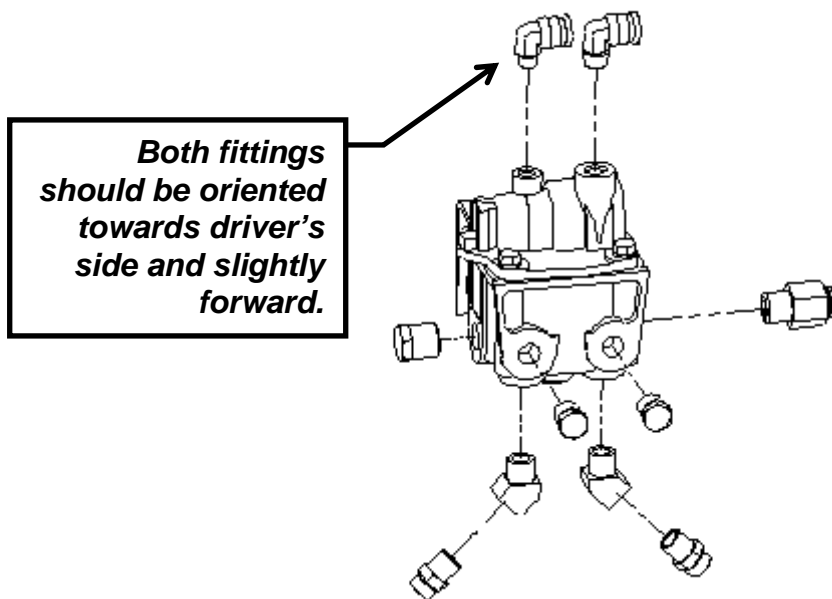
**Figure 5**

6. Clean threads if necessary.
7. Install elbow (2017509C1). Orient fitting toward driver's side as shown.

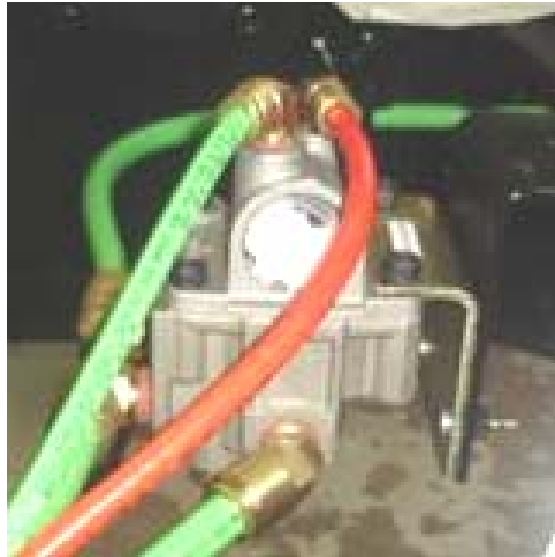
8. Install 3/8" OD BLACK service tubing (417199C3) to connect BP-1 bobtail proportioning valve with the TP-5 tractor protection valve. Route tubing as necessary securing with strap-locks no greater than 12" (305mm).

**Figure 6a – 3/8" OD Service Tube shown in RED for Clarity**

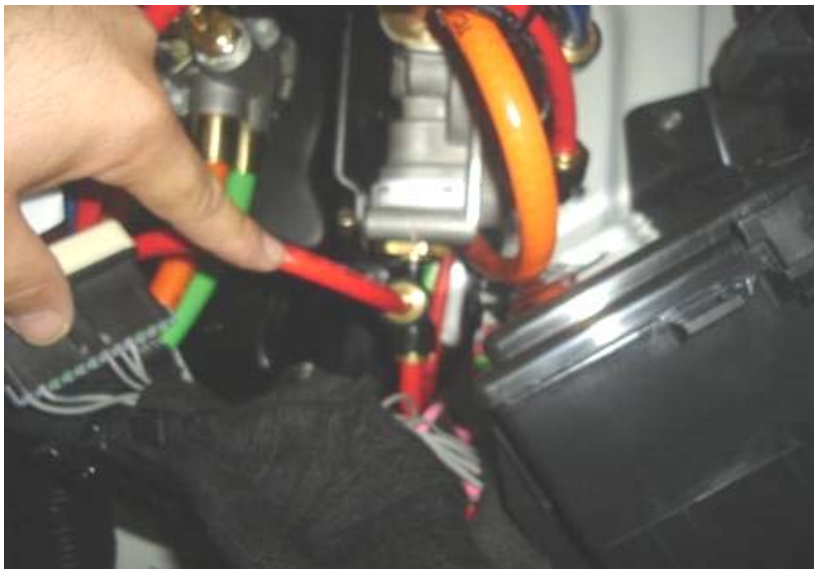
**Figure 6b – 3/8" OD Service Tube shown in RED for Clarity**
