# IB Integrated Design Project

Group Name: *“Not quite M1”*

## Overall design

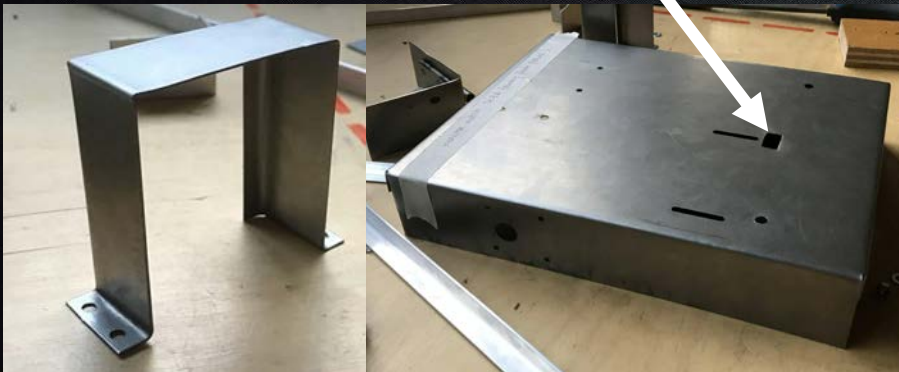
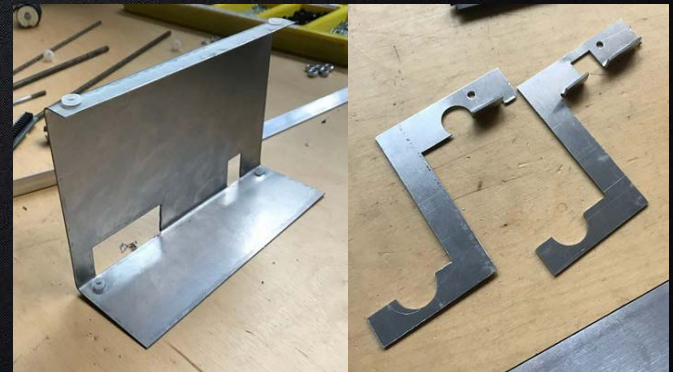
- Initial tests show lift mechanism to have very low friction (see video)
- Motors and components fit with good tolerance in chassis
- Some modification required to rack fitting

Original	Modification	Reason
Valve assy and PCB in middle	Valve assy and PCB on sides	Prevent sagging in chassis
Bracing on inside of motor raise unit	Bracing along the length of the robot	Better support against buckling
Grabber arms made of steel	Grabber arms made of alum.	Thicker, for better hold on box, and no conductivity
Grabber arms height = 30mm	Grabber arms height = 90mm	Account for wheel height
	Added flats to grabber arms	Improve slide along plate
Lift mechanism back plate height = 200mm	Back plate height = 110mm	Material savings
30 spoke gear	20 spoke gear	Improved torque

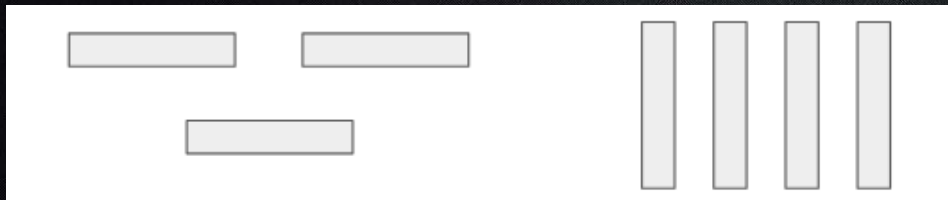
**Original** Sensor Layout

**New** sensor layout

4 bit number rather than 3

16 cases rather than 8

Improves accuracy of line following tremendously
