FRONT ULTRASONIC SENSOR SHORT-CORD INSPECTION

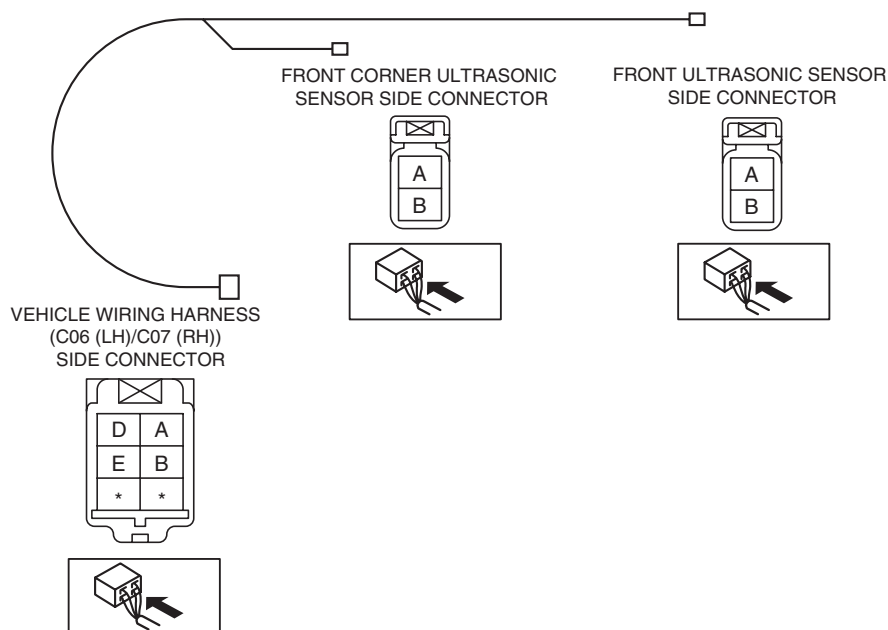
ac5wzw00003267

Test condition	Terminal							
	Vehicle wiring harness (C06 (LH)/C07 (RH)) side connector				Front ultrasonic sensor side connector		Front corner ultrasonic sensor side connector	
	A	B	D	E	A	B	A	B
Under any condition	○							○
		○					○	
			○		○			
				○		○

ILLUSTRATION INDICATES LEFT SIDE. (RH SIDE IDENTICAL)

- If not as indicated in the table, replace the front ultrasonic sensor short-cord.
