## VISUAL INSPECTION OF PARTS [FW6A-EL]

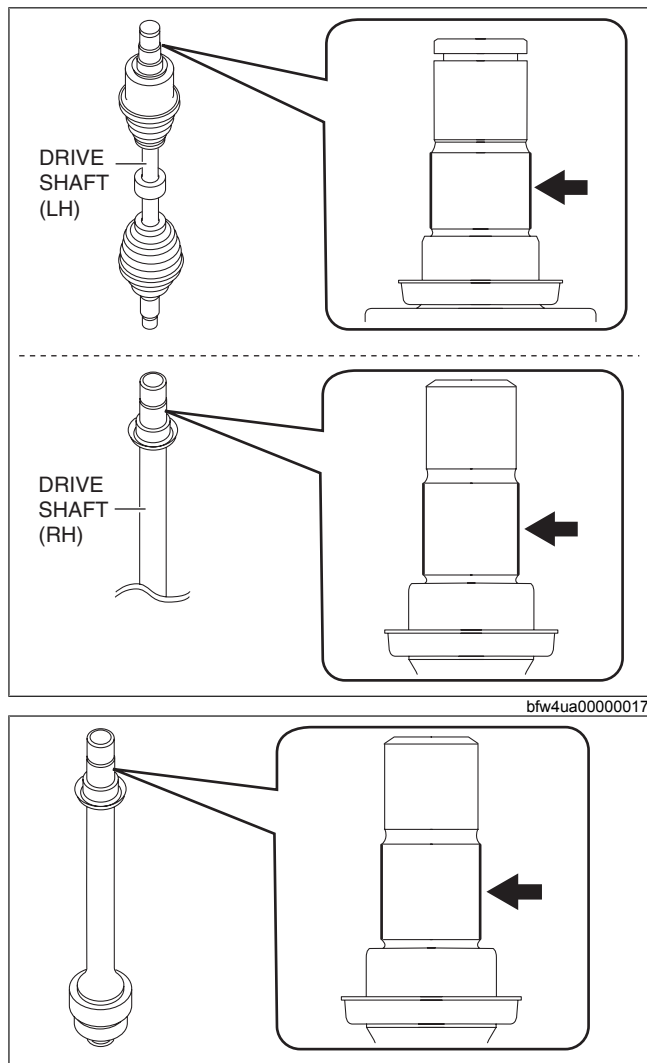
- For the drive shaft disassembly/assembly procedure, verify the Workshop Manual.
- Joint shaft
  - If there is a malfunction, replace the joint shaft with a new one.
