GLASS ANTENNA INSPECTION

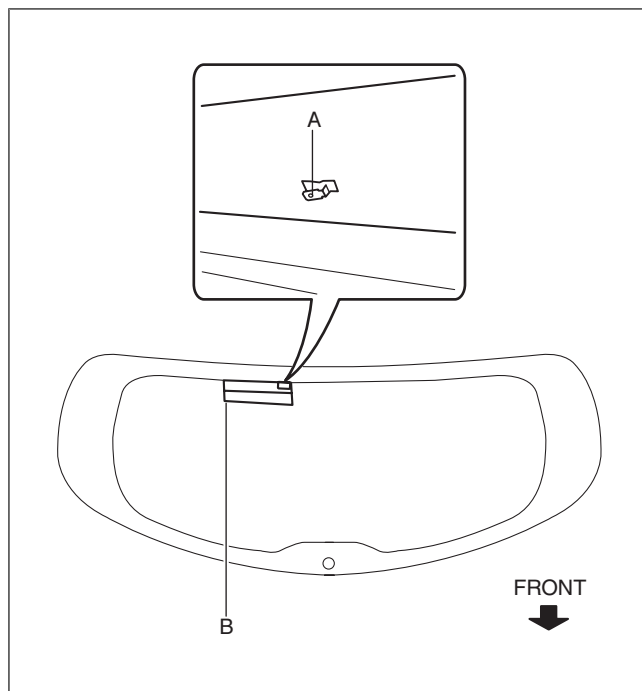
am3zzw00009853

1. Disconnect the negative battery cable. (See NEGATIVE BATTERY CABLE DISCONNECTION/CONNECTION [SKYACTIV-G 2.0, SKYACTIV-G 2.5].) (See NEGATIVE BATTERY CABLE DISCONNECTION/CONNECTION [SKYACTIV-G 2.0, SKYACTIV-G 2.5 (WITHOUT i-stop)].) (See NEGATIVE BATTERY CABLE DISCONNECTION/CONNECTION [SKYACTIV-D 2.2].)
2. Partially peel back the seaming welt.
3. Remove the liftgate upper trim. (See LIFTGATE UPPER TRIM REMOVAL/INSTALLATION.)
4. Disconnect antenna feeder connector. (See ANTENNA FEEDER NO.3 REMOVAL/INSTALLATION.)
5. Visually inspect the glass antenna for damage.
6. Verify that the continuity between the glass antenna terminals is as indicated in the table.

- If not as indicated in the table, repair the glass antenna. (See FILAMENT INSPECTION.)
