## TWEETER INSPECTION

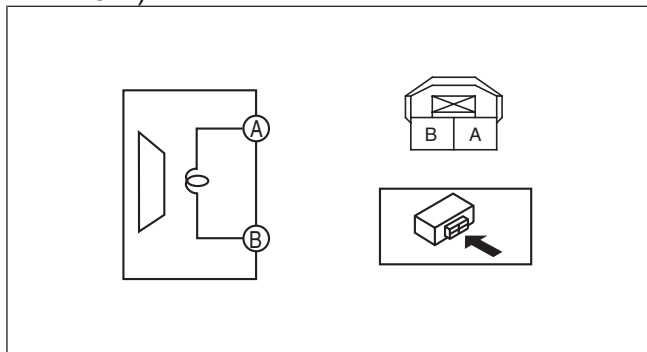
ac5wzw00005605

1. Disconnect the negative battery cable. (See NEGATIVE BATTERY CABLE DISCONNECTION/CONNECTION [SKYACTIV-G 2.0, SKYACTIV-G 2.5].) (See NEGATIVE BATTERY CABLE DISCONNECTION/CONNECTION [SKYACTIV-G 2.0, SKYACTIV-G 2.5 (WITHOUT i-stop)].) (See NEGATIVE BATTERY CABLE DISCONNECTION/CONNECTION [SKYACTIV-D 2.2].)
2. Remove the side speaker grille. (See SPEAKER GRILLE REMOVAL/INSTALLATION.)
3. Remove the tweeter. (See TWEETER REMOVAL/INSTALLATION.)
4. Verify that the resistance between the tweeter terminals is as indicated in the table.
  - If not as indicated in the table, replace the tweeter.

Test condition	Terminal		Resistance (ohm)
	A	B	
Under any condition	○○		3.4—4.6

Test condition	Terminal		Resistance (ohm)
	A	B	
Under any condition	○○		3.24—3.96
