SUNROOF SWITCH INSPECTION

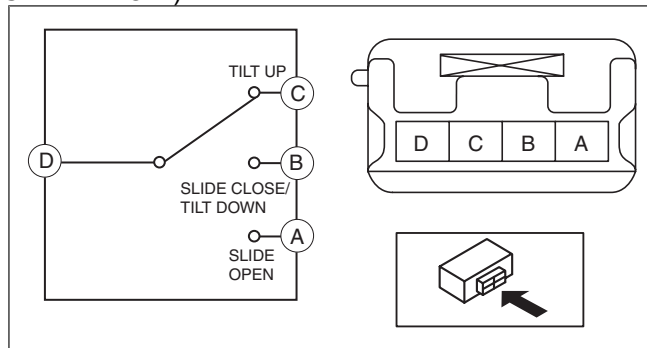
ac5wzw00002996

1. Disconnect the negative battery cable. (See NEGATIVE BATTERY CABLE DISCONNECTION/CONNECTION [SKYACTIV-G 2.0, SKYACTIV-G 2.5].) (See NEGATIVE BATTERY CABLE DISCONNECTION/CONNECTION [SKYACTIV-G 2.0, SKYACTIV-G 2.5 (WITHOUT i-stop)].) (See NEGATIVE BATTERY CABLE DISCONNECTION/CONNECTION [SKYACTIV-D 2.2].)
2. Remove the map light. (See MAP LIGHT REMOVAL/INSTALLATION.)
3. Verify that the continuity between the sunroof switch terminals is as indicated in the table.

Switch position	Terminal			
	A	B	C	D
SLIDE OPEN	○			○
SLIDE CLOSE / TILT DOWN		○		○
TILT UP			○	○

- If not as indicated in the table, replace the sunroof switch.
