## REAR DOOR SPEAKER INSPECTION

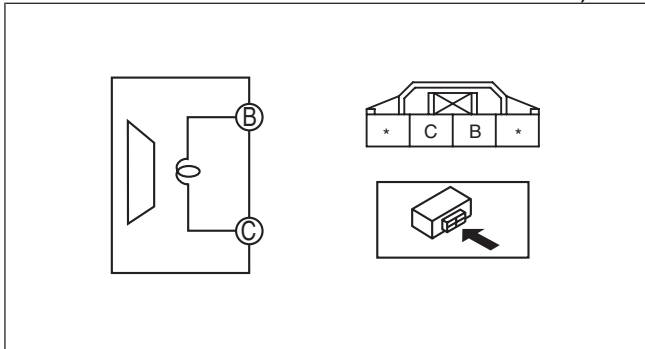
adejw00001161

1. Disconnect the negative battery cable. (See NEGATIVE BATTERY CABLE DISCONNECTION/CONNECTION [SKYACTIV-G 2.0, SKYACTIV-G 2.5].) (See NEGATIVE BATTERY CABLE DISCONNECTION/CONNECTION [SKYACTIV-G 2.0, SKYACTIV-G 2.5 (WITHOUT i-stop)].) (See NEGATIVE BATTERY CABLE DISCONNECTION/CONNECTION [SKYACTIV-D 2.2].)
2. Remove the rear door trim. (See REAR DOOR TRIM REMOVAL/INSTALLATION.)
3. Disconnect the rear door speaker connector. (See REAR DOOR SPEAKER REMOVAL/INSTALLATION.)
4. Verify that the resistance between the rear door speaker terminals is as indicated in the table.

- If not as indicated in the table, replace the rear door speaker.

○○ : Resistance
Test condition	Terminal		Resistance (ohm)
	B	C	
Under any condition	○○		3.4—4.6

○○ : Resistance
Test condition	Terminal		Resistance (ohm)
	A	B	
Under any condition	○○		3.7
