FUEL PUMP UNIT INSPECTION [SKYACTIV-G 2.0, SKYACTIV-G 2.5]

Continuity Inspection

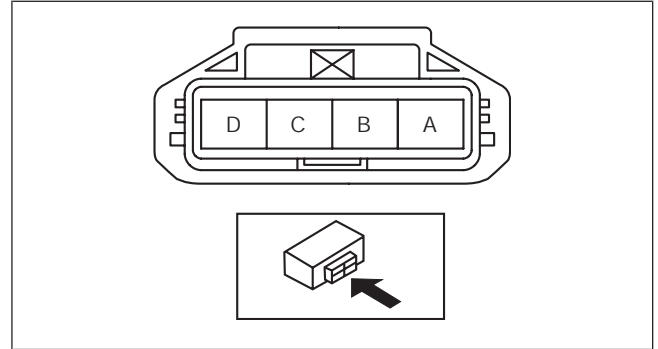
1. Disconnect the negative battery cable. (See NEGATIVE BATTERY CABLE DISCONNECTION/CONNECTION [SKYACTIV-G 2.0, SKYACTIV-G 2.5].) (See NEGATIVE BATTERY CABLE DISCONNECTION/CONNECTION [SKYACTIV-G 2.0, SKYACTIV-G 2.5 (WITHOUT i-stop)].)
2. Disconnect the fuel pump unit connector.
3. Inspect for continuity between fuel pump unit terminals B—D.
 - If there is no continuity, replace the fuel pump unit. (See FUEL PUMP UNIT REMOVAL/INSTALLATION [SKYACTIV-G 2.0, SKYACTIV-G 2.5].)
