## CLUTCH PEDAL POSITION (CPP) SWITCH INSPECTION [SKYACTIV-G 2.0, SKYACTIV-G 2.5]

### Continuity Inspection

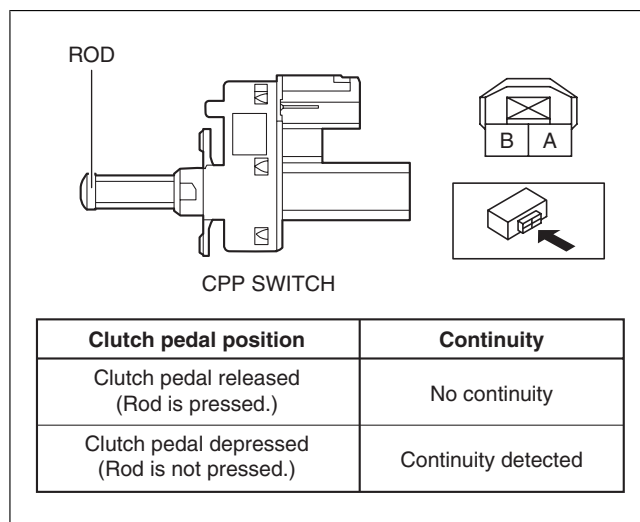
ac5wzw00006331

1. Verify that the CPP switch is installed properly. (See CLUTCH PEDAL POSITION SWITCH REMOVAL/INSTALLATION [C66M-R, C66MX-R].)
2. Disconnect the negative battery cable. (See NEGATIVE BATTERY CABLE DISCONNECTION/CONNECTION [SKYACTIV-G 2.0, SKYACTIV-G 2.5].) (See NEGATIVE BATTERY CABLE DISCONNECTION/CONNECTION [SKYACTIV-G 2.0, SKYACTIV-G 2.5 (WITHOUT i-stop)].)
3. Disconnect the CPP switch connector.
4. Verify that the continuity between CPP switch terminals A and B when the clutch pedal is depressed and when it is released is according to the following table:
  - If not as verified, replace the CPP switch. (See CLUTCH PEDAL POSITION SWITCH REMOVAL/INSTALLATION [C66M-R, C66MX-R].)
