REAR WIPER AND WASHER SWITCH INSPECTION

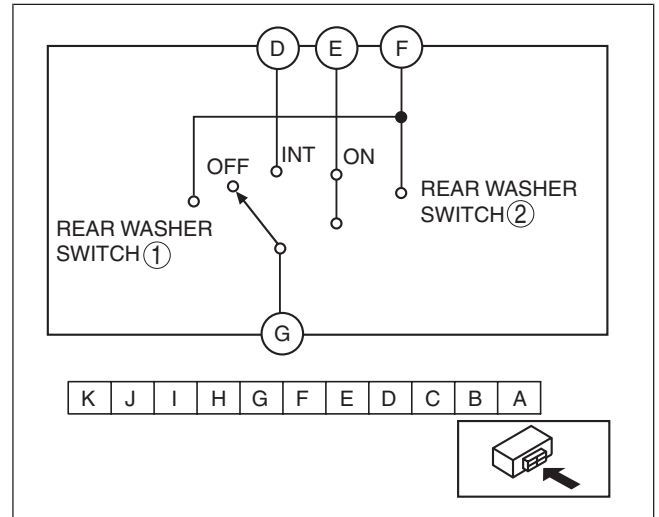
ac5wzw00004632

With wiper and washer switch on right side

○—○: Continuity

| Switch position | | Terminal | | | |
| | | G | F | E | D |
| Rear washer ① | ON | ○—○ | | | |
| Rear washer switch | OFF | | | | |
| | INT | ○—○ | ○—○ | | ○—○ |
| | ON | ○—○ | ○—○ | ○—○ | |
| Rear washer ② | ON | ○—○ | ○—○ | ○—○ | |

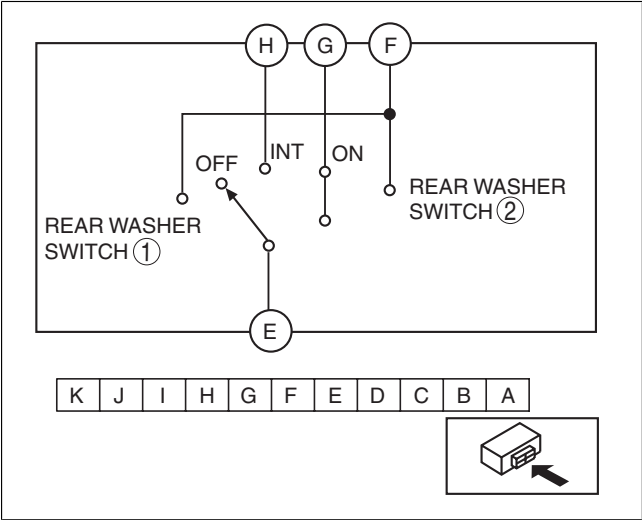
ac5wzw00001591

With wiper and washer switch on left side

○—○: Continuity

| Switch position | | Terminal | | | |
| | | E | F | G | H |
| Rear washer① | ON | ○—○ | | | |
| Rear washer switch | OFF | | | | |
| | INT | ○— | —○ | | ○ |
| | ON | ○— | —○ | ○ | |
| Rear washer② | ON | ○—○ | ○—○ | | |
