UP SWITCH INSPECTION [FW6A-EL, FW6AX-EL]

Continuity Inspection

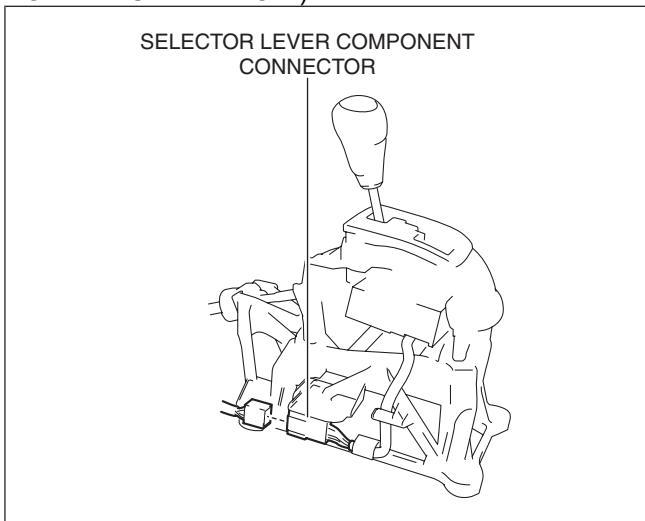
ac5wzw00000786

- Disconnect the negative battery cable. (See NEGATIVE BATTERY CABLE DISCONNECTION/CONNECTION [SKYACTIV-G 2.0, SKYACTIV-G 2.5 (WITHOUT i-stop)].) (See NEGATIVE BATTERY CABLE DISCONNECTION/CONNECTION [SKYACTIV-G 2.0, SKYACTIV-G 2.5].)
- Remove the front console. (See FRONT CONSOLE REMOVAL/INSTALLATION.)
- Disconnect the selector lever component connector.

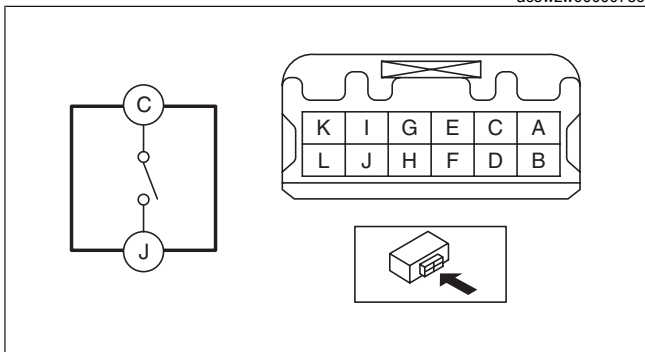
ac5wzw00000787

- Verify that the continuity between selector lever component terminals C and J.
 - If not as verified, replace the selector lever component. (See AUTOMATIC TRANSAXLE SHIFT MECHANISM REMOVAL/INSTALLATION.)

Up switch specification

Test condition	Continuity
Selector lever is in the M position (+) side position.	Continuity
Selector lever is not in the M position (+) side position.	No continuity
