FAN SWITCH INSPECTION [MANUAL AIR CONDITIONER]

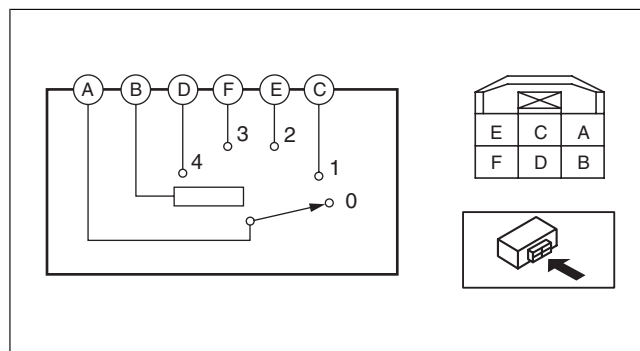
ac5wzw00002943

4. Verify that the continuity between the fan switch terminals as indicated in the table.
 - If there is any malfunction, replace the fan switch.

○—○ : Continuity

Switch position	Terminal					
	A	B	C	D	E	F
0						
1	○		○			
2	○				○	
3	○	○				○
4	○	○		○
