VANITY MIRROR ILLUMINATION INSPECTION

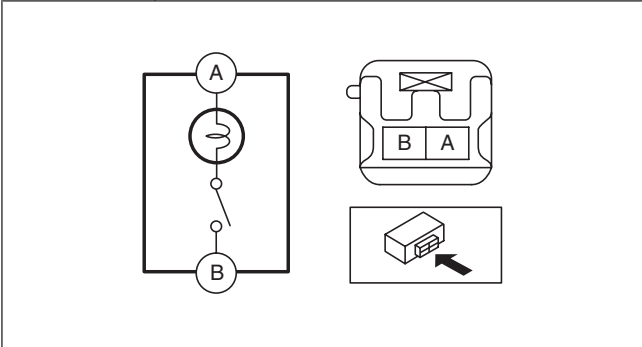
ac5wzw00000044

1. Disconnect the negative battery cable. (See NEGATIVE BATTERY CABLE DISCONNECTION/CONNECTION [SKYACTIV-G 2.0, SKYACTIV-G 2.5].) (See NEGATIVE BATTERY CABLE DISCONNECTION/CONNECTION [SKYACTIV-G 2.0, SKYACTIV-G 2.5 (WITHOUT i-stop)].) (See NEGATIVE BATTERY CABLE DISCONNECTION/CONNECTION [SKYACTIV-D 2.2].)
2. Remove the sunvisor. (See SUNVISOR REMOVAL/INSTALLATION.)
3. Verify that the continuity between the vanity mirror illumination terminals is as indicated in the table.

- If not as indicated in the table, replace the sunvisor. (See SUNVISOR REMOVAL/INSTALLATION.)
