## DRIVE BELT INSPECTION [SKYACTIV-D 2.2]

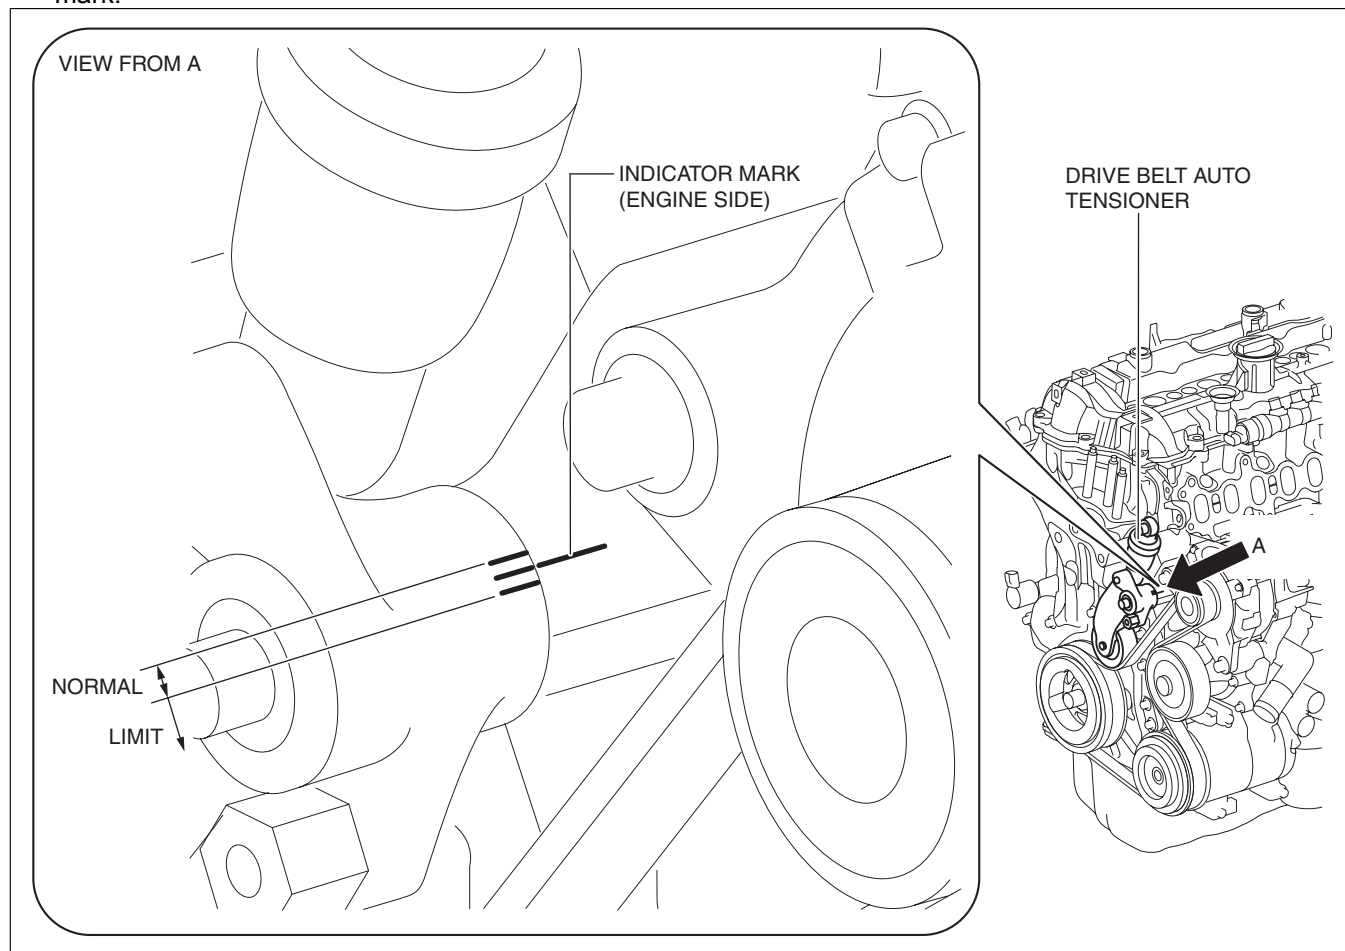
ac5wzw00005256

1. Verify that the indicator part of the engine side is within the normal range of the drive belt auto tensioner indicator mark.

- If it exceeds the limit, replace the drive belt. (See DRIVE BELT REMOVAL/INSTALLATION [SKYACTIV-D 2.2].)
