## REAR PARKING SENSOR BUZZER INSPECTION

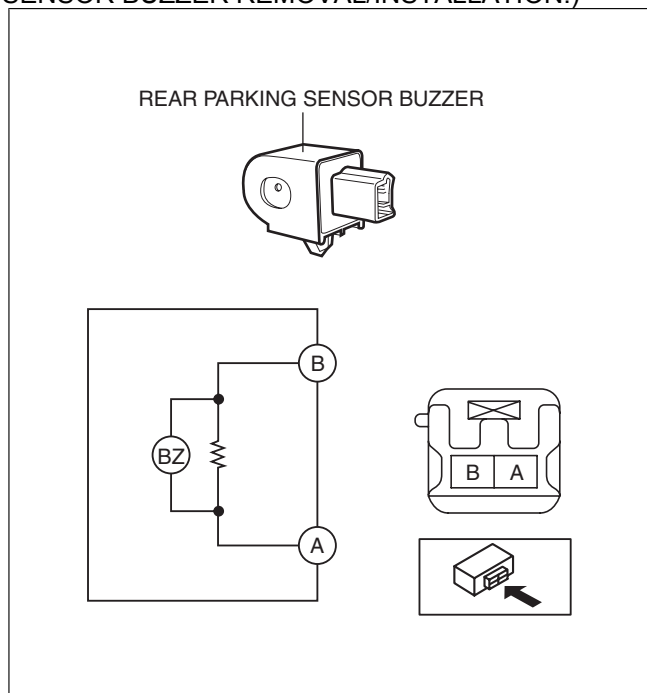
ac5wzw00003791

1. Disconnect the negative battery cable. (See NEGATIVE BATTERY CABLE DISCONNECTION/CONNECTION [SKYACTIV-G 2.0, SKYACTIV-G 2.5].)(See NEGATIVE BATTERY CABLE DISCONNECTION/CONNECTION [SKYACTIV-G 2.0, SKYACTIV-G 2.5 (WITHOUT i-stop)].)(See NEGATIVE BATTERY CABLE DISCONNECTION/CONNECTION [SKYACTIV-D 2.2].)
2. Remove the following parts:
  - (1) Liftgate upper trim (See LIFTGATE UPPER TRIM REMOVAL/INSTALLATION.)
  - (2) Liftgate side trim (See LIFTGATE SIDE TRIM REMOVAL/INSTALLATION.)
  - (3) Liftgate recess (See LIFTGATE RECESS REMOVAL/INSTALLATION.)
  - (4) Liftgate lower trim (See LIFTGATE LOWER TRIM REMOVAL/INSTALLATION.)
  - (5) Rear parking sensor buzzer (See REAR PARKING SENSOR BUZZER REMOVAL/INSTALLATION.)
3. Verify the continuity between rear parking sensor buzzer terminals A and B.

Test condition	Terminal	
	A	B
Under any condition	○—○	○—○

- If not as indicated in the table, replace the rear parking sensor buzzer.
