FRONT CENTER SPEAKER INSPECTION

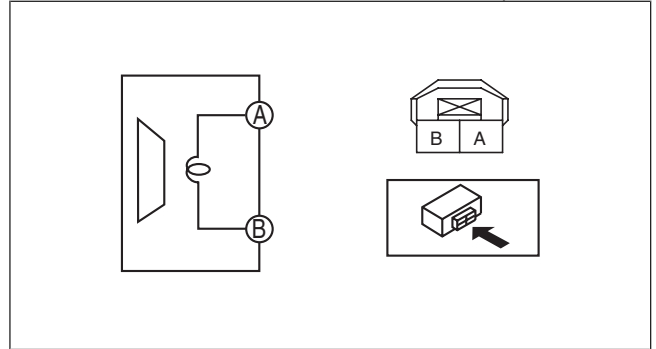
am6zzw00001612

1. Disconnect the negative battery cable. (See NEGATIVE BATTERY CABLE DISCONNECTION/CONNECTION [SKYACTIV-G 2.0, SKYACTIV-G 2.5].) (See NEGATIVE BATTERY CABLE DISCONNECTION/CONNECTION [SKYACTIV-G 2.0, SKYACTIV-G 2.5 (WITHOUT i-stop)].) (See NEGATIVE BATTERY CABLE DISCONNECTION/CONNECTION [SKYACTIV-D 2.2].)
2. Remove the center speaker grille. (See SPEAKER GRILLE REMOVAL/INSTALLATION.)
3. Remove the front center speaker. (See FRONT CENTER SPEAKER REMOVAL/INSTALLATION.)
4. Verify that the resistance between the front center speaker terminals is as indicated in the table.

Test condition	Terminal		Resistance (ohm)
	A	B	
Under any condition	○○		3.24—3.96

- If not as indicated in the table, replace the front center speaker.
