LIFTGATE OPENER SWITCH INSPECTION

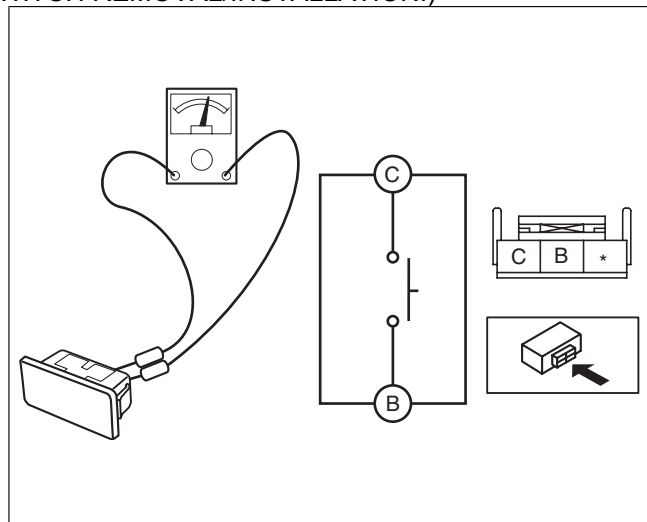
ac5wzw00002763

1. Disconnect the negative battery cable. (See NEGATIVE BATTERY CABLE DISCONNECTION/CONNECTION [SKYACTIV-G 2.0, SKYACTIV-G 2.5].) (See NEGATIVE BATTERY CABLE DISCONNECTION/CONNECTION [SKYACTIV-G 2.0, SKYACTIV-G 2.5 (WITHOUT i-stop)].) (See NEGATIVE BATTERY CABLE DISCONNECTION/CONNECTION [SKYACTIV-D 2.2].)
2. Remove the following parts:
 - (1) Liftgate upper trim (See LIFTGATE UPPER TRIM REMOVAL/INSTALLATION.)
 - (2) Liftgate side trim (See LIFTGATE SIDE TRIM REMOVAL/INSTALLATION.)
 - (3) Liftgate lower trim (See LIFTGATE LOWER TRIM REMOVAL/INSTALLATION.)
 - (4) Liftgate garnish (See LIFTGATE GARNISH REMOVAL/INSTALLATION.)
 - (5) Liftgate opener switch (See LIFTGATE OPENER SWITCH REMOVAL/INSTALLATION.)
3. Verify the continuity of liftgate opener switch terminals B and C.

○—○: CONTINUITY		
SWITCH POSITION	TERMINAL	
	B	C
ON (PUSH)	○—○	○—○
OFF (RELEASE)

- If not as indicated in the table, replace the liftgate opener switch.
