RVM SWITCH INSPECTION

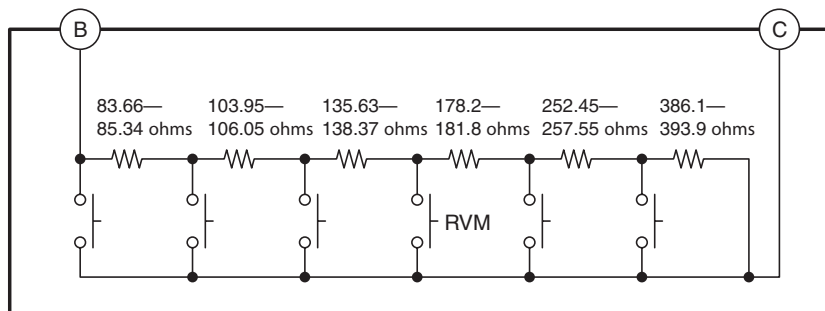
ac5wzw00000182

1. Disconnect the negative battery cable. (See NEGATIVE BATTERY CABLE DISCONNECTION/CONNECTION [SKYACTIV-G 2.0, SKYACTIV-G 2.5].)(See NEGATIVE BATTERY CABLE DISCONNECTION/CONNECTION [SKYACTIV-G 2.0, SKYACTIV-G 2.5 (WITHOUT i-stop)].)(See NEGATIVE BATTERY CABLE DISCONNECTION/CONNECTION [SKYACTIV-D 2.2].)
2. Remove the RVM switch. (See RVM SWITCH REMOVAL/INSTALLATION.)
3. Verify that the resistance between RVM switches B and C is as indicated in the table.

TEST CONDITION	RESISTANCE (ohms)
RVM SWITCH PRESSED	323.24—329.76
ALL SWITCHES RELEASED	1,139.99—1,163.01

- If the resistance cannot be verified as indicated in the table, replace the cluster switch.
4. Apply battery positive voltage to RVM switch terminal J, and connect terminal I to ground.
 5. Verify that the LED illuminates.
 - If there is any malfunction, replace the cluster switch.
