## FRONT DOOR SPEAKER INSPECTION

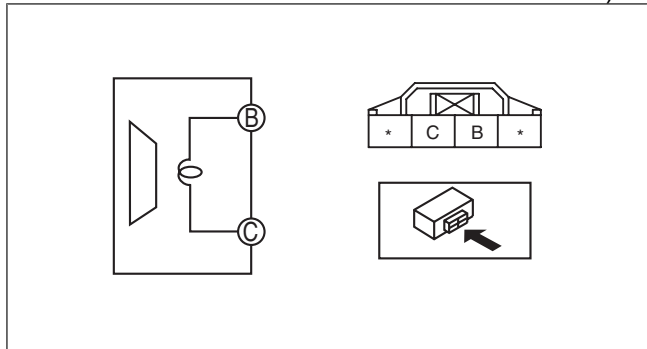
adejjw00001161

1. Disconnect the negative battery cable. (See NEGATIVE BATTERY CABLE DISCONNECTION/CONNECTION [SKYACTIV-G 2.0, SKYACTIV-G 2.5].) (See NEGATIVE BATTERY CABLE DISCONNECTION/CONNECTION [SKYACTIV-G 2.0, SKYACTIV-G 2.5 (WITHOUT i-stop)].) (See NEGATIVE BATTERY CABLE DISCONNECTION/CONNECTION [SKYACTIV-D 2.2].)
2. Remove the following parts:
  - (1) Inner garnish (See INNER GARNISH REMOVAL/INSTALLATION)
  - (2) Front door trim (See FRONT DOOR TRIM REMOVAL/INSTALLATION.)
3. Disconnect the front door speaker connector. (See FRONT DOOR SPEAKER REMOVAL/INSTALLATION.)
4. Verify that the resistance and continuity between the front door speaker terminals is as indicated in the table.

- If not as indicated in the table, replace the front door speaker.

Test condition	Terminal		Resistance (ohm)
	A	B	
Under any condition	○○	○○	3.4—4.6

Test condition	Terminal		Resistance (ohm)
	B	C	
Under any condition	○○	○○	1.25
