RECLINER MOTOR INSPECTION

L.H.D.

R.H.D.

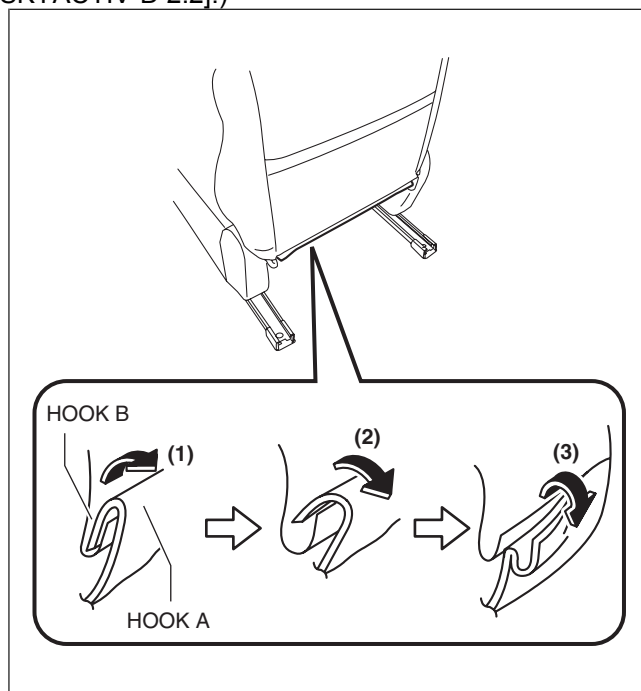
ac5uuw00002045

- Disconnect the negative battery cable and wait for **1 min or more**. (See NEGATIVE BATTERY CABLE DISCONNECTION/CONNECTION [SKYACTIV-G 2.0, SKYACTIV-G 2.5].) (See NEGATIVE BATTERY CABLE DISCONNECTION/CONNECTION [SKYACTIV-G 2.0, SKYACTIV-G 2.5 (WITHOUT i-stop)].) (See NEGATIVE BATTERY CABLE DISCONNECTION/CONNECTION [SKYACTIV-D 2.2].)
- Slide hooks A in the order of arrows (1), (2), (3) shown in the figure and disconnect them from hooks B.

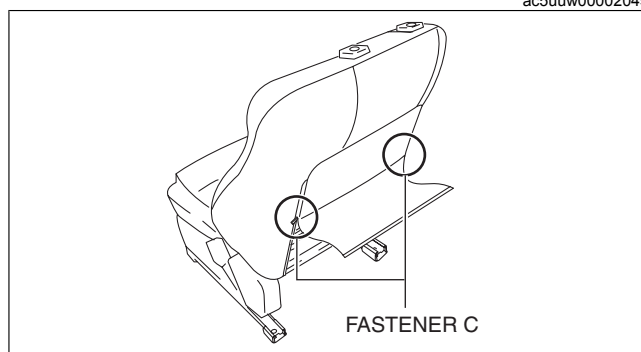
ac5uuw00002046

- Open fasteners C.
- Disconnect the recliner motor connector.

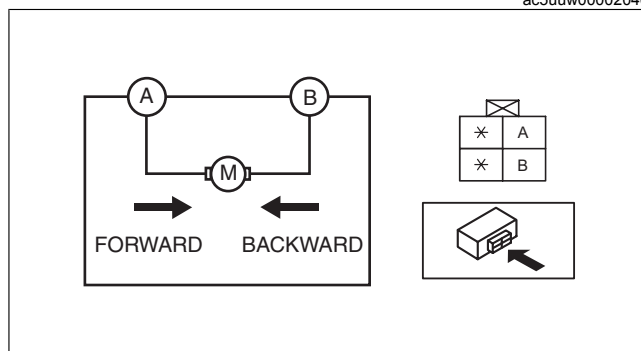
ac5wzw00003148

- Apply battery positive voltage to the recliner motor terminals and inspect the front seat operation.

Front seat operation	Connection	
	A	B
Forward	B+	GND
Backward	GND	B+

- If not as specified, replace the front seat back frame. (See FRONT SEAT BACK TRIM REMOVAL/INSTALLATION.)

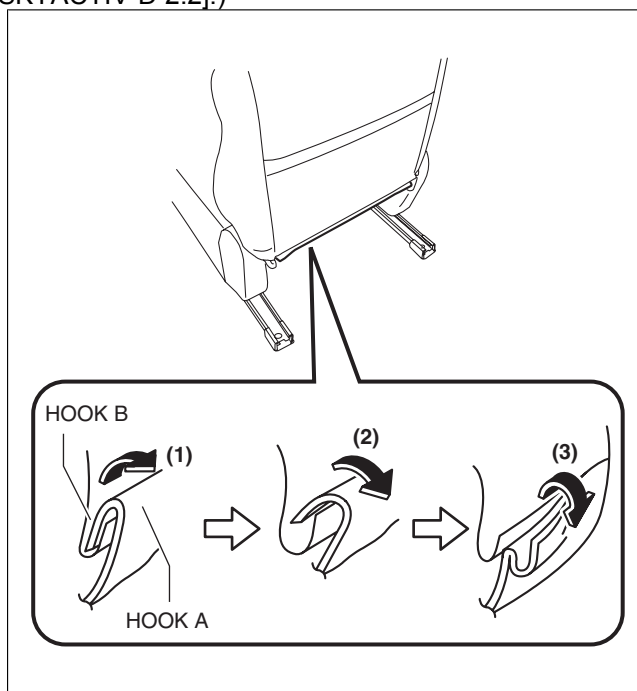
ac5uuw00002045

1. Disconnect the negative battery cable and wait for **1 min or more**. (See NEGATIVE BATTERY CABLE DISCONNECTION/CONNECTION [SKYACTIV-G 2.0, SKYACTIV-G 2.5].) (See NEGATIVE BATTERY CABLE DISCONNECTION/CONNECTION [SKYACTIV-G 2.0, SKYACTIV-G 2.5 (WITHOUT i-stop)].) (See NEGATIVE BATTERY CABLE DISCONNECTION/CONNECTION [SKYACTIV-D 2.2].)
2. Slide hooks A in the order of arrows (1), (2), (3) shown in the figure and disconnect them from hooks B.

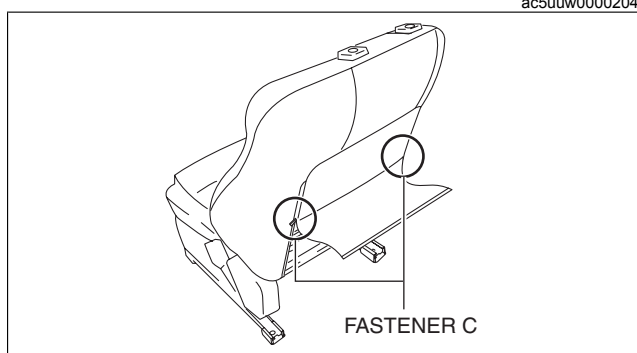
ac5uuw00002046

3. Open fasteners C.
4. Disconnect the recliner motor connector.

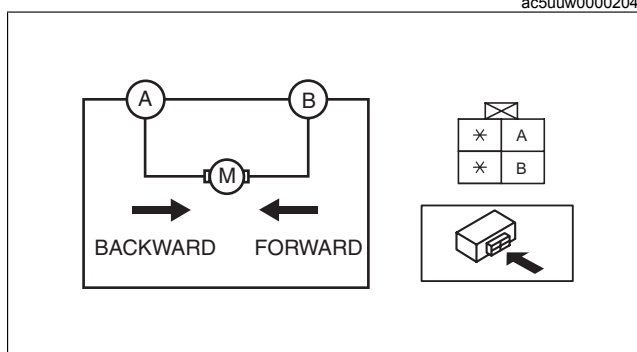
ac5wzw00003149

5. Apply battery positive voltage to the recliner motor terminals and inspect the front seat operation.

Front seat operation	Connection	
	A	B
Forward	GND	B+
Backward	B+	GND

- If not as specified, replace the front seat back frame. (See FRONT SEAT BACK TRIM REMOVAL/INSTALLATION.)
