## VACUUM CHAMBER INSPECTION [SKYACTIV-D 2.2]

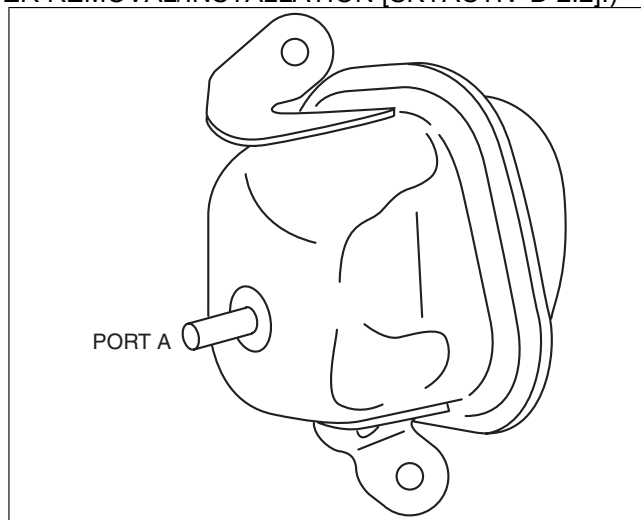
ac5wzw00004892

1. Remove the vacuum chamber. (See VACUUM CHAMBER REMOVAL/INSTALLATION [SKYACTIV-D 2.2].)
2. Apply negative pressure (**-94 kPa {-705 mmHg, -28 inHg}**) on the port A for one minute to check for the leakage of negative pressure.
  - If there is air leakage, replace the vacuum chamber. (See VACUUM CHAMBER REMOVAL/INSTALLATION [SKYACTIV-D 2.2].)
