DOWN SWITCH INSPECTION [GW6A-EL, GW6AX-EL]

Continuity Inspection

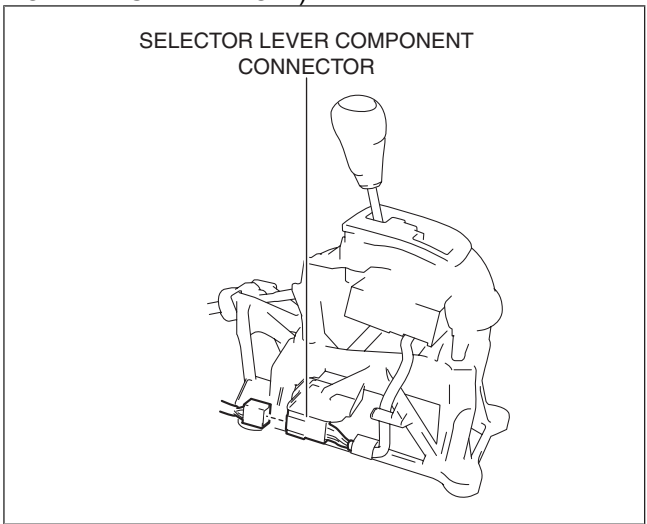
ac5wzw00000788

1. Disconnect the negative battery cable. (See NEGATIVE BATTERY CABLE DISCONNECTION/CONNECTION [SKYACTIV-D 2.2].)
2. Remove the front console. (See FRONT CONSOLE REMOVAL/INSTALLATION.)
3. Disconnect the selector lever component connector.

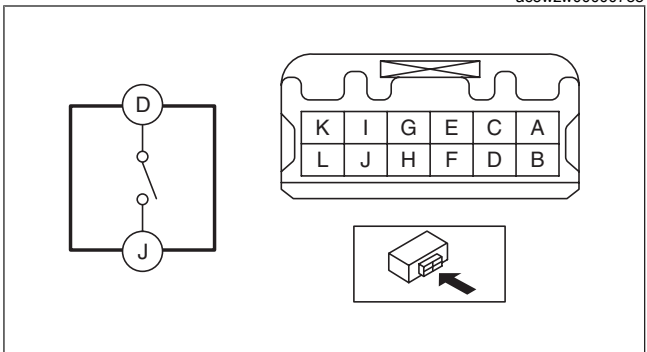
ac5wzw00000789

4. Verify that the continuity between selector lever component terminals D and J.
 - If not as verified, replace the selector lever component. (See AUTOMATIC TRANSAXLE SHIFT MECHANISM REMOVAL/INSTALLATION.)

Down switch specification

Test condition	Continuity
Selector lever is in the M position (–) side position.	Continuity
Selector lever is not in the M position (–) side position.	No continuity
