THEFT-DETERRENT HORN INSPECTION

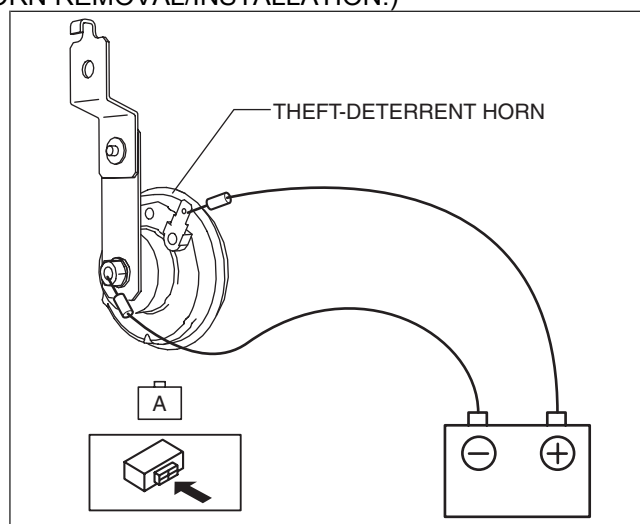
ac5jjw00001192

1. Disconnect the negative battery cable. (See NEGATIVE BATTERY CABLE DISCONNECTION/CONNECTION [SKYACTIV-G 2.0, SKYACTIV-G 2.5].) (See NEGATIVE BATTERY CABLE DISCONNECTION/CONNECTION [SKYACTIV-G 2.0, SKYACTIV-G 2.5 (WITHOUT i-stop)].) (See NEGATIVE BATTERY CABLE DISCONNECTION/CONNECTION [SKYACTIV-D 2.2].)
2. Remove the following parts:
 - (1) Trunk end trim (See TRUNK END TRIM REMOVAL/INSTALLATION.)
 - (2) Rear scuff plate (RH) (See REAR SCUFF PLATE REMOVAL/INSTALLATION.)
 - (3) Trunk side trim (RH) (See TRUNK SIDE TRIM REMOVAL/INSTALLATION.)
 - (4) Theft-deterrent horn (See THEFT-DETERRENT HORN REMOVAL/INSTALLATION.)
3. Apply battery positive voltage to horn terminal A, and connect the horn retaining bolt to ground as shown in the figure, and then verify that the horn sounds.
 - If the horn does not sound, replace the horn.
