UP SWITCH INSPECTION [GW6A-EL, GW6AX-EL]

Continuity Inspection

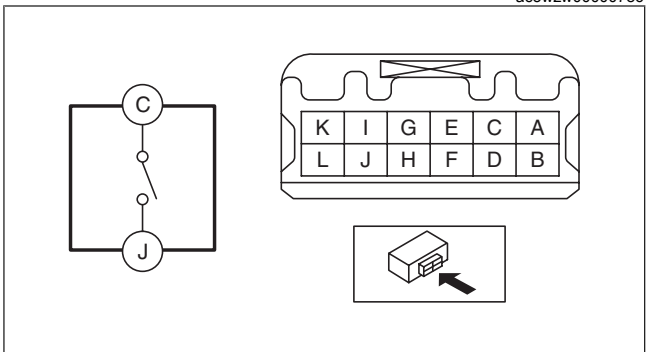
ac5wzw00000787

4. Verify that the continuity between selector lever component terminals C and J.
 - If not as verified, replace the selector lever component. (See AUTOMATIC TRANSAXLE SHIFT MECHANISM REMOVAL/INSTALLATION.)

Up switch specification

Test condition	Continuity
Selector lever is in the M position (+) side position.	Continuity
Selector lever is not in the M position (+) side position.	No continuity
