M POSITION SWITCH INSPECTION [FW6A-EL, FW6AX-EL]

Continuity Inspection

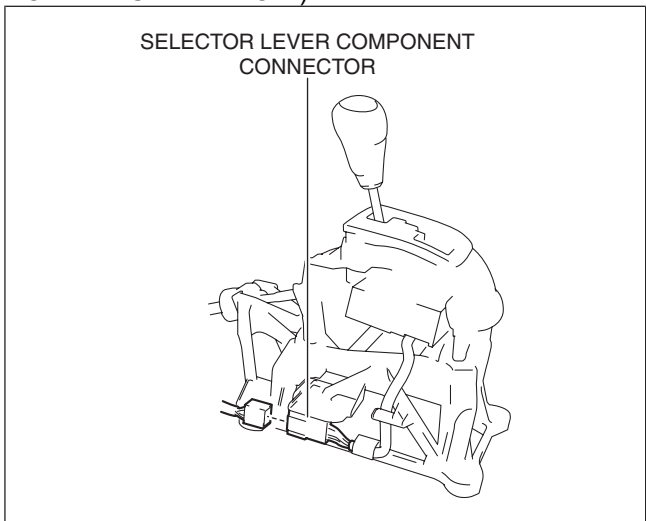
ac5wzw00000784

- Disconnect the negative battery cable. (See NEGATIVE BATTERY CABLE DISCONNECTION/CONNECTION [SKYACTIV-G 2.0, SKYACTIV-G 2.5 (WITHOUT i-stop)].) (See NEGATIVE BATTERY CABLE DISCONNECTION/CONNECTION [SKYACTIV-G 2.0, SKYACTIV-G 2.5].)
- Remove the front console. (See FRONT CONSOLE REMOVAL/INSTALLATION.)
- Disconnect the selector lever component connector.

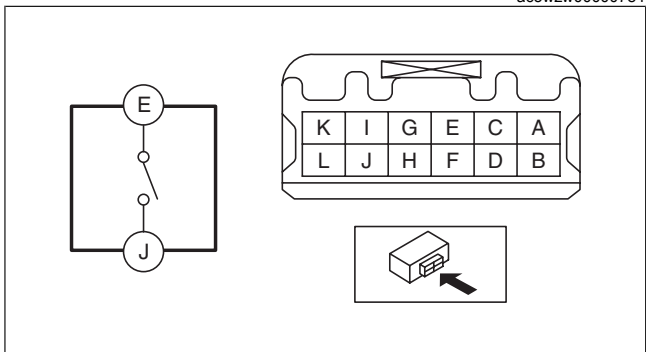
ac5wzw00000785

- Verify that the continuity between selector lever component terminals E and J.
 - If not as verified, replace the selector lever component. (See AUTOMATIC TRANSAXLE SHIFT MECHANISM REMOVAL/INSTALLATION.)

M position switch specification

Test condition	Continuity
Selector lever is in the M position.	Continuity
Selector lever is not in the M position.	No continuity
