Bluetooth UNIT REMOVAL/INSTALLATION

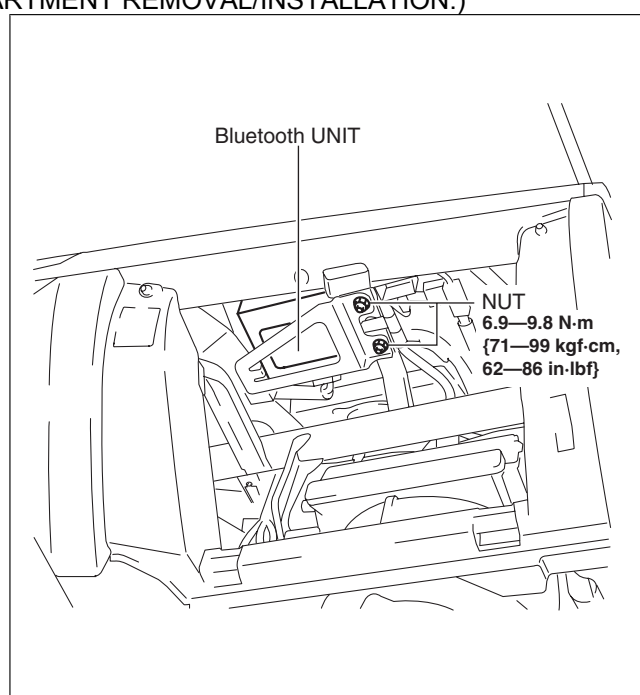
ac5jjw00000475

1. Disconnect the negative battery cable. (See NEGATIVE BATTERY CABLE DISCONNECTION/CONNECTION [SKYACTIV-G 2.0, SKYACTIV-G 2.5].) (See NEGATIVE BATTERY CABLE DISCONNECTION/CONNECTION [SKYACTIV-G 2.0, SKYACTIV-G 2.5 (WITHOUT i-stop)].) (See NEGATIVE BATTERY CABLE DISCONNECTION/CONNECTION [SKYACTIV-D 2.2].)
2. Remove the glove compartment. (See GLOVE COMPARTMENT REMOVAL/INSTALLATION.)
3. Remove the nuts.

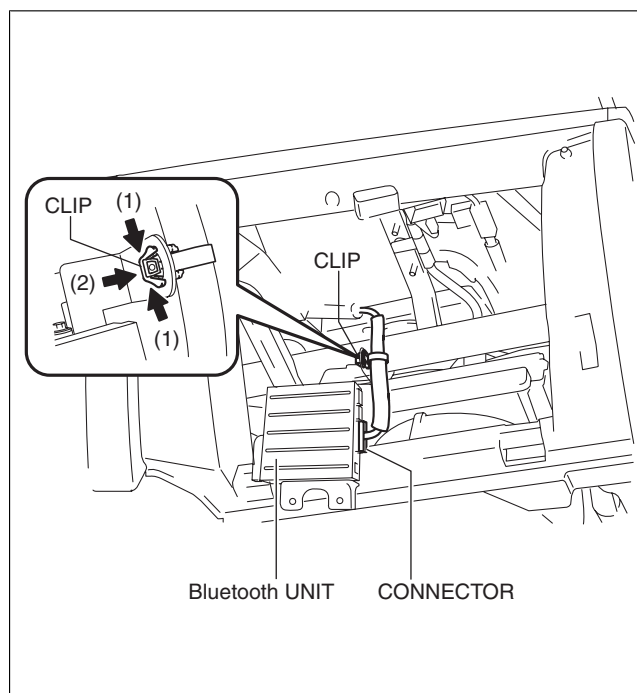
ac5jjw00000476

4. While pressing the tabs of the clip in the direction of the arrows (1) shown in the figure, press the clip in the direction of the arrow (2) to detach it from the Bluetooth unit.
5. Detach the clip.
6. Disconnect the connector.
7. Remove the Bluetooth unit.
8. Install in the reverse order of removal.
