CAVITATION EROSION RESISTANCE OF THE AUSTENITIC STAINLESS STEEL FROM WELDING RECONDITIONED HYDRAULIC TURBINES BLADES ZONES

Abstract: Samples of the austenitic stainless steel GX5CrNi19-10 have been thermally treated and tested under cavitation erosion. There have been obtained modifications of the cavitation resistance dependent on the thermal treatment by use of structural analyses and micro hardness tests the influence of microstructure on the steel cavitation resistance had been stressed out. The paper presents the researches carried on upon the cavitation erosion of austenitic stainless steel GX5CrNi 19-10 (SR EN 10283/99) [8] after solution treatment used for manufacturing Kaplan and Francis runner blades. The research is focused on the thermal influenced zones subsequently of the welding process performed in the repair work [5]. The thermal treatment of solution treatment followed by welding give a high cavitation resistance to austenitic stainless steel GX4CrNi19-10.

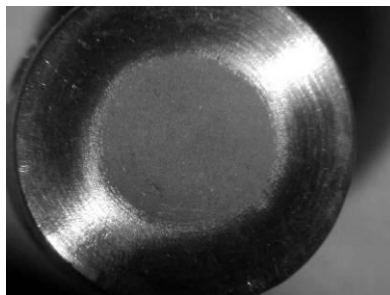
a) After the cavitation erosion tests
Optical microscop with 10X increase factor

Figure no. 4 The macroscopic aspect of the steel GX5CrNi19-10

The cavitation-tested specimens were analyzed at various aggrandizements using a stereomicroscope. Through macroscopic and microscopic analyses it was put into evidence the manner in which the cavitation erosion take place, inclusively the granulation and structural modifications of the layers subjected by cavitation (figures no. 4 a and b).

- a central zone is heavily eroded and presents crakes and microcrakes (figure no. 4b);
- a zone adjacent to the central one has only shallow erosions (figure no. 4a);
- a third zone is also heavily eroded and presents microcrakes (figure no. 4b);
- a fourth zone has only few erosions (figure no. 4a).

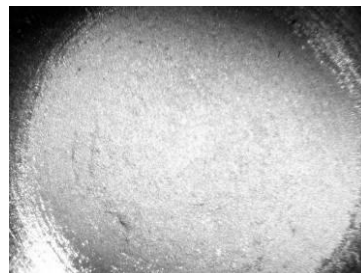
b) After heat solution treatment and welding
Optical microscop with 20X increase factor

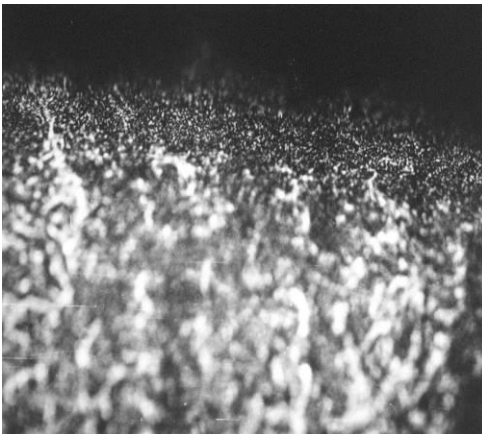
Optical microscope with 500X increase factor
Figure no. 7

The samples from the stainless steel GX5CrNi19-10, after the cavitation tests were sectioned on the generatrix, prepared and analyzed metallographical. The metallographic attack was made with the reactive CR 12361. The metallographic examination was made with an optical microscope having a photo camera. The structure of the specimens is presented in the figure no. 5, 6, 7, 8.

- the development dendritic of the crystalline grains perpendicular at frontal welder (figure no. 5, 6);
- the fines structure in the thermal influenced zone with the numerous fines precipitate intergranular complex carbides (figure no. 6);
- it appears also a finishing of the granulation in the thermal influenced zone, (figure no. 7);
- taking off and the expulsion of some material particles, (figure no. 8);
- breaking up of the crystalline grains, formation the micro fissures and the intensification of the separations of complex carbides at the boundaries of the grains, (figure no. 7, 8).
