## FAILURE ANALYSIS OF A KAPLAN TURBINE RUNNER BLADE

The paper presents the results of the failure analysis of a Kaplan turbine runner blade from a hydropower station in Romania.

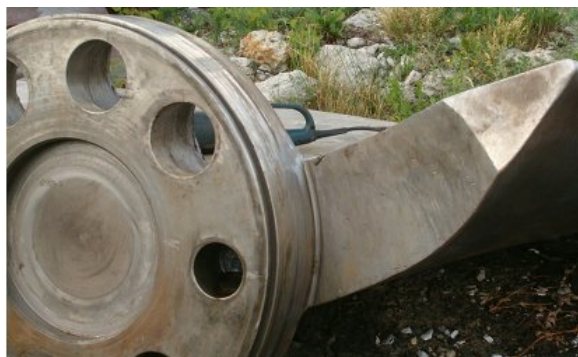
[Figure 1](#) The runner blade

The analyzed turbine is included in a power plant cascade equipped with low head Kaplan turbines with the same geometrical characteristics (runner with 4 blades-[Figure 1](#)), and, although it operates to a higher head compare with the rest of turbines, the solution was promoted from economical reasons.

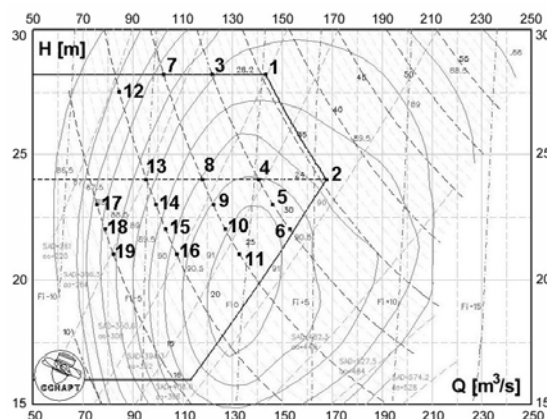
Figure 12 The placement of the operating points in the prototype hill chart

Table 1 presents the operation points considered for resistance calculus, which correspond to the following power values: 35.5 MW, 30 MW, 25 MW, 20 MW and 15 MW at different head values. The axial thrust and tangential forces were calculated for 4 and 6 runner blade. The placement of the operating points in the prototype hill chart is shown in Figure 12.

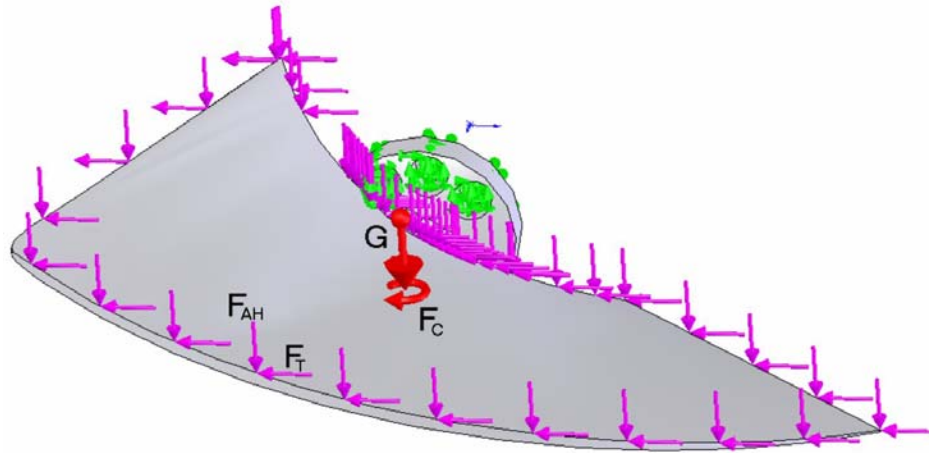
Figure 13 Loads and restrictions applied to the blade

Figure 13 show the loads and restrictions applied to the blade:

- *Fixed* type constraints applied to the flange holes, which impose 0 value for the translations and rotations of the selected entities;

- axial thrust  $F_{AH}$ ;
- tangential force  $F_T$ ;
- centrifugal force  $F_C$ ;
- blade gravity  $G$ .

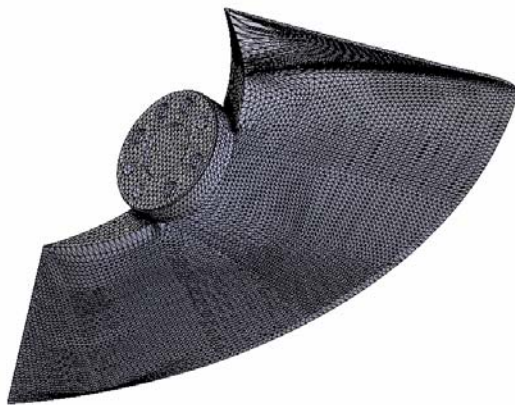
Figure 14 The blade mesh

Because the blade cannot be generated as a surface with constant thickness, for finite element analyse, only solid mesh (parabolic tetrahedral solid elements) can be used. The mesh is shown in Figure 14. For original stress relieve groove R8x20 a local fine mesh was used, Figure 15. The results are presented numerically in Table 2, and graphically in Figure 16 and Figure 17, only for operating point no. 1.

Figure 15 The blade mesh in the stress relieve groove area

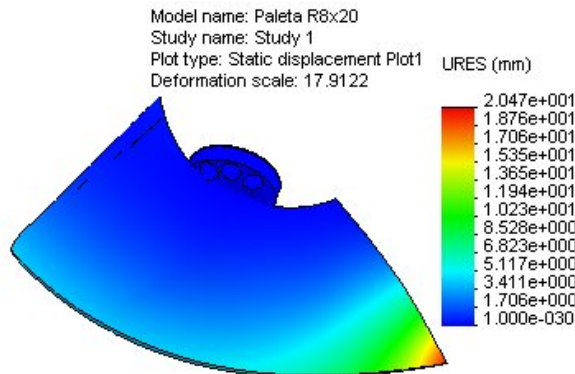
Figure 16 The resultant displacement plot

Figure 17 The Von Mises stress plot

The calculations carried out led to the conclusion that the cracking of the blade started and developed from the stress concentrator placed between blade and blade flange on leading edge direction.
