Sprint 3.5-4 Prototypes

4/9/2016

This is a prototype report to give the status of the UAV Lander project after sprints 3.5 and 4. The team was able to make progress and achieve the goals of manual flight and autonomous GPS waypoint navigation.

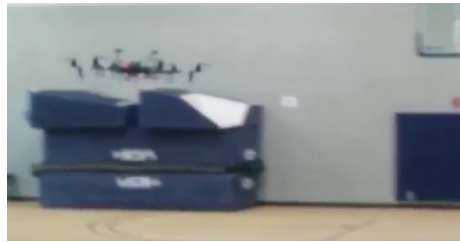
Figure 1: UAV Flying in the Gym

The manual flight in the gym was a good measure of first success for the team, as it showed that the UAV was assembled properly, and that the flight controller functioned well with our hexacopter setup. One thing that was mentioned to us here was that the handheld radio that the team was using was designed for fixed-wing aircraft such as model airplanes. This posed a problem when flying the UAV under manual control, because the throttle inputs would click into place, rather than being continuous. This was a problem because in order to maintain altitude, the pilot would have to constantly be clicking the throttle stick between various positions.

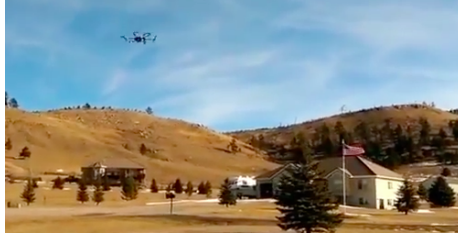
Figure 2: UAV Navigating Through Waypoints in the Wind

One exciting result during testing was that the team flew the UAV on a windy day. In the above image, you can see that a flag is blowing in the wind. The UAV did not show any signs of being blown around, even despite this.

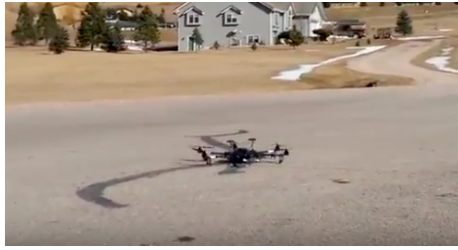
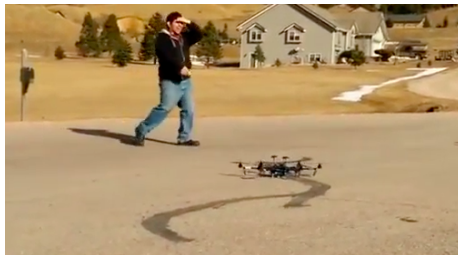
Figure 3: Location of UAV Before Takeoff

Figure 4: Location of UAV After Landing

The above two images show just how accurate the GPS waypoint navigation was. The UAV started at the location in the first image, took off, flew through a series of waypoints, and landed at the location in the second image. This test was done the same day, so this result was observed even in the wind. Another success that makes the team believe that GPS is reliable is that during these tests, one of the motor arms on the UAV had come loose and rotated. The flight controller was still able to keep the UAV under control, even despite these problems
