LLOYD**WARWICK**
INTERNATIONAL

Report No. 1

Damage to tipper and excavator, Amazonas, Peru

28 October 2019

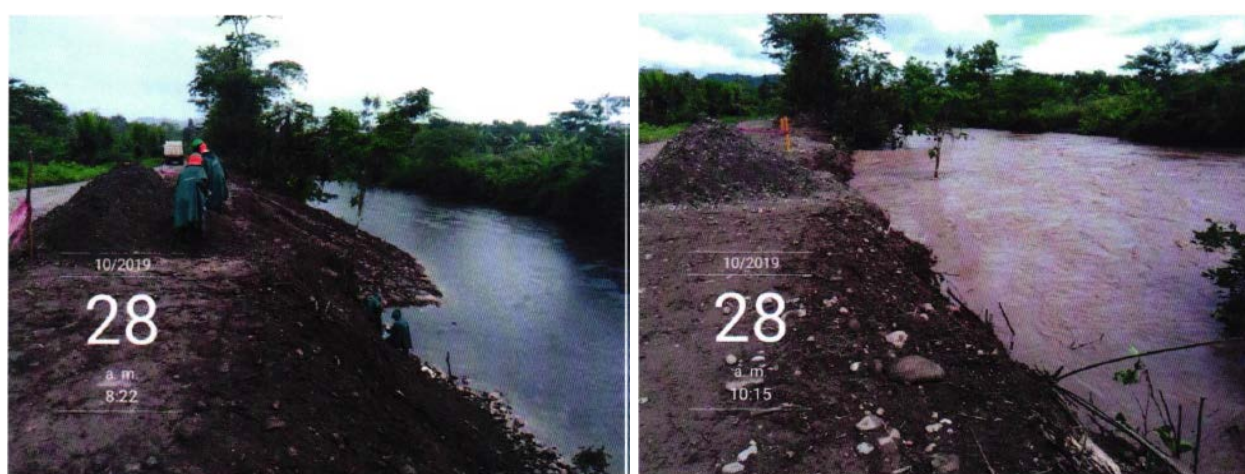
Fig 2.1: Chiangos River at 08.22 (left) and 10.15 (right) hours on 28 October 2019

From the information provided, it appears that flash flooding of the Chiangos River was the cause of the incident.

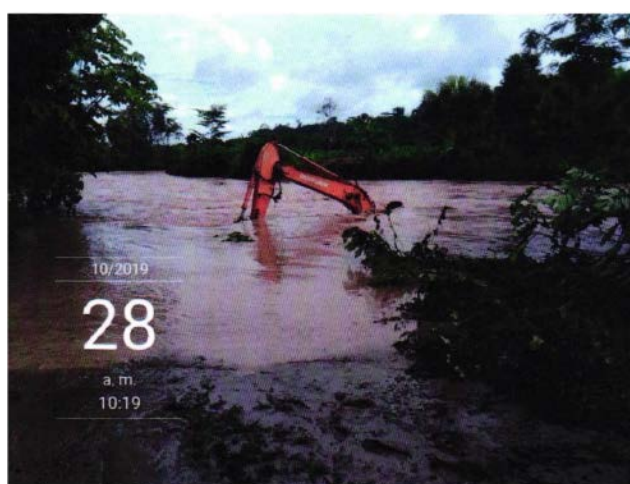
Whilst our enquiries are at a very early stage, from the information available it appears that excavations were being made in the vicinity of pipeline marker location KM 391+162 which required the use of a dump truck (with plate EGW-935) and excavator along the banks of the Chiangos River in the vicinity of pipeline marker location KM 391+162. At around 9am on 28 October 2019 an unexpected flash flooding event was experienced which resulted in the dump truck overturning and being dragged downstream. We understand the rising waters also submerged the excavator.

Fig 2.2: Photo of submerged excavator

At this stage it is unclear whether the equipment can be repaired or will require replacement. We have requested these details from the Insured and will report further as this information becomes available.
