A GIS-based optimization analysis of the Smock Riverwalk Trail

Noah Bebee, Maddie Betts, Maryellen Scowden, Elisia Wright

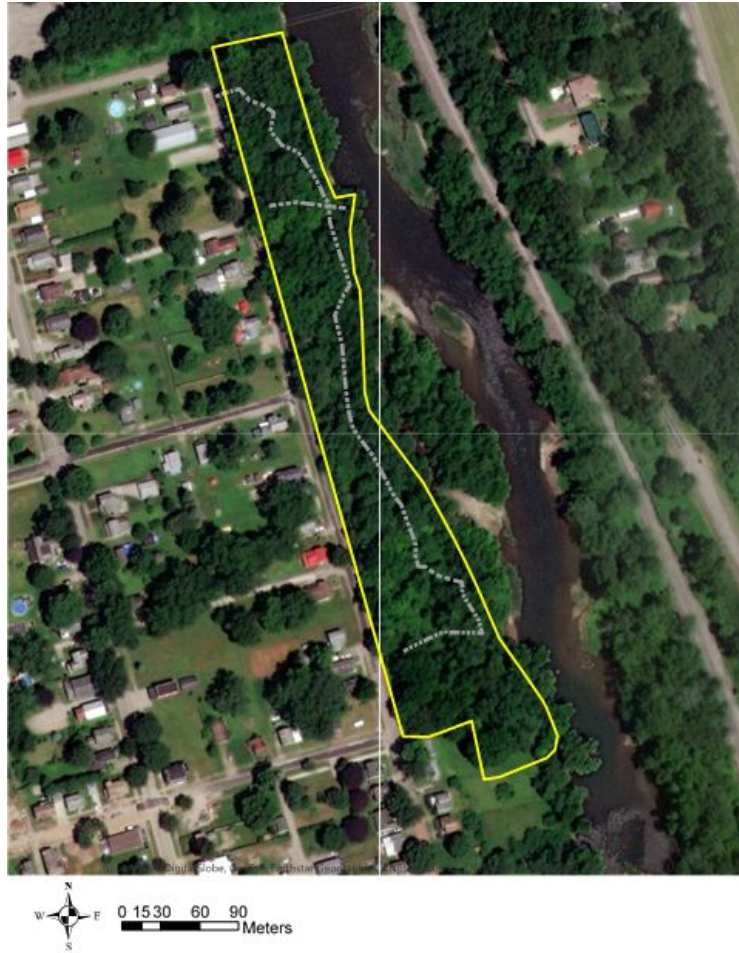
Figure 1: Smock Riverwalk property boundary and pre-established trail and boat launch.

The Smock Riverwalk, owned by the French Creek Valley Conservancy, is an 8-acre property located off of Wadsworth Avenue in Meadville, PA. It is moderately well-forested with dense underbrush and lies directly adjacent to French Creek, with much of the property falling within the recommended width of French Creek's riparian buffer (Lehigh Valley Planning Commission 2011). One trail and one boat launch have been pre-established within property boundaries. The trail is approximately 0.3 miles in length, with two points of entry (Figure 1).

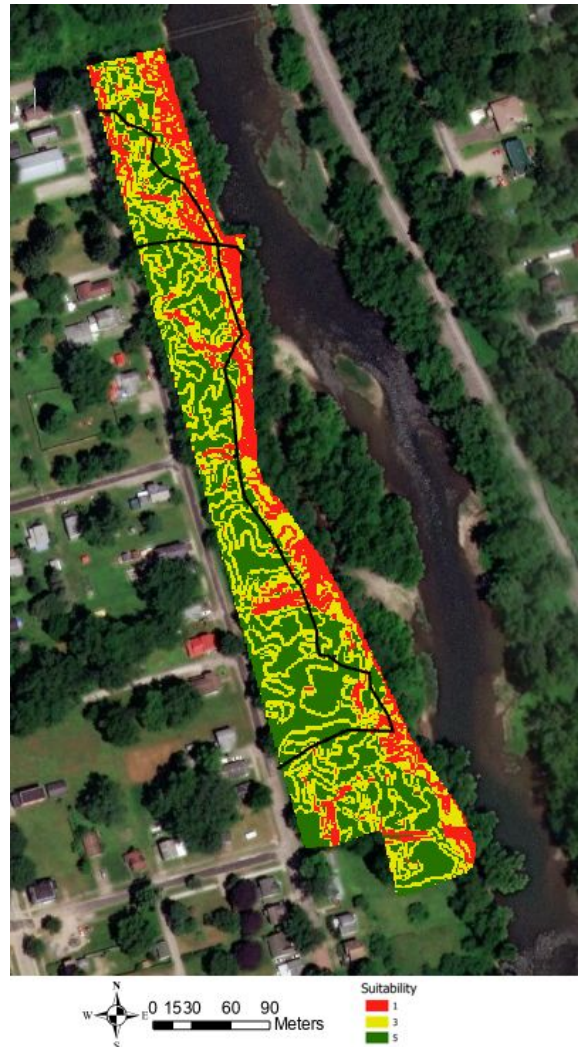
Figure 3: Composite map of two weighted variables (slope and proximity to stream). Green (5) denotes areas most suitable for trail placement after combining variables, red (1) denotes areas most unsuitable. Current trail placement is represented by black line.

A composite map was created by overlaying slope and proximity to stream raster datasets and giving both inputs equal weights of 50%. This map therefore depicts reclassified values from both slope and proximity to stream data. The established trail and boat launch were symbolized on the map as black lines in order to assess their current contribution to soil erosion (Figure 3).

We determined from this composite map that the current trail/boat launch on the Smock Riverwalk property is not located in a way that prevents soil erosion and damage to the riparian

ecosystem and French Creek. Much of the trail cuts directly through large swaths of unsuitable land and narrowly borders the streambank. The boat launch (seen near the top of the property as the black line that sits east to west) would be better situated along the south side of the property, in the green area of the map just north of where the trail changes directions from east-west to north-south. The trail itself would be better located if it were pushed westward, as areas along the west side of the property appear to be more suitable overall, given the variables we considered. However, modifying trail location now would likely cause more damage to the riparian ecosystem than it would solve, and because of this we recommend simply using the methods developed here for planning additional trails on additional properties.

Based on the suitability map (Figure 3) there are many segments of the trail that fall in unsuitable areas that appear to be in close vicinity to the identified muddy and exposed netting areas. Under optimal circumstances, the trail system would be planned using similar GIS suitability methods prior to the construction of the trail in order to minimize erosion and soil loss. However, since the trail is already established and in a sensitive riparian zone, attempting to optimize the current trail system would be more detrimental over time than if the LNT trail were left as is. In any case, only one third of all drainage issues would be solved by relocating a trail because the surrounding area does not change drastically in elevation. Hence, where altering the current trail system is not feasible, improving drainage features to minimize erosion and soil loss and installing elevated walkways (punchions) are the most effective solutions (Root & Knapik 1972; Bayfield & Lloyd 1973). Utilizing elevated walkways around muddy areas would also mitigate undesignated trail usage and trail widening. Research demonstrates that if a trail becomes muddy due to poor drainage, hikers are more likely to veer off-trail to circumvent those areas. This contributes significantly to excessive trail widening (Marion et al. 1996). These features would not
