Solar Panel Inspection Report

Reporting Period: 2025-06-24 19:34:11 to 2025-07-24 19:34:11

Inspection Line: Smart Conveyor Automated System

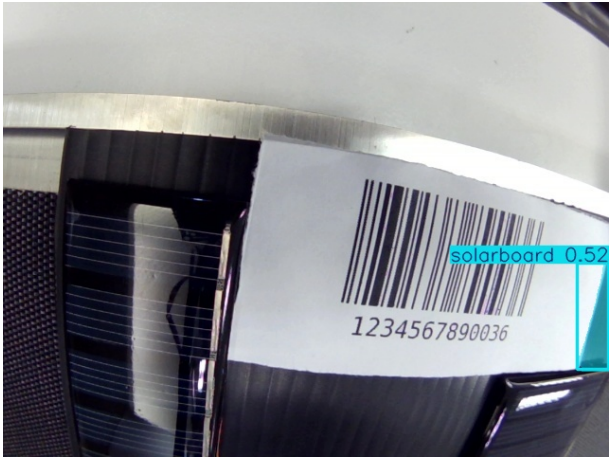
Panel Images:

****Overall Assessment:**** The thermal data shows localized hotspots in areas 2, 4, and 5, exceeding the expected operating temperature of the cells. Coupled with the YOLOv8 detection showing multiple instances of "solarboard" with varying confidence levels, suggesting potential misalignment or overlapping panels, a comprehensive investigation is needed. This points toward likely manufacturing defects rather than field damage.

* ****Area 2:**** Elevated temperatures (up to 31.55°C) in a localized region. This suggests potential delamination or poor cell-to-cell contact in this section.

* ****Area 4:**** Similar to Area 2, with a hotspot reaching 31.35°C. This again points to a possible delamination, poor cell contact, or a localized manufacturing defect. The pattern also suggests potential misalignment of cells during stringing.

* ****Area 5:**** Hotspot reaching 31.72°C. This is the most significant hotspot and possibly indicates a combination of issues: delamination, poor cell contact, and potentially a manufacturing defect related to soldering or lamination process.

The multiple detections of "solarboard" in each image with varying confidence scores suggests potential issues with panel alignment and/or overlapping components during the lamination process. Lower confidence scores (0.65, 0.79, 0.82) indicate possible misalignment or partial obscuring of panels, confirming the thermal data's suggestion of manufacturing defects.

1. ****Lamination Pressure:**** The hotspots suggest insufficient pressure in certain areas, leading to incomplete bonding and delamination. This could be due to inconsistent pressure distribution across the lamination press. ***Recommendation:*** Investigate the lamination press for uneven pressure distribution. Calibrate the pressure sensors and ensure uniform pressure across the entire lamination area.

2. ****Lamination Temperature:**** While the average temperature is likely within the acceptable range, localized temperature variations during the lamination process might have occurred, resulting in inconsistent bonding. ***Recommendation:*** Check the uniformity of the lamination temperature profile. Ensure even heat distribution across the entire lamination surface by recalibrating the heating elements.

3. ****Cell Stringing Speed:**** The inconsistencies in YOLOv8 detections suggest potential misalignment of cells, implying potentially high stringing speed. ***Recommendation:*** Review and adjust the cell stringing speed to ensure proper cell alignment and prevent stress accumulation. Aim for the lower end of the recommended range (0.5-0.8 m/s).

4. ****Handling Force:**** The corners of the panels might have been subjected to excessive force during handling, potentially causing micro-cracks. ***Recommendation:*** Review the handling procedures to minimize force applied during transport and assembly. Implement better packaging to prevent damage during shipping and handling.

- * **Visual Inspection:** A thorough visual inspection of the solar panel is crucial to identify any visible cracks, delamination, or other physical defects. This should be conducted under magnification.
- * **Electroluminescence Imaging (ELI):** ELI will help identify any micro-cracks or faulty cells which might not be visible during visual inspection.
- * **Infrared Thermography:** A more detailed infrared thermographic scan would provide a higher resolution map of the hotspots, allowing for precise pinpointing of the defective areas.
- * **Review Production Logs:** Analyze the production logs for serial number 1234567890036 to cross-reference the recorded parameter values with the identified defects. This will confirm suspected parameter deviations.

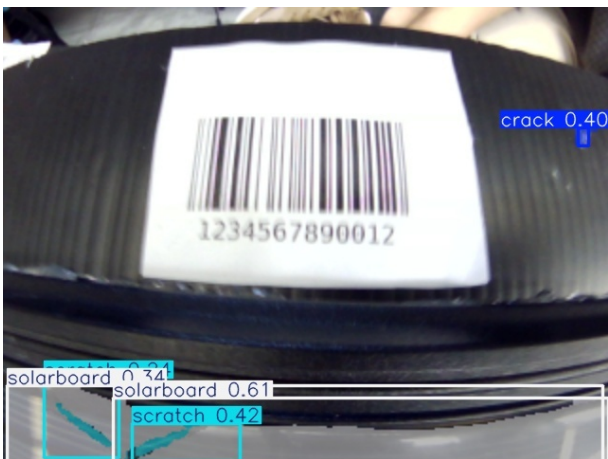
Panel Images:

Model Name: SolarBoard MAX50000
Timestamp: 2025-07-24T11-04-45
Status: cracked

Scan Duration: 2025-06-29T17-17-07 to 2025-07-24T11-04-45
Total Scans: 8
Cracked Count: 2
Crack Rate: 25.00%
