"2002" SEMINAR INFORMATION

"What's New for '2002' Technical Seminar"

AUTOMATIC TRANSMISSION SERVICE GROUP

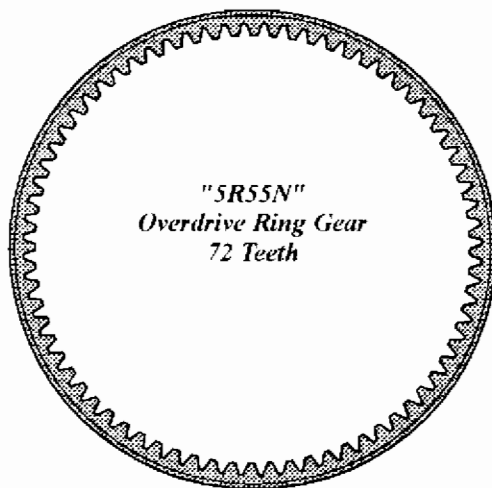
Figure 8

**5R55N OVERDRIVE RING GEAR
AND CENTER SHAFT**

"5R55N"
Overdrive Center Shaft
72 Teeth

Figures 9 and 10 are illustrations of the two different overdrive ring gears and the overdrive center shafts. Notice the difference in the tooth counts of both pieces.

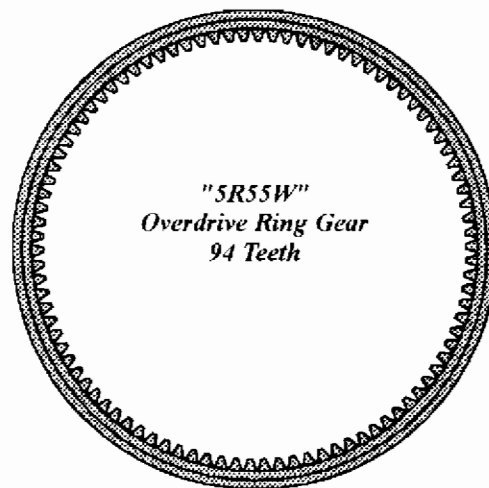
Figure 9

**5R55W OVERDRIVE RING GEAR
AND CENTER SHAFT**

"5R55W"
Overdrive Center Shaft
94 Teeth
