## THM 4T80-E FLUID LEAKING FROM BELLHOUSING

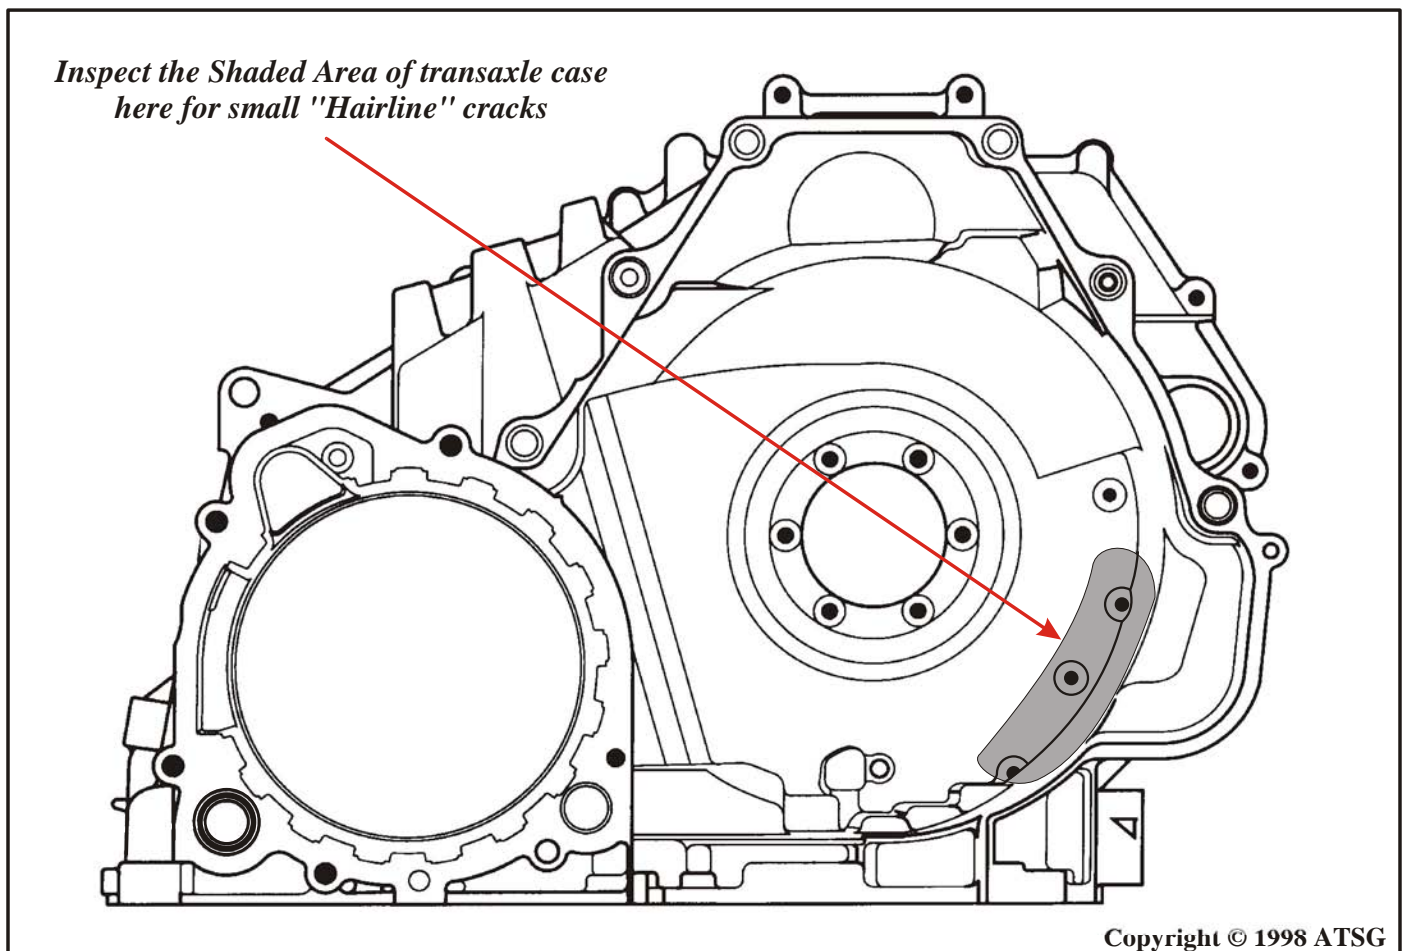
Figure 1

**COMPLAINT:** Transaxle fluid leaking from the bell housing area, even after rebuild or a converter seal and torque converter replacement.

**CAUSE:** The cause may be, a transaxle case with a small hairline crack in the shaded area shown in Figure 1, from high line pressure conditions.

**CORRECTION:** Inspect the transaxle case closely in the shaded area shown in Figure 1, for small hairline cracks and replace the transaxle case as necessary. Hydra-matic cast the case thicker in this area during the 1996 model year to eliminate this condition.
