1995 SEMINAR INFORMATION
"HOW TO SURVIVE IN 95"

INDEX
FORD MOTORS

INTRODUCTION

In this third manual of the "HOW TO SURVIVE IN '95" Seminar We continue with Up Dates on the FORD E4OD, AXODE, A4LD and ATX. Plus the many request we get on check ball location in these FORD units. The FORD section concludes with information on the new computer controlled 4R44E/4R55E transmission which is a fully computerized A4LD rear drive unit. The Chrysler section of the manual covers the Up Dates on the A-604 Transaxle and the 42RE Transmission which is the computer controller version of the A-500 transmission.

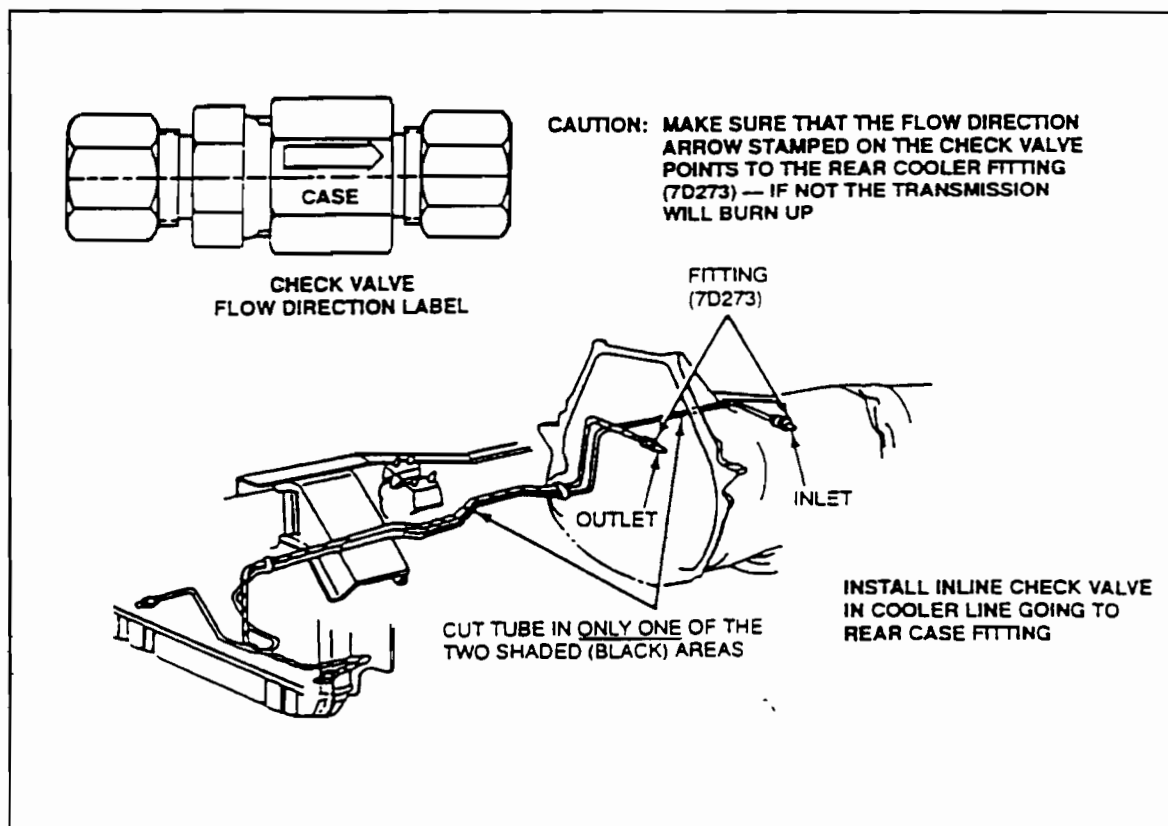
FIGURE 1

CAUSE:

The cause may be, converter drainback through the cooler.

Install an in-line check valve, OEM part number F0TZ-7D174-A, in the "Cooler Return Line" going to the rear case fitting (See Figure 1).

NOTE: MAKE SURE THAT THE FLOW DIRECTION ARROW STAMPED ON THE CHECK VALVE POINTS TOWARDS THE REAR COOLER FITTING, OR A TRANSMISSION FAILURE

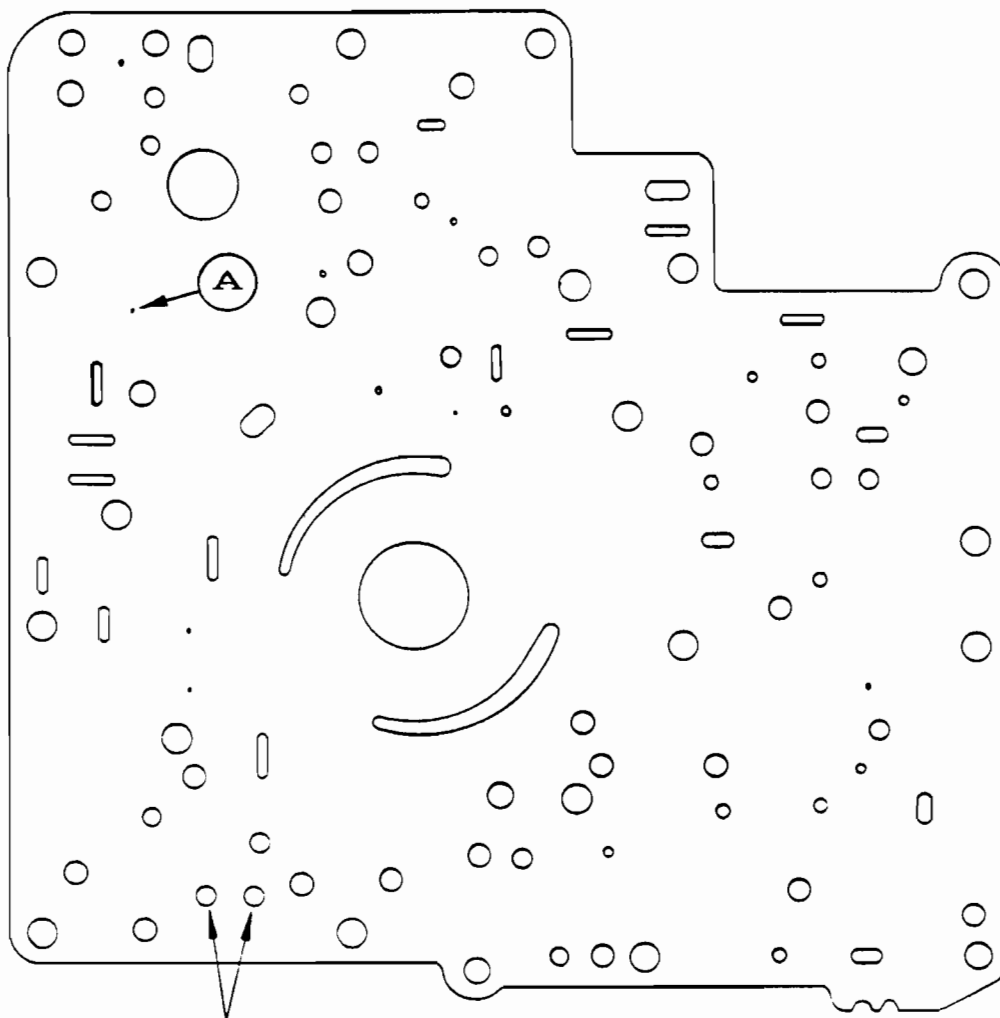
Figure 1

AXOD-E PUMP SPACER PLATE
"EARLY" 1991 ONLY.

TWO HOLES
USES NUMBER 12 CHECKBALL.

HOLE "A" .030" = LOCK-UP SOLENOID (LUS).
.215" = MODULATED LOCK-UP SOLENOID (MLUS).

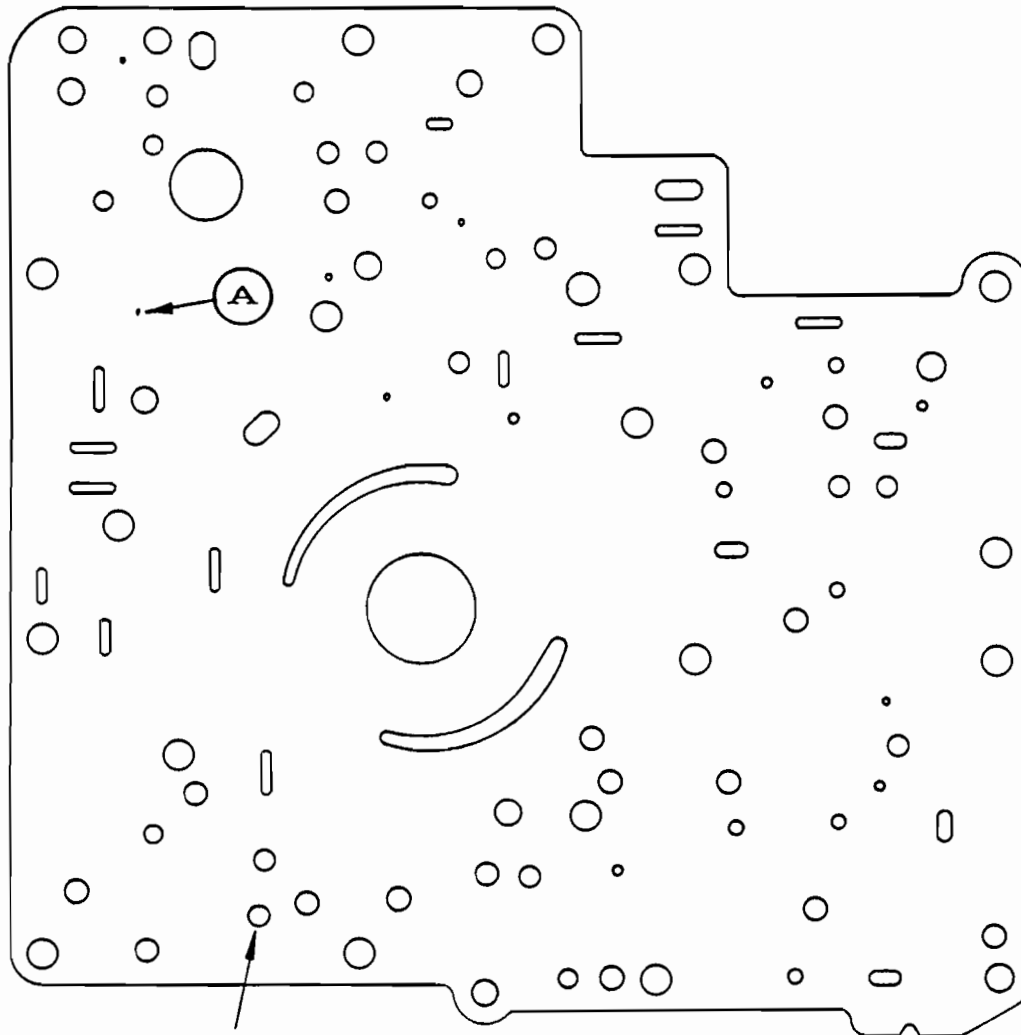
Figure 2

AXOD-E PUMP SPACER PLATE
"LATE" 1991 ONLY.

ONE HOLE
DOES NOT USE NUMBER 12 CHECKBALL.

HOLE "A" .030" = LOCK-UP SOLENOID (LUS).
.215" = MODULATED LOCK-UP SOLENOID (MLUS).

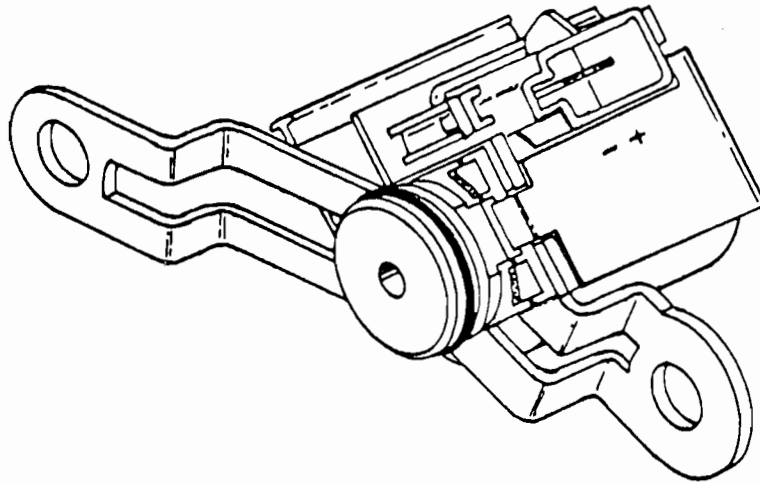
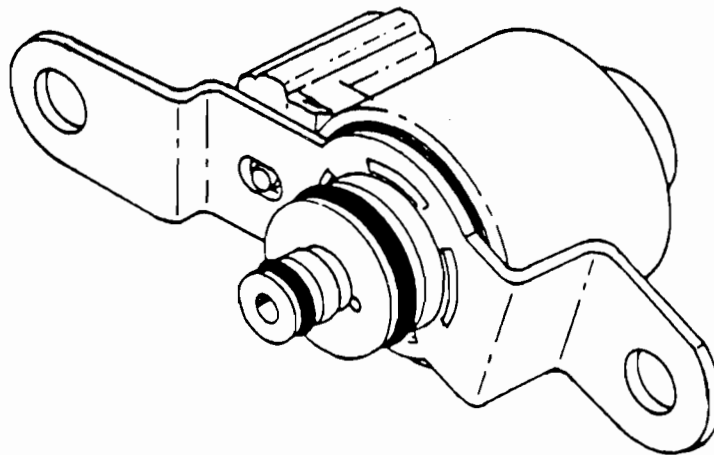
Figure 3

LOCK-UP SOLENOID (LUS)
FOUND IN: 1991 TAURUS/SABLE ONLY.

OEM PART NUMBER: F1DZ-7G136-A

MODULATED LOCK-UP SOLENOID (MLUS)
FOUND IN: 1991 CONTINENTAL ONLY.
FOUND IN: 1992 "ALL MODELS".

OEM PART NUMBER: F10Y-7G136-A

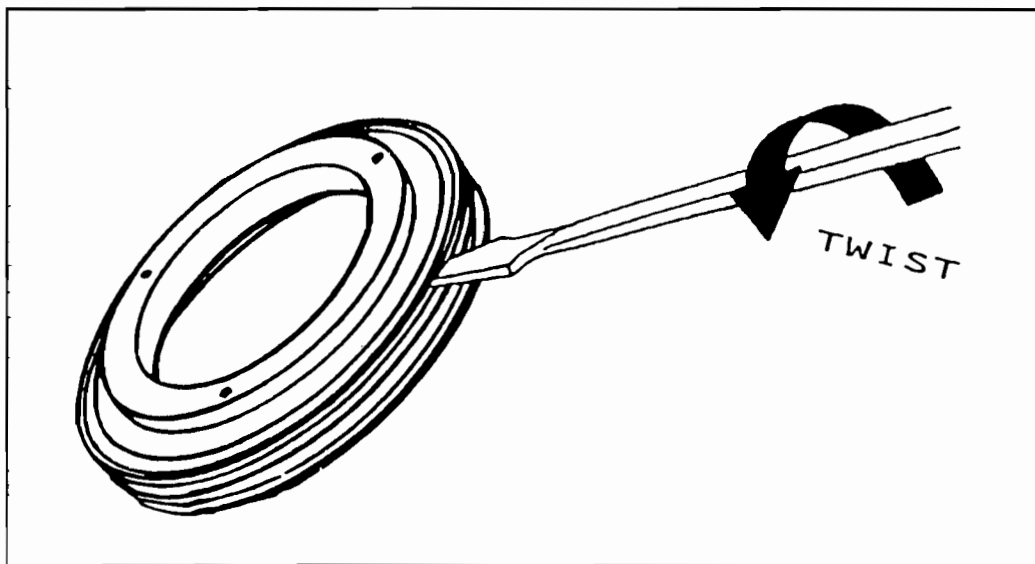
FIGURE 1

The forward clutch piston may be cracked on the outside diameter, seal groove or apply wall (bottom of piston). This condition will cause leakage resulting in apply concerns. See Figure 1.

Use the following chart to see which application forward clutch piston is needed for replacement.

F4DZ-7A262-A	F4DZ-7A262-B
3.0L Taurus 3.0L Sable 3.8L Taurus 3.8L Sable 3.8L Continental 3.8L Windstar	3.2L Taurus Sho

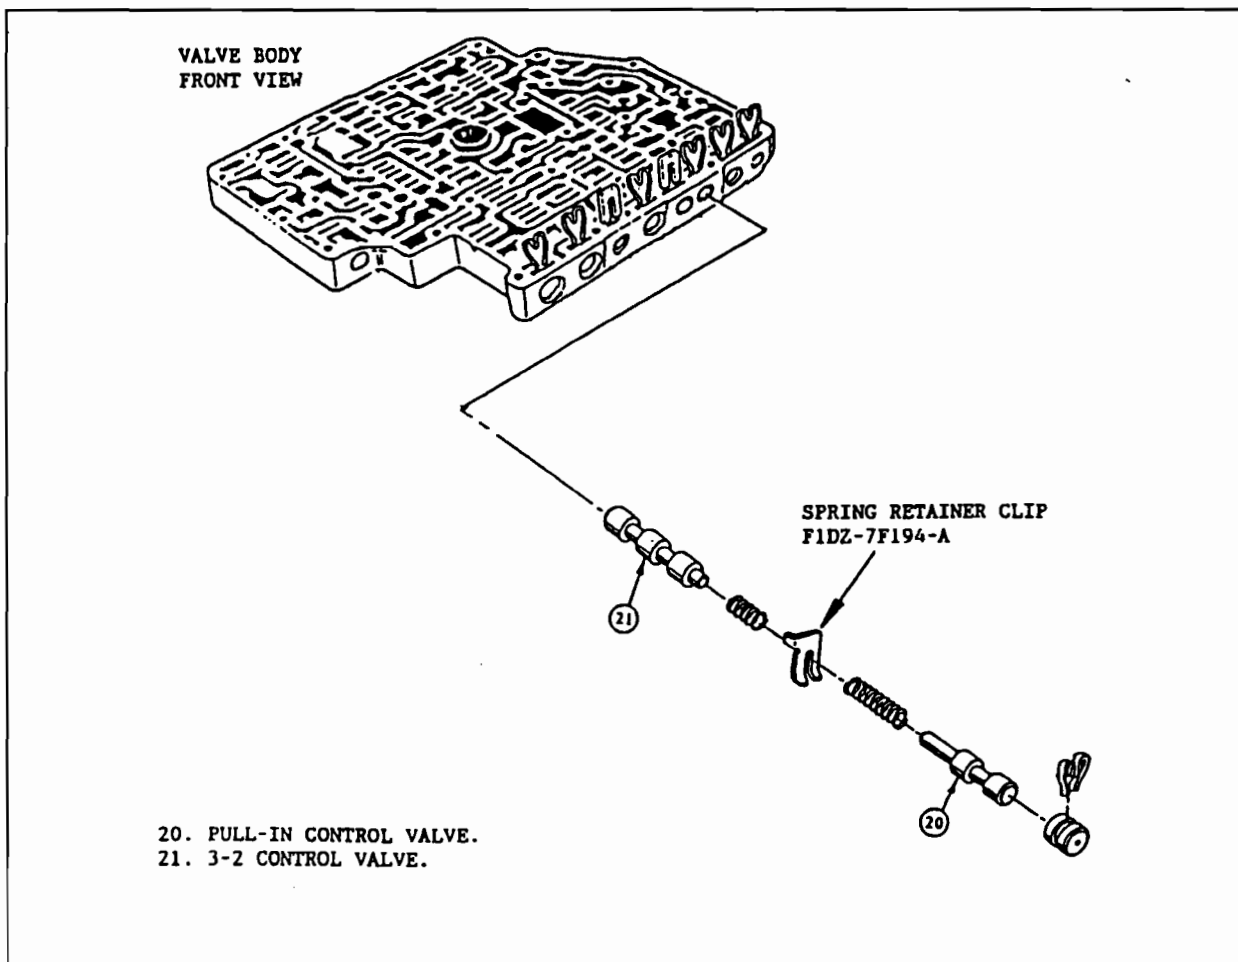
FIGURE 1

The cause may be, a broken spring retainer clip between the pull-in control valve spring and the 3-2 control valve spring, as shown in Figure 1.

Replace the spring retainer clip with **OEM part number F1DZ-7F194-A**.

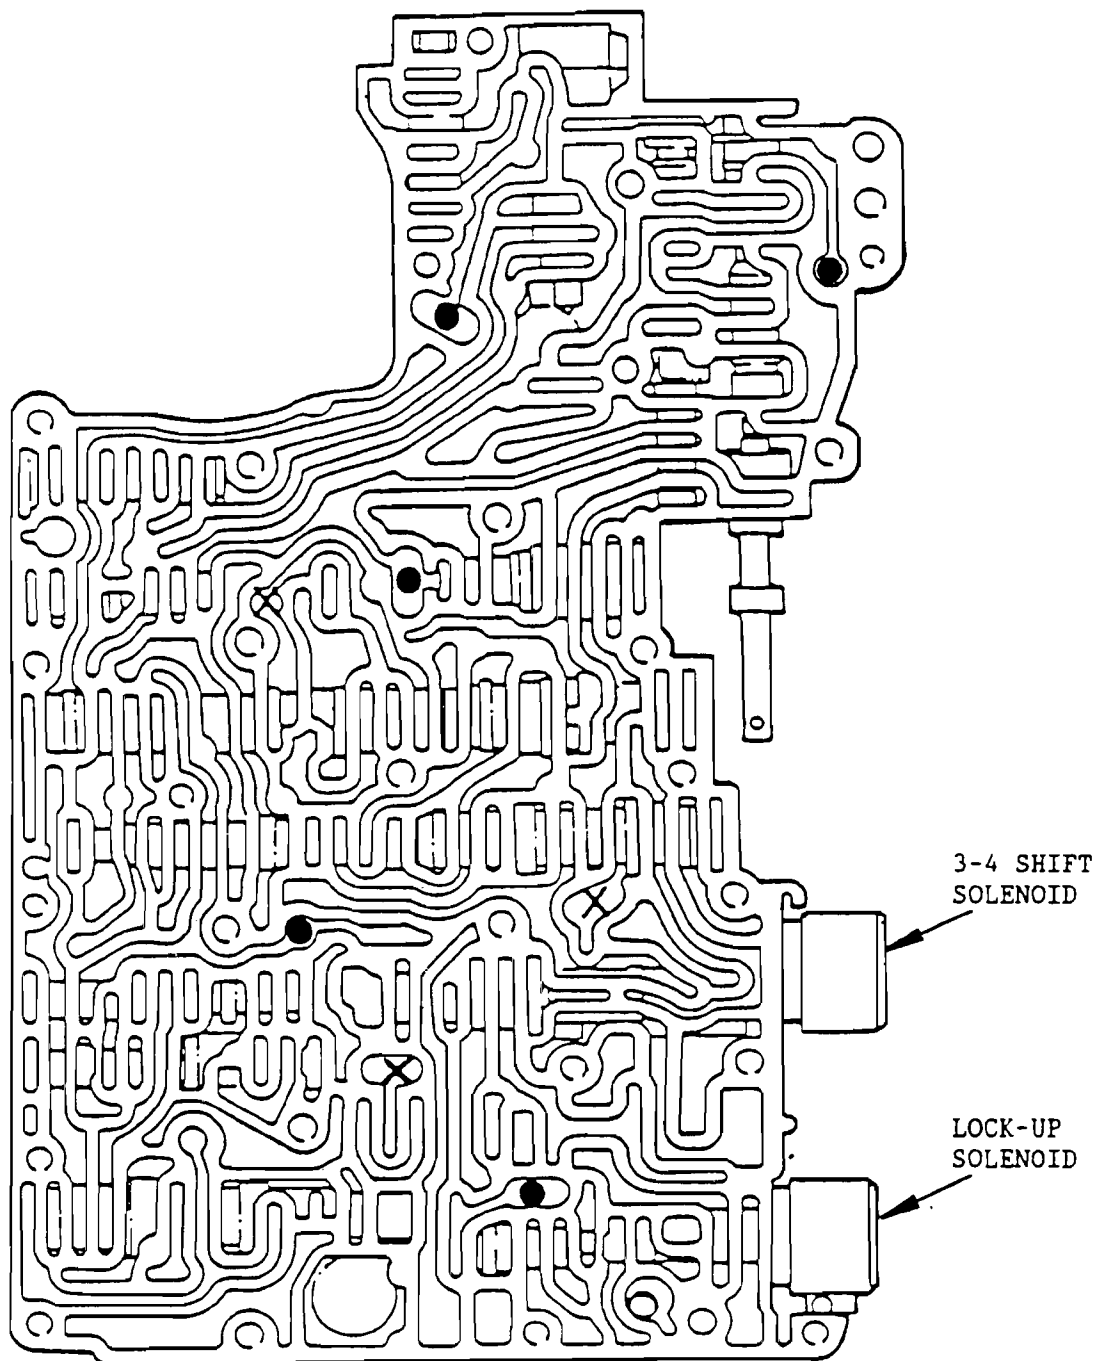
Figure 2

LATE 1988-90 ELECTRONIC 3-4 SHIFT CHECK BALL LOCATION TWO SOLENOID

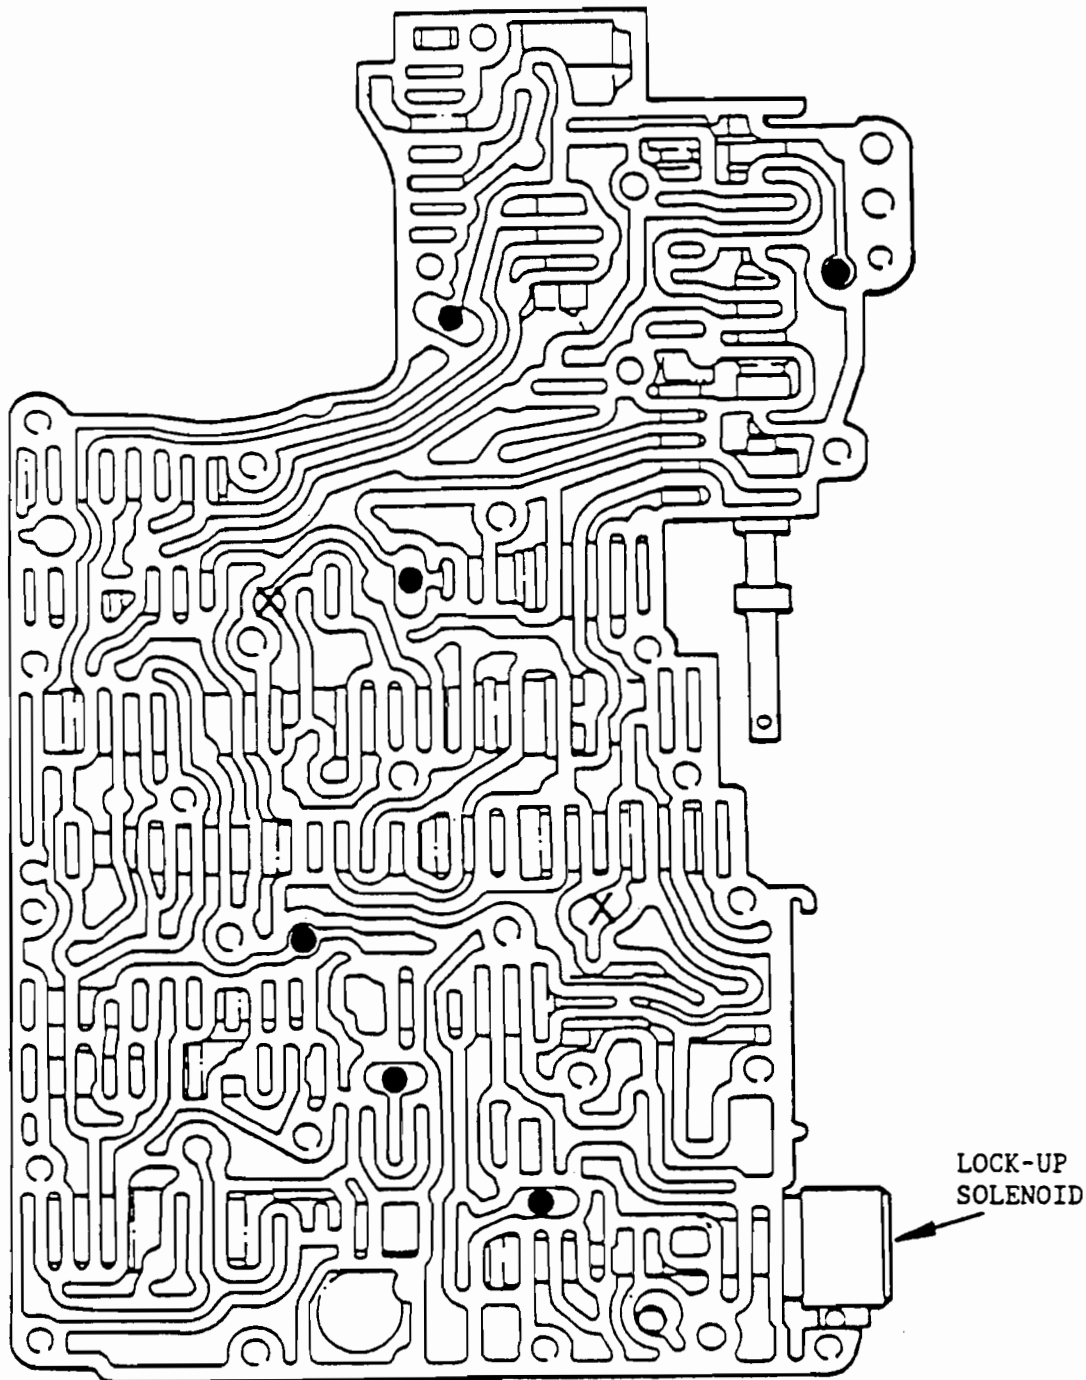
Figure 1

EARLY 1985-1987 HYDRAULIC 3-4 SHIFT CHECKBALL LOCATION ONE SOLENOID

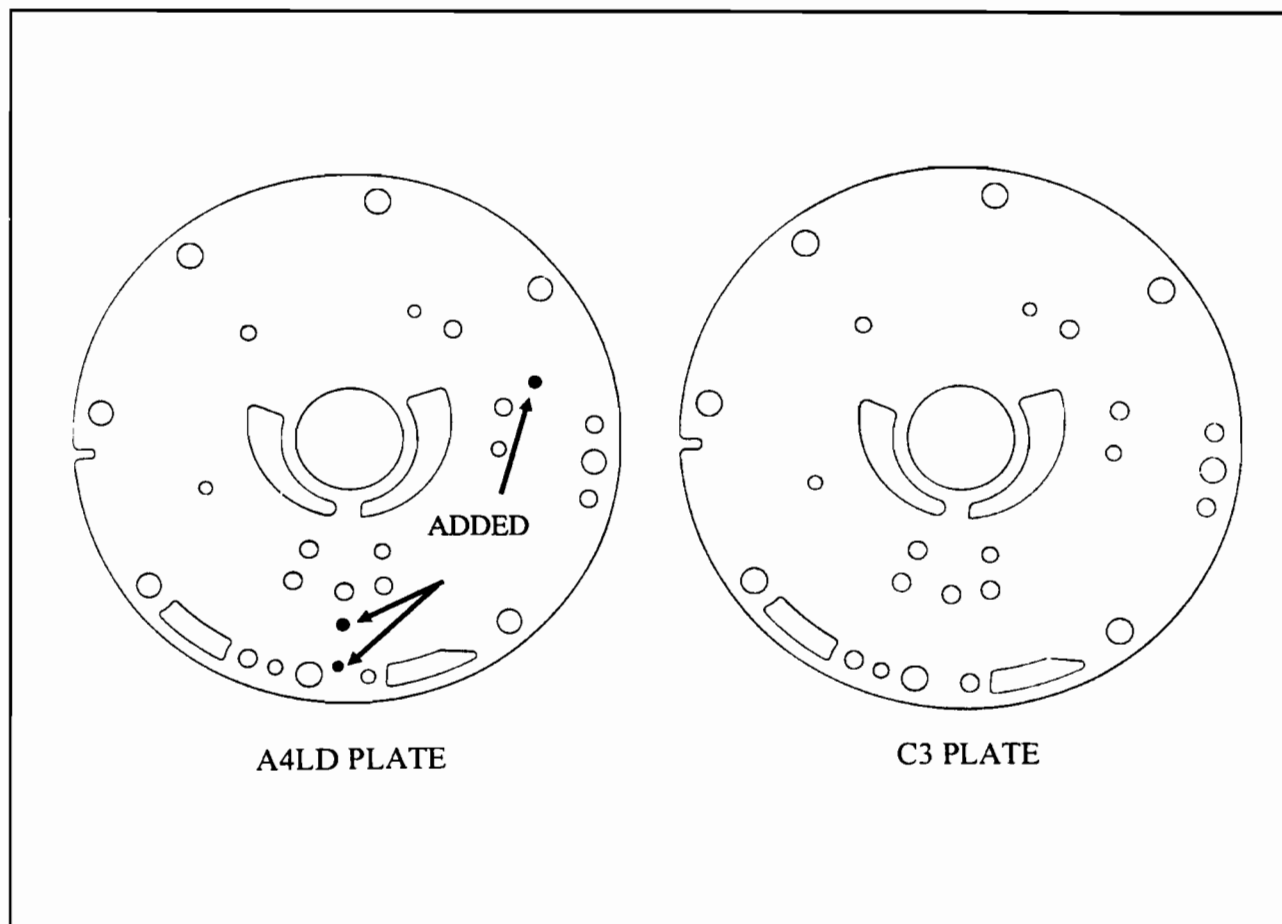
FIGURE 9

Bell housings, plates and pumps are interchangeable as a matched set. A C-3 pump plate can be used with an A4LD pump if the three (3) holes in Figure 9 are drilled. An A4LD pump plate must be used to locate the holes.

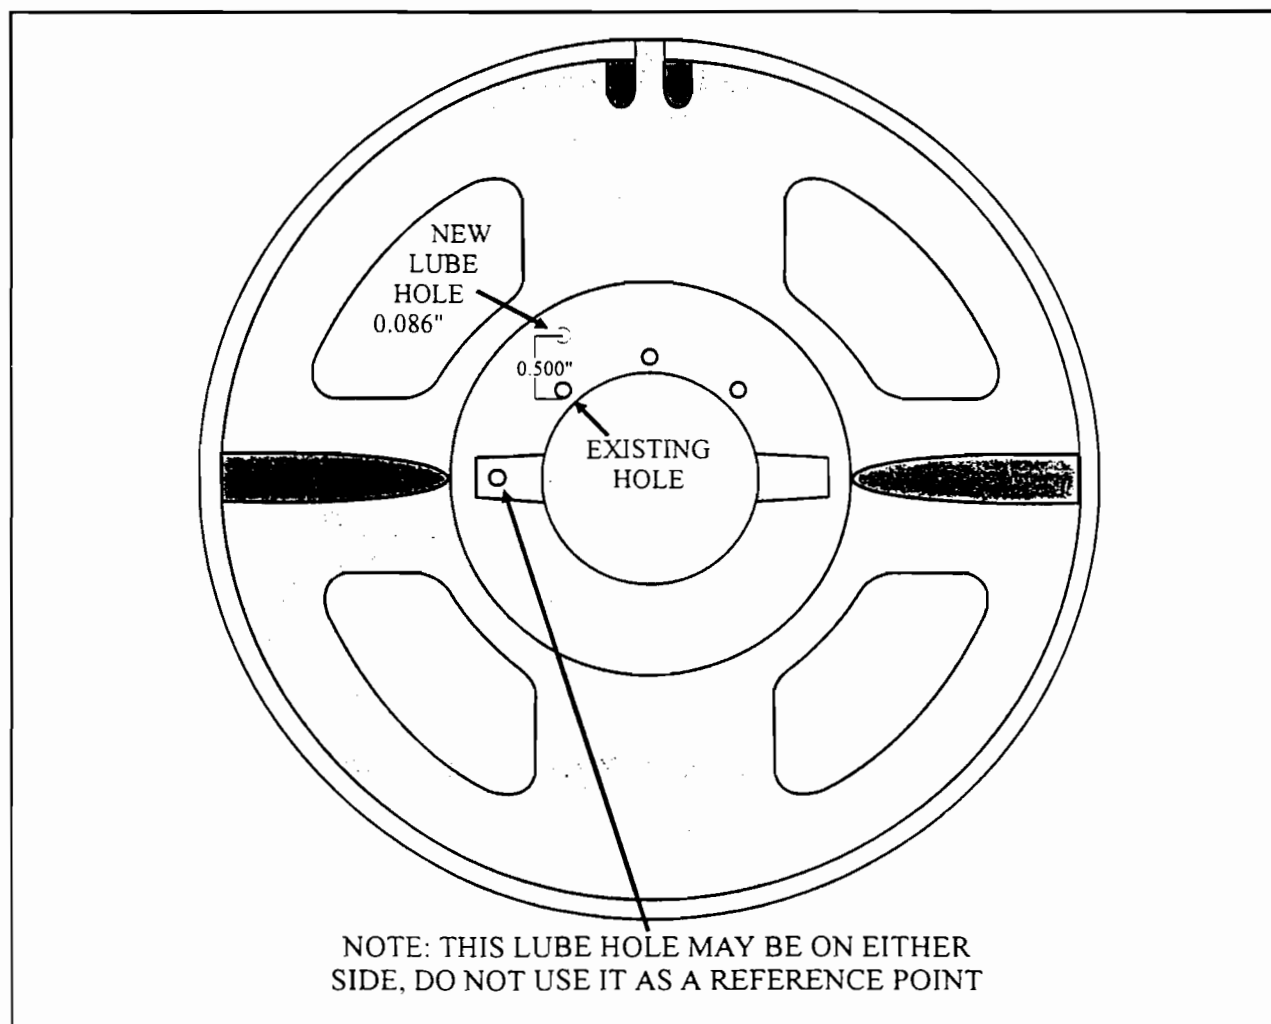
**FIGURE 1**

Failure of the selective thrust washer between the center support and the direct drum.

The cause may be lack of lubrication to the center support thrust washer.

Drill a new lube hole in the center support. Measure 0.500" up from the bottom of the existing hole, drill a 0.086" hole all the way through the center support (See Figure 1).

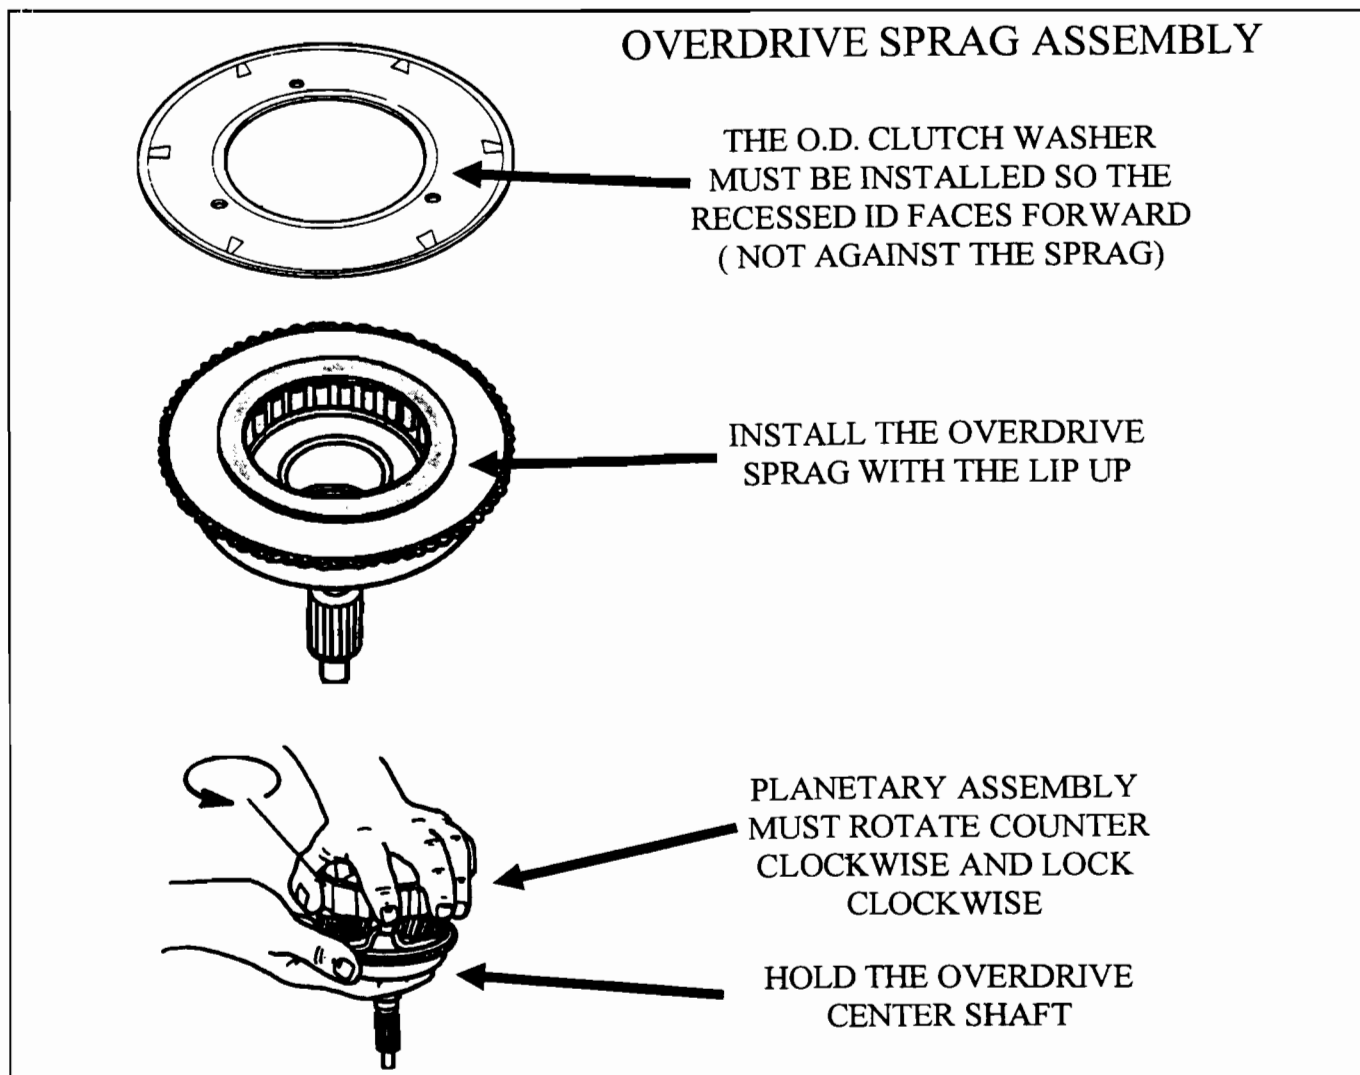
FIGURE 1

Vehicle will not move in the OD range, but will move in D3, 2 and 1. Another common complaint is a flair-up on a 4-3 kick down, and is also caused by the overdrive sprag not holding properly.

The cause may be the overdrive sprag is in backwards or not holding (See Figure 1).

Replace the overdrive sprag, and inspect the inner and outer sprag races for wear or damage.

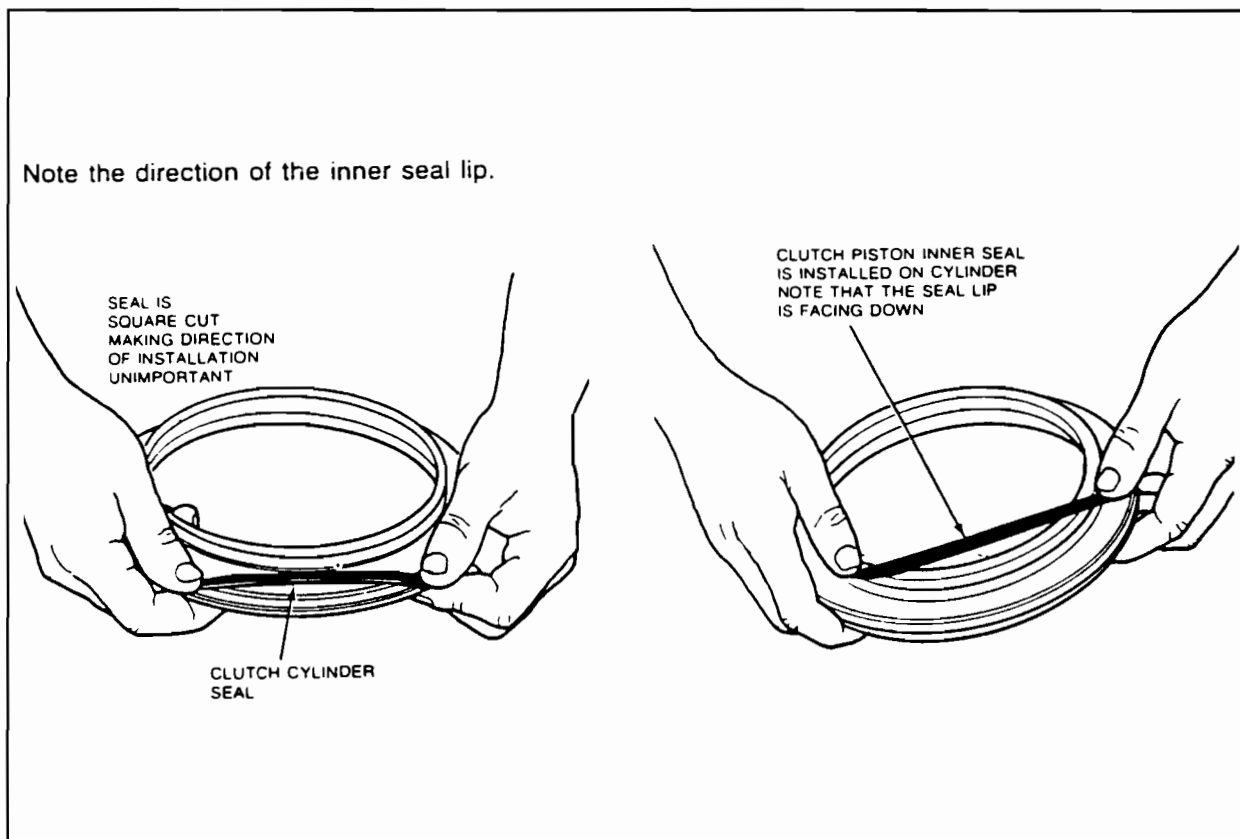
Figure 1

Some vehicles may exhibit the lack of reverse in extreme cold conditions

This can be caused by the inner and outer reverse clutch piston seals adhering to the adjacent surfaces and separating when the piston moves.

Replace the inner and outer reverse clutch piston seals. **The inner Reverse Clutch Piston Seal F43Z-7D403-A and the Outer Reverse Clutch Piston Seal F43Z-7D404-A**

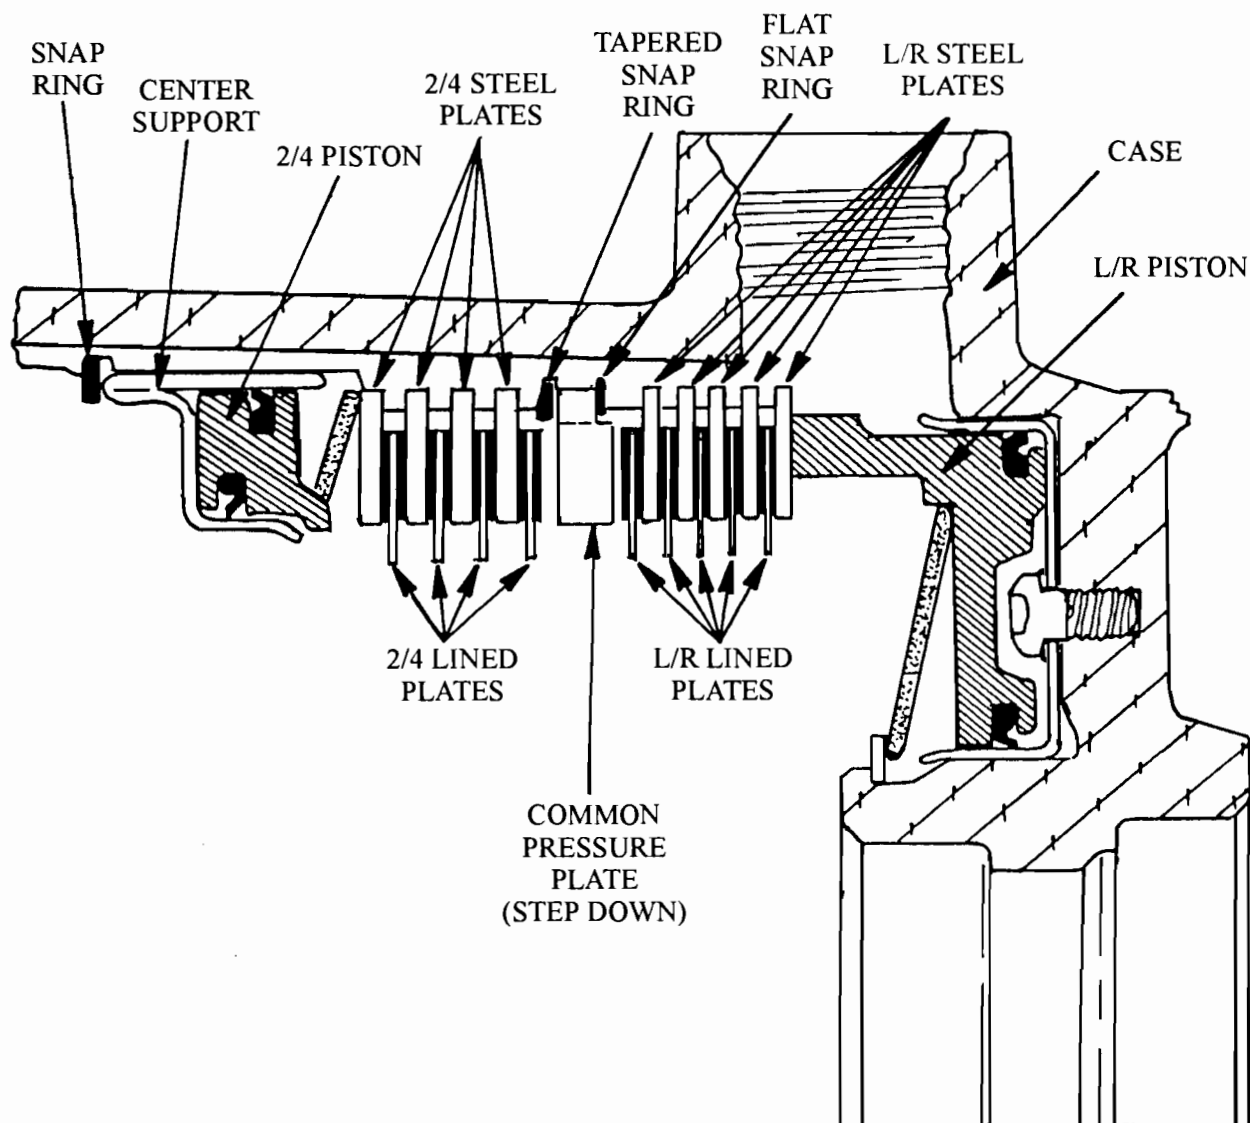
TWO/FOUR AND LOW/REVERSE CLUTCH PLATES

LOW/REVERSE CLUTCH PACK TAKES 5 STEEL PLATES (.070") AND 5 LINED PLATES (.070")

TWO/FOUR CLUTCH PACK TAKES 4 STEEL PLATES (.100") AND 4 LINED PLATES (.085")

We have provide the correct clutch plate arrangement to assist you with the proper assembly of the 2/4 and L/R clutch packs (See Figure 20).

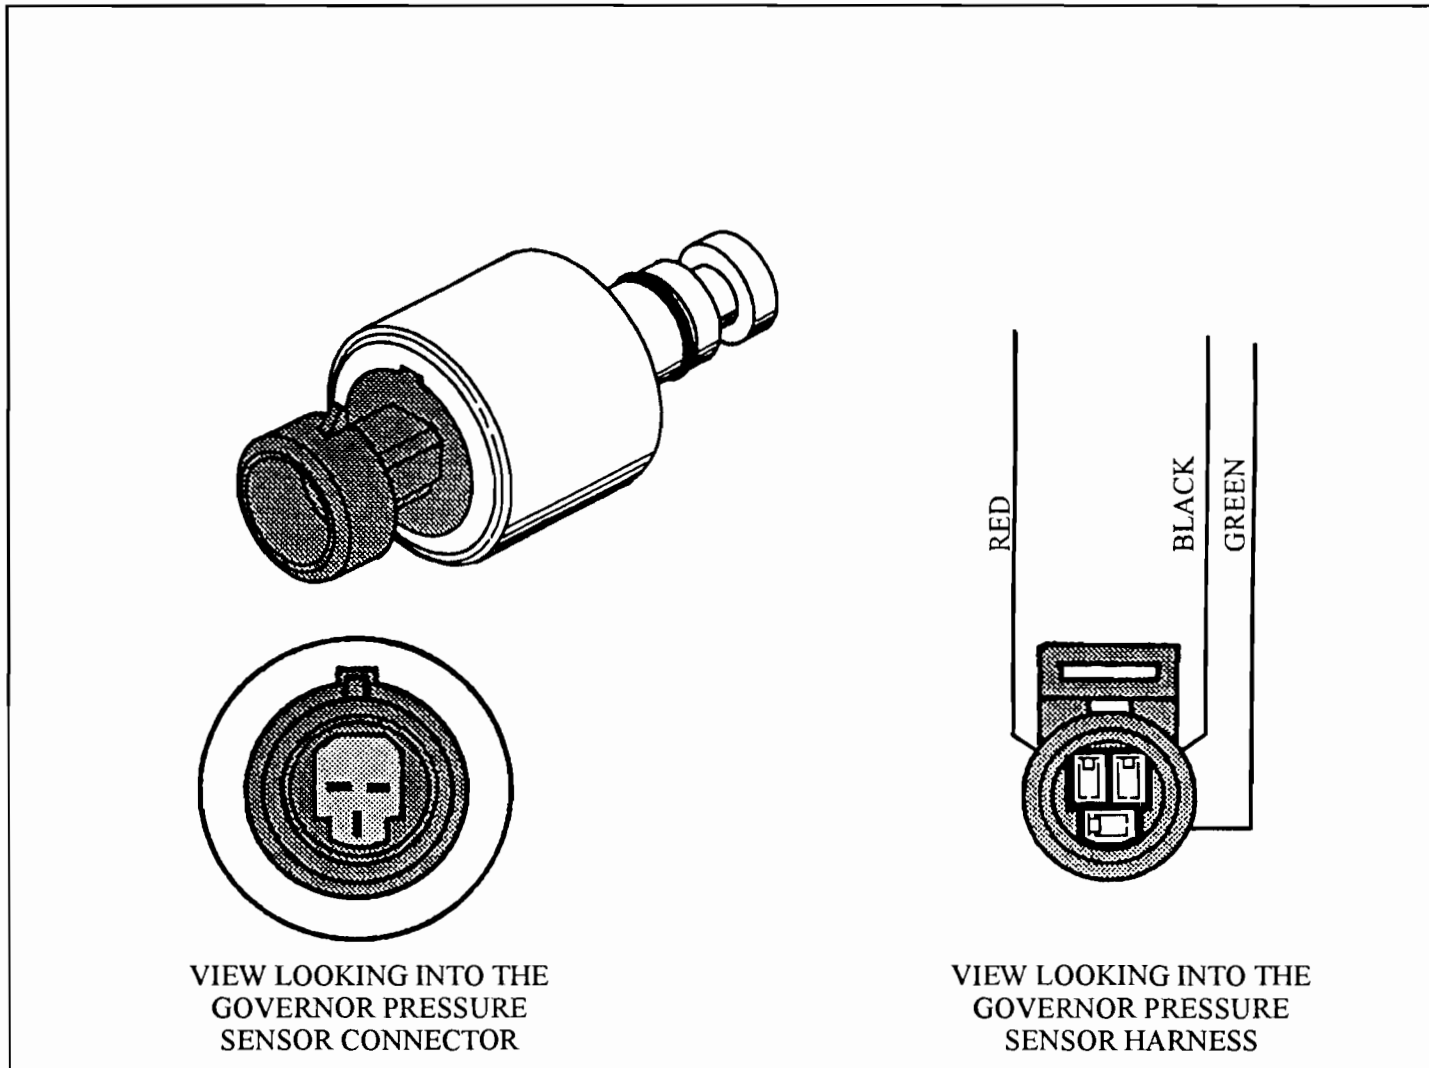
Figure 24

GOVERNOR PRESSURE SENSOR

GOVERNOR PRESSURE SENSOR - The Governor Pressure Sensor output signal provides the necessary feedback to the TCM. This feedback information is needed by the TCM to adequately control governor pressure for varying conditions.

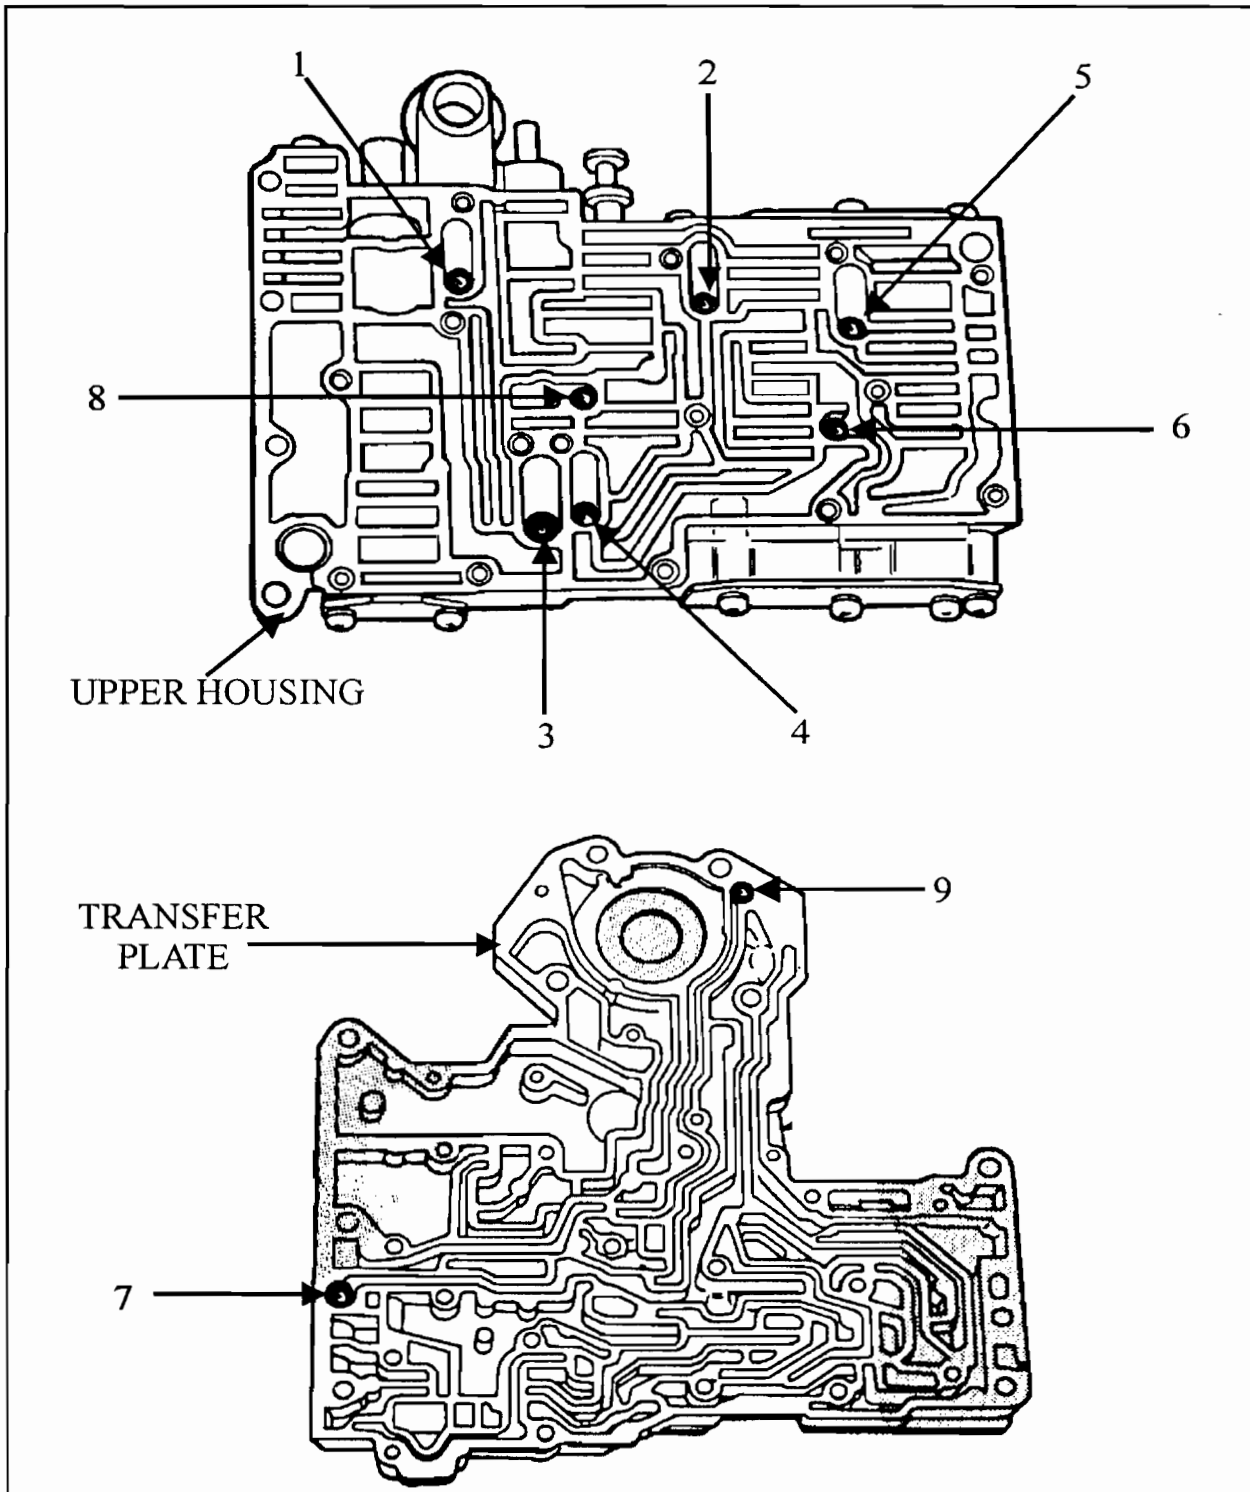
Figure 26

CHRYSLER 42RE VALVE BODY CHECK BALL LOCATION & IDENTIFICATION

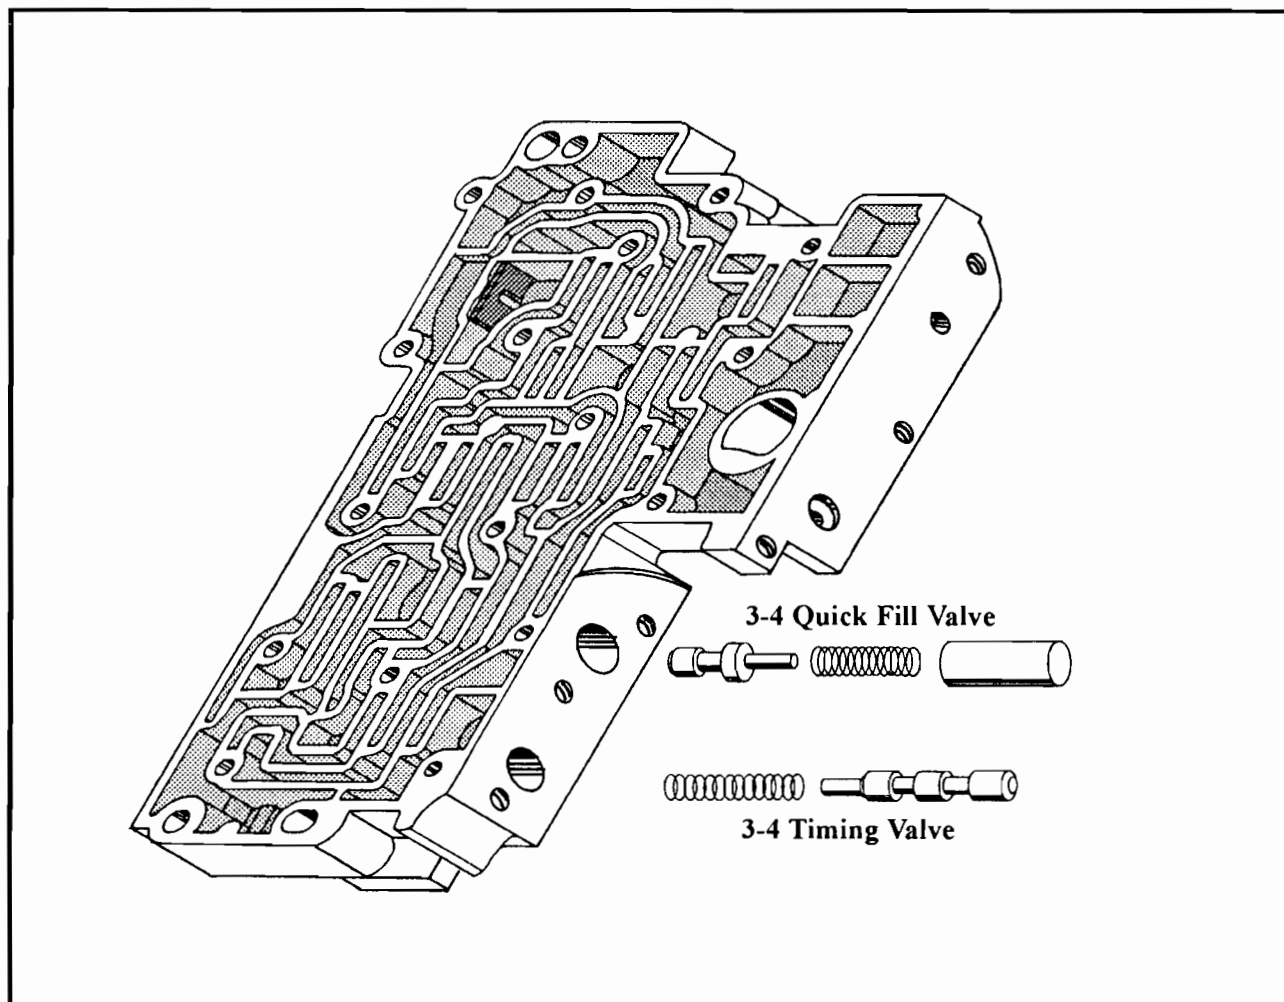
Figure 27

COMPLAINT : The transmission exhibits a no 3-4 shift condition after overhaul.

CORRECTION : Install the 3-4 Quick Fill valve as shown below in figure 27.

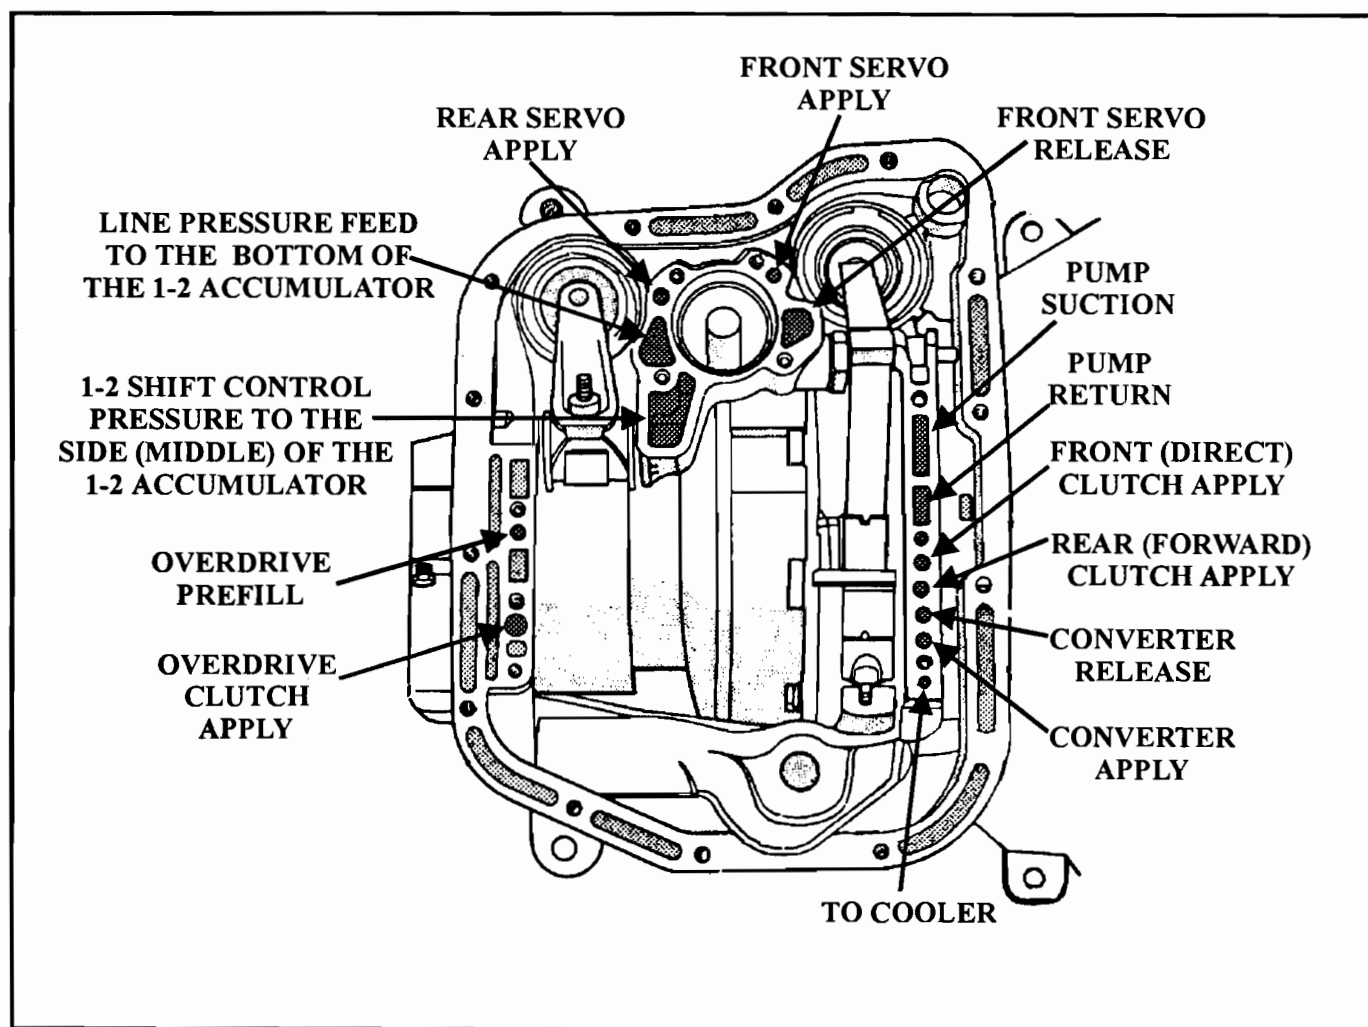
Figure 29

If any of the pressure tests that were performed had failed, a quick check on the integrity of that specific circuit can be checked with the use of air. Use figure 29 below for the specific passage that needs to be tested.
