Technical Service Information

THM 4L60 (700-R4) T.V. EXHAUST VALVE

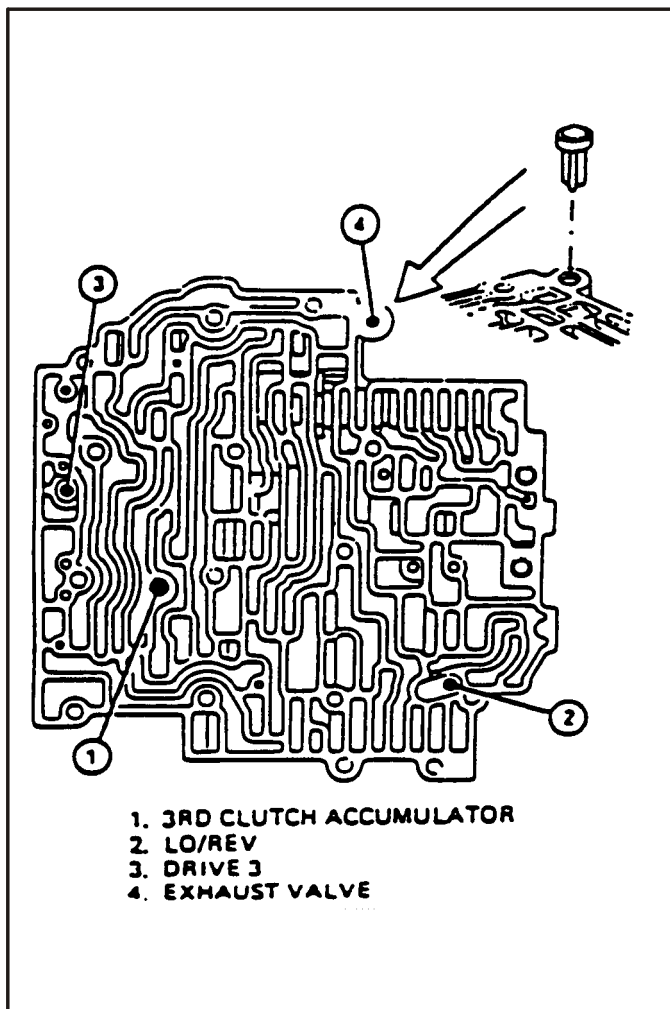
Figure 1

The 1982/83 Models of the THM 700 R4 did not come with a TV Exhaust valve I4 (Figure 1). All Information that was published prior to production will show this valve, however it was never installed.

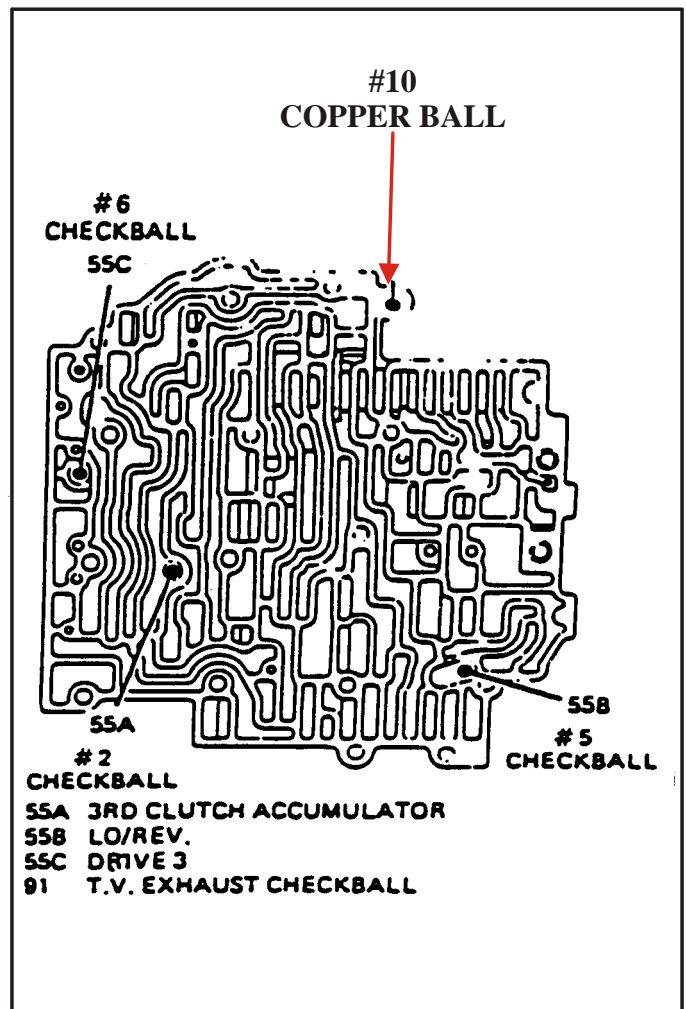
Figure 2

For 1984, there is now a I 10 check ball as shown in (Figure 2) this check ball is larger in diameter than the others, and can easily be identified by its dark copper color. Also note that the check balls have been renumbered.

The intent of cht # 10 check ball is to protect the transmission in the event of a broken or unhooked cable. Causing a late or no upshift condition. We recommend leaving this check ball out
