Technical Service Information

SATURN MOVES FORWARD ALL GEAR SELECTIONS REVERSE AND/OR FORWARD WITH THE SELECTOR IN PARK OR NEUTRAL

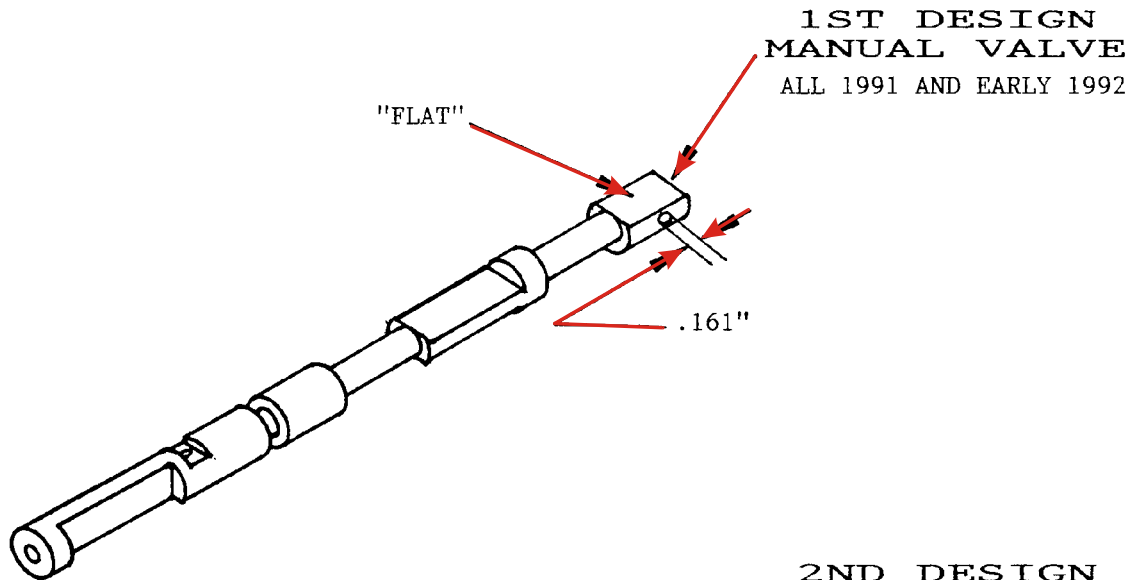
2nd design Manual Valve installed improperly with the "Notch" facing down towards the case. The "Notch" MUST face up towards the top pan (See Figure 1).

1st design "Stamped Form" Manual Valve Link is used on all 91-93 models, and the stem diameter is .153" (See Figure 1).

"FLAT" OR "NOTCH MUST BE
INSTALLED FACING UP TOWARDS
THE TOP PAN.

CORRECTION: On ALL 1991 to 1993 models, remove the valve body and orient the Manual Valve with the "Flat" (1st Design) or "Notch" (2nd Design) on the Manual Valve facing UP TOWARDS THE TOP PAN, as shown in Figure 1. Reinstall the valve body and torque to proper specifications.

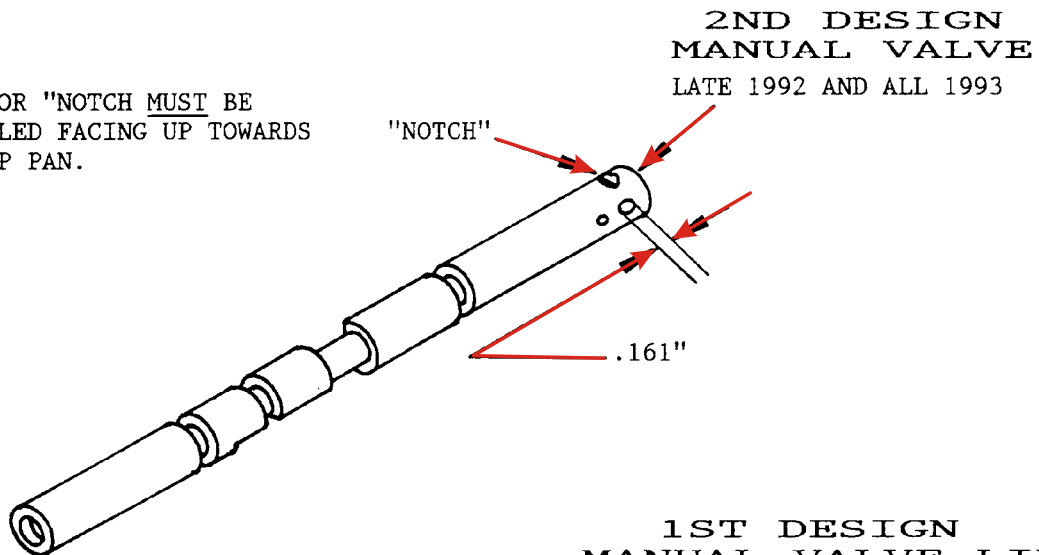
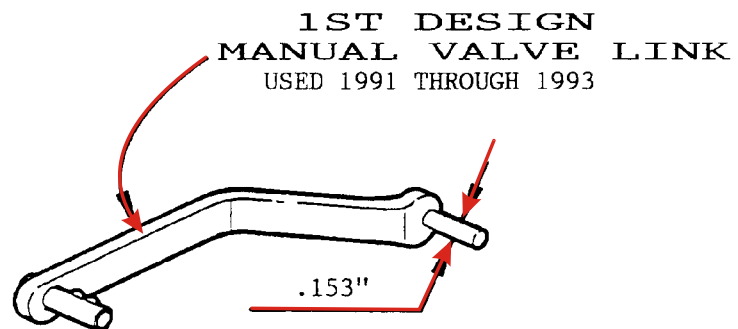
1994 (3rd Design) Manual Valve used with a 91-93 "Stamped Form" Manual Valve Link, that allows extra play in the shift linkage because of mis-matched parts. Refer to Figure 2 for dimension differences

2nd design "One Piece Wire" Manual Valve Link is used on all 1994 models, and the stem diameter is .194" (See Figure 2).

As a result of the change to the Manual Link, the hole in the Manual Valve also had to increase in diameter from .161" to .202", to accommodate the 2nd design manual link (See Figure 2).

There was also a plastic cap added to the 1994 (3rd Design) Manual Valve as an assembly aid to prevent the manual valve from being installed to the manual link backwards (See Figure 2).

Install the proper design level Manual Valve Link with the matching Manual Valve. Functionally, the 1994 (3rd Design) Manual Valve is the same as the late 1992 and 1993 (2nd Design) Manual Valve. There are two different stem diameters on the Manual Valve Links, where it goes into the manual valve.
