"2002" SEMINAR INFORMATION

"What's New for '2002' Technical Seminar"

AUTOMATIC TRANSMISSION SERVICE GROUP

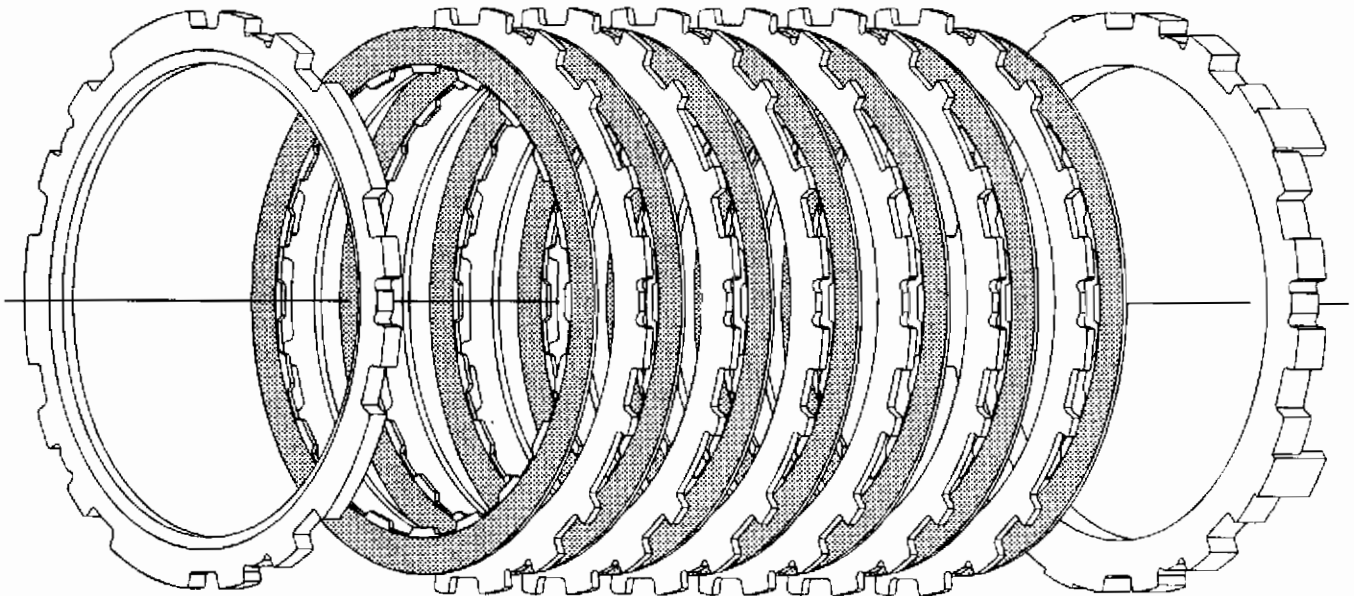
**THM 4L65-E (M32) 3-4 CLUTCH
SEVEN FRICTION STACK-UP**

*Friction Plates = .065" Thick, 7 Required
Steel Plates = .097" Thick, 6 Required*

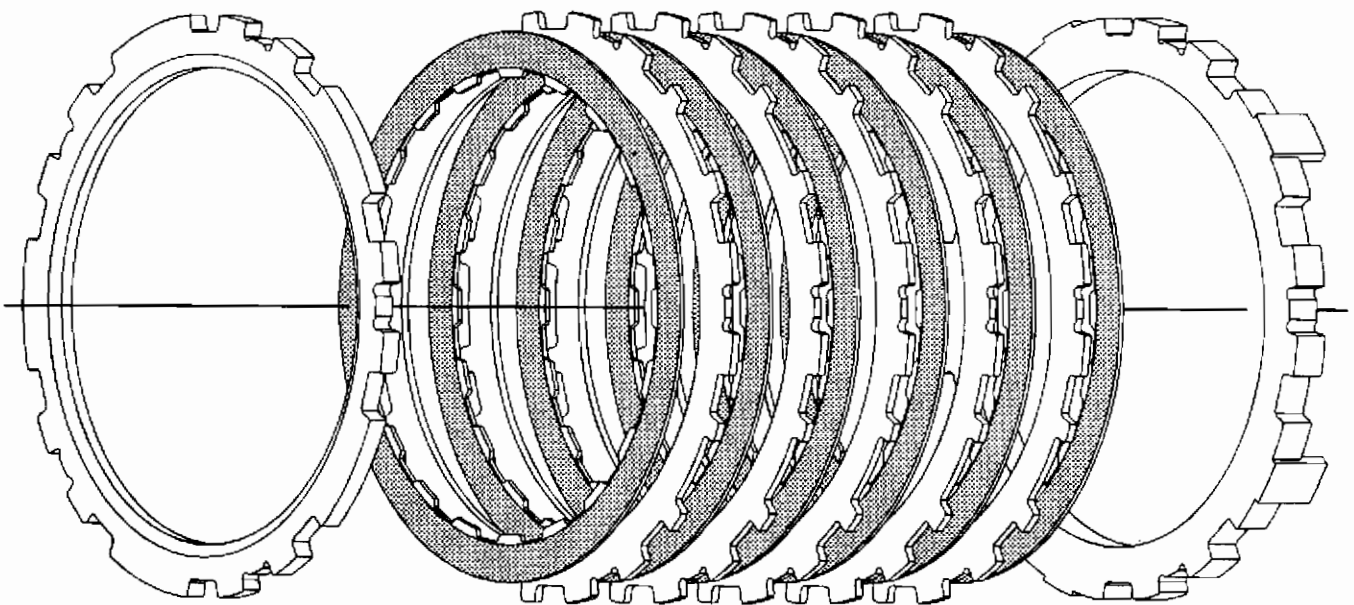
**THM 4L60-E (M30) 3-4 CLUTCH
SIX FRICTION STACK-UP**

*Friction Plates = .082" Thick, 6 Required
Steel Plates = .106" Thick, 5 Required*

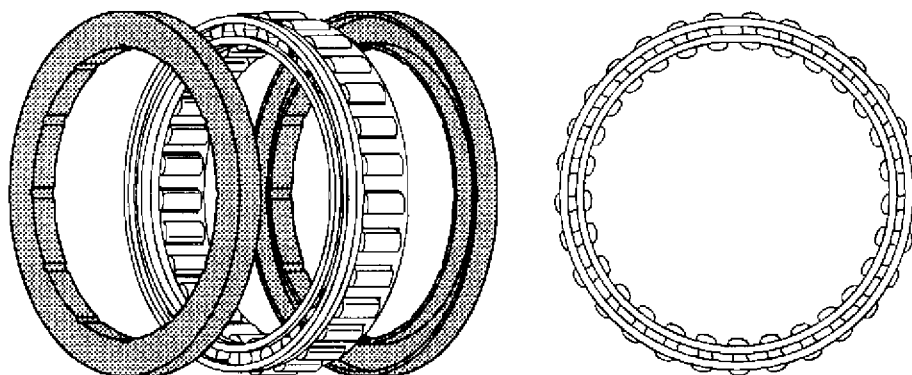
**29 ELEMENT, DUAL CAGE SPRAG
FROM BORG-WARNER CORP.
PART NUMBER 29236AM**

Borg-Warner Corporation has now released a new design 29 element input sprag with a dual cage, as shown in Figure 1. This new product will retro-fit back on all 4L60 (700-R4), all 4L60-E and the new 4L65-E transmissions. You will now have the extra load capacity of the 29 elements that replaces the previous 26 and 28 element sprags, and the extra stability of the dual cage over the current 29 element design from General Motors. This new design 29 element, dual cage input sprag is available under Borg-Warner part number 29236AM.

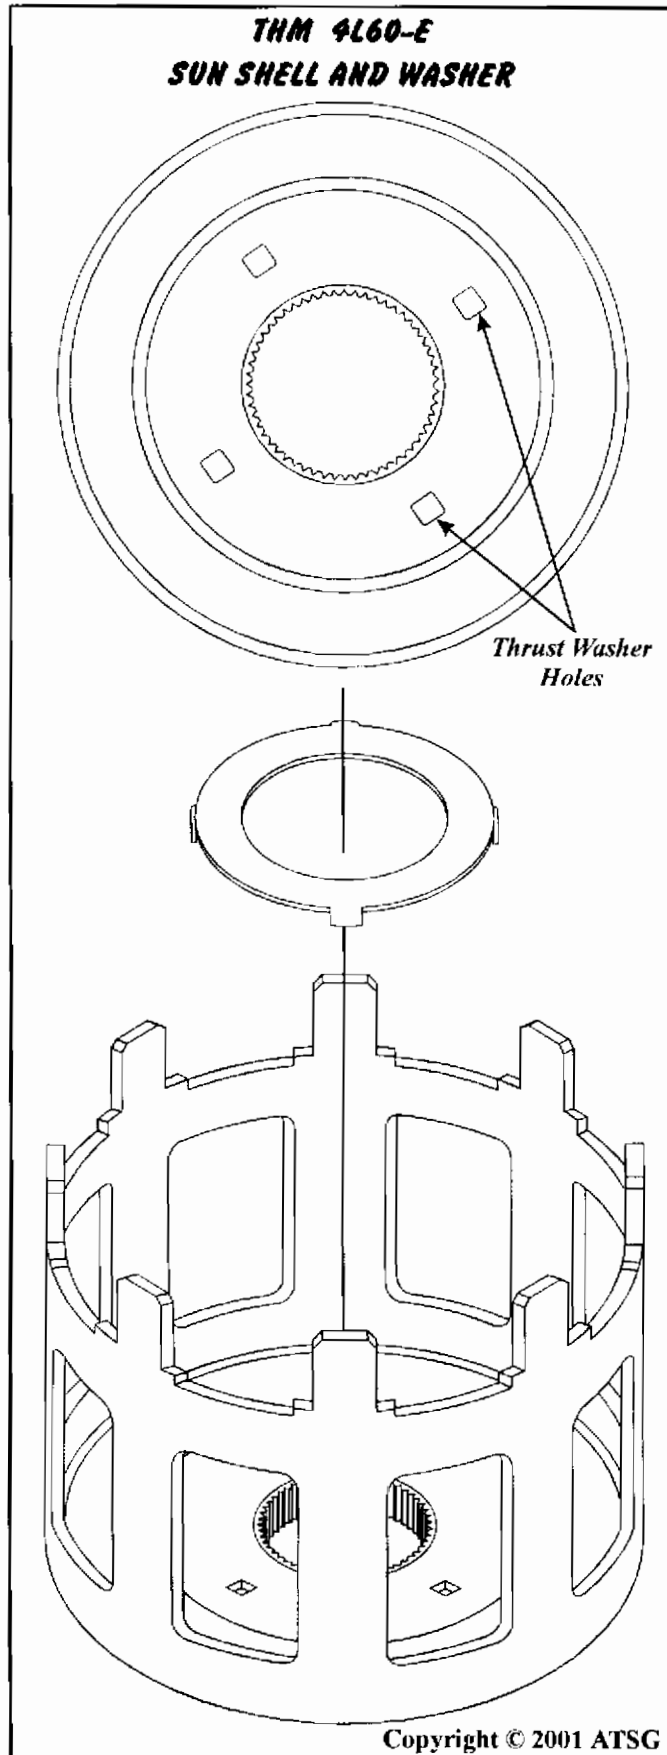
Figure 1

CHANGE: Beginning at the start of production for model year 2001, General Motors introduced a new transmission designated THM 4L65-E (M32) with many engineering changes. Currently this unit is found in all 2001 Cadillac Escalade and any vehicle with 6.0L engine or larger, that was previously equipped with the THM 4L60-E transmission. One of the changes includes a new design sun gear shell and thrust bearing to replace the previous design washer, as shown in Figures 1 and 2.

Sun Gear Shell (New Design)	24217145
Reaction Carrier Shaft (New Design)	24217157
Sun Shell Thrust Bearing (New Design)	24217328

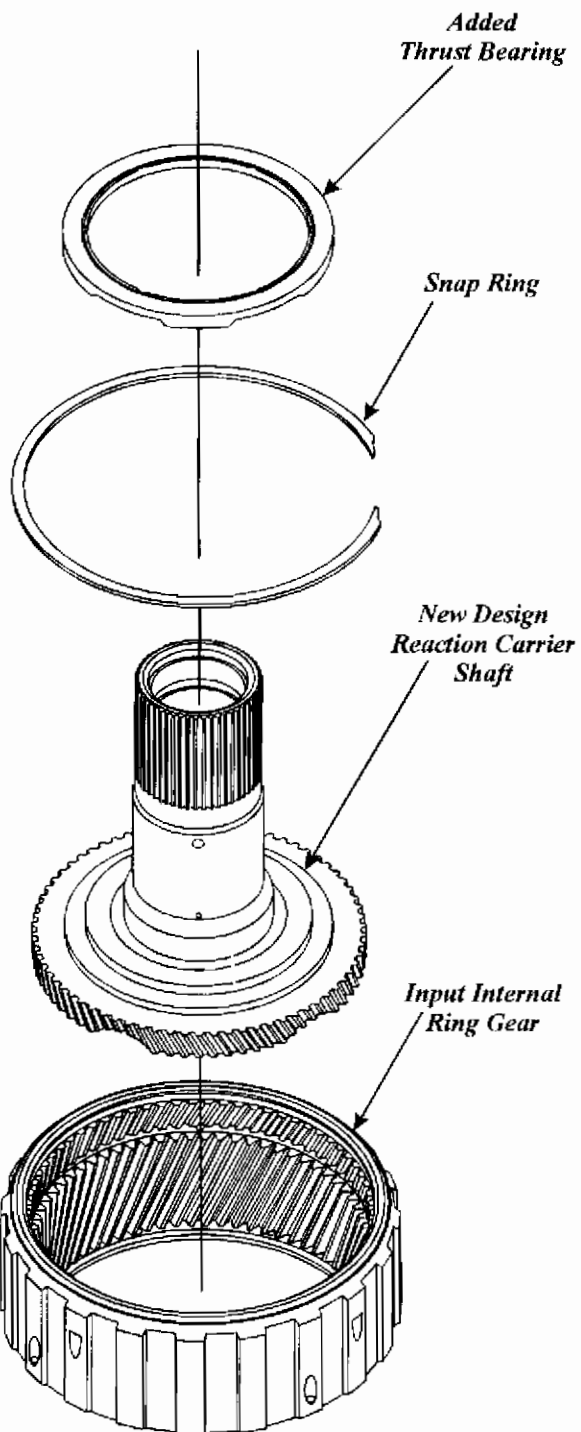
Figure 3

THM 4L65-E (M32) REACTION SHAFT AND NEW THRUST BEARING

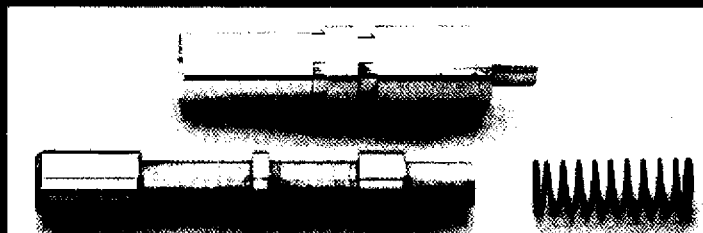
4L80E-ACTUATOR LIMIT VALVE REPAIR KIT

Correct low line pressure, clutch burnup and wrong gear starts using special valves that have 50% more linear support and less oscillation than the original design. This stops the wear and makes the valve body more durable. Kit includes Boring guide, boring tool and 6 longer oversized valves and springs.

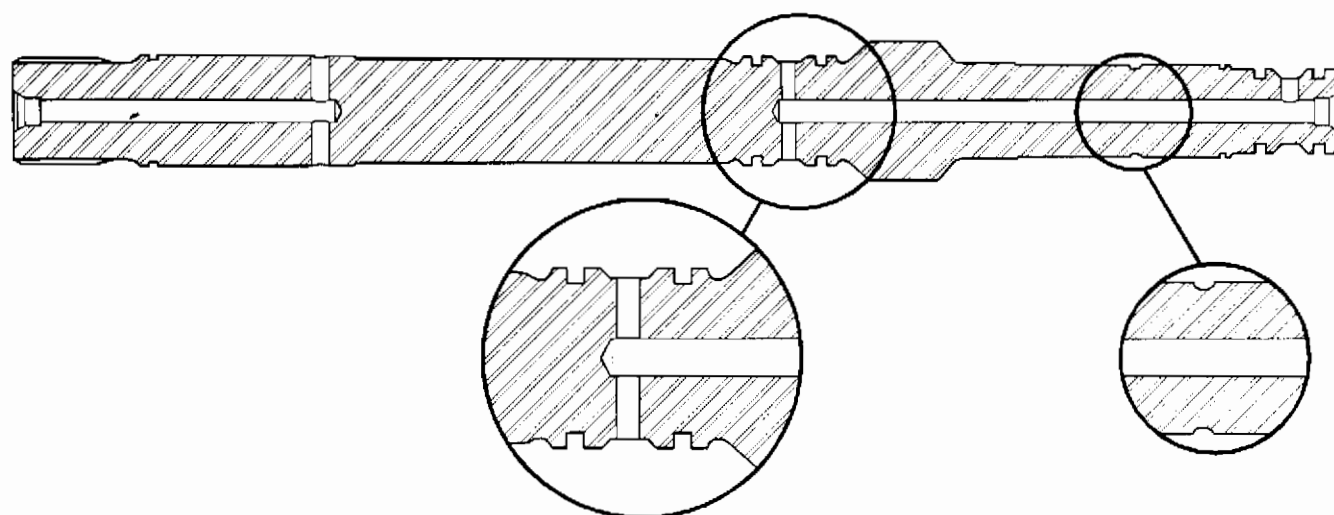
"1ST" DESIGN TURBINE SHAFT

***"2ND" DESIGN TURBINE SHAFT***

***Forward Clutch Feed
Hole Drilled Through***

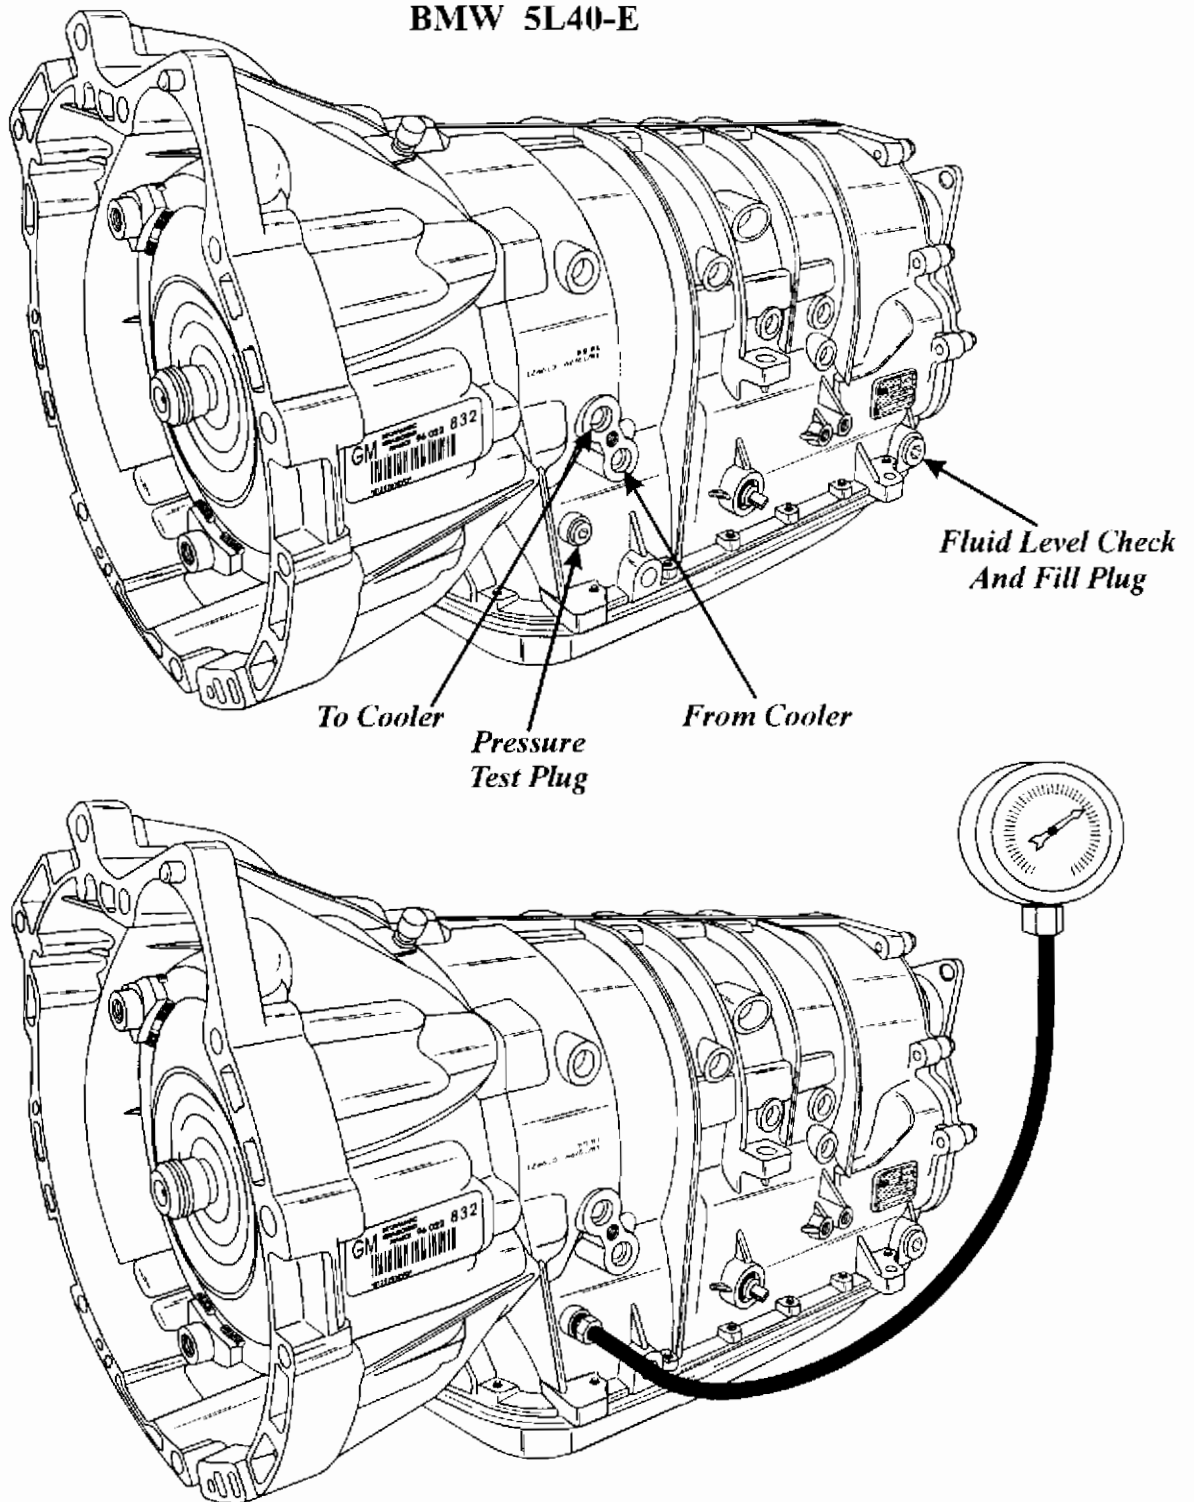
Figure 1

RANGE	LINE PRESSURE	
	Minimum	Maximum
P, N, D, M4, M3, M2	48 psi	180 psi
REVERSE	60 psi	232 psi

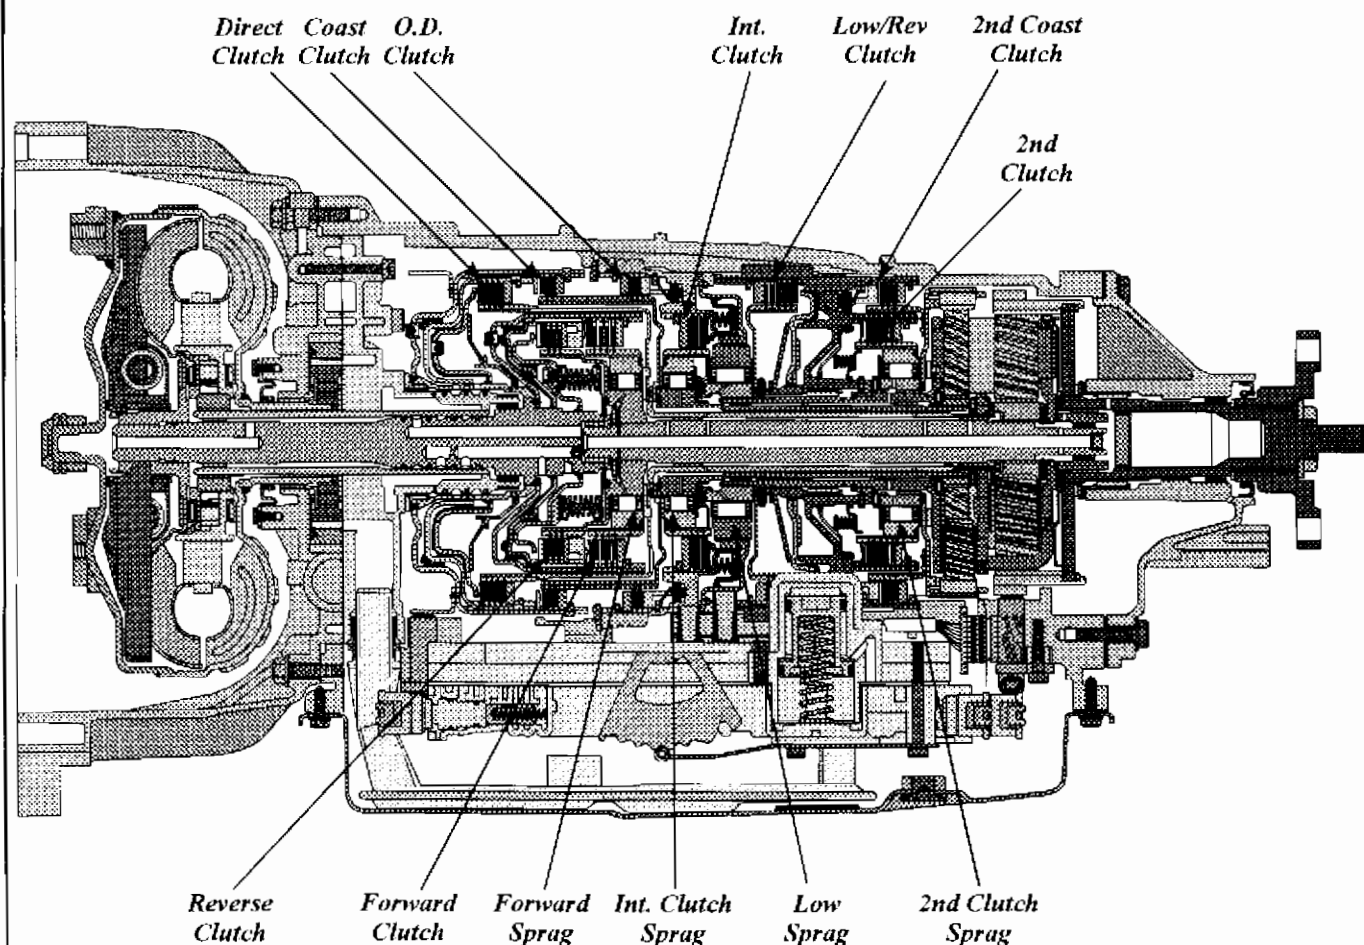
5L40-E COMPONENT APPLICATION CHART

RANGE	GEAR	Engine Braking	Direct Clutch	Coast Clutch	Reverse Clutch	Fwd. Clutch	2nd Clutch	Int. Clutch	O.D. Clutch	Low/Reverse Clutch	2nd Coast Clutch	Fwd. Clutch Sprag	Low Clutch Sprag	2nd Clutch Sprag	Int. Clutch Sprag	Gear Ratio
Park/Neutral																
Reverse	R	Yes			On					On						3.03
D, 4, 3, 2,	1st	No*		On		On						Hold	Hold			3.42
	1st	Yes		On		On				On		Hold	Hold			3.42
	2nd	No*		On		On	On					Hold		Hold		2.21
	2nd	Yes		On		On	On				On	Hold		Hold		2.21
	3rd	No*		On		On	On	On				Hold			Hold	1.60
	3rd	Yes		On		On	On	On	On			Hold			Hold	1.60
	4th	Yes	On	On		On	On	On				Hold				1.00
	5th	Yes	On			On	On	On	On							0.75

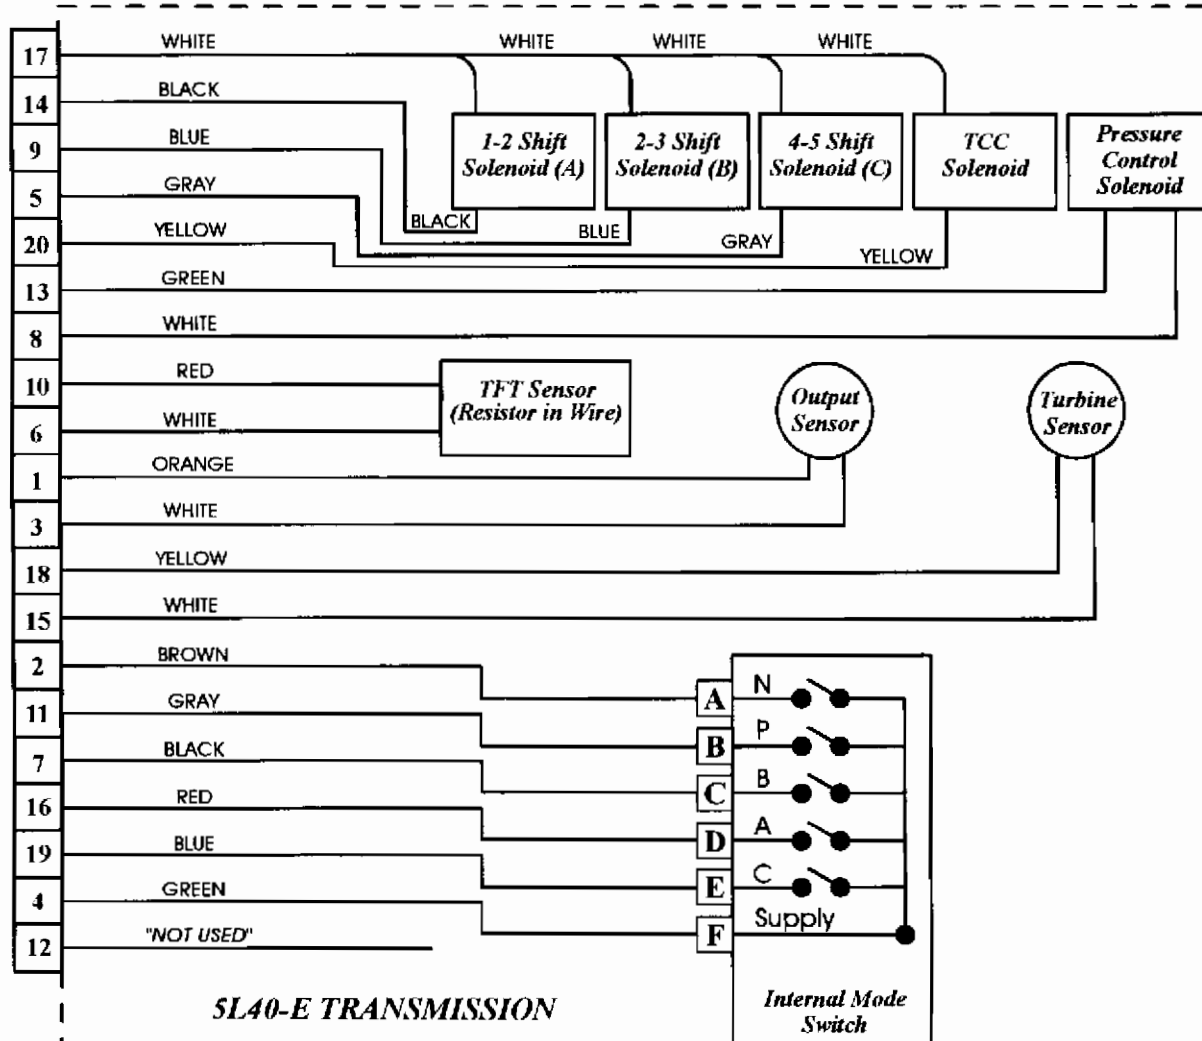
BMW INTERNAL WIRE SCHEMATIC

View Looking Into
Trans Case Connector

Case Connector Terminal Identification			
Pin No.	Description	Pin No.	Description
1	Output Speed Sensor (OSS)	11	Internal Mode Switch Signal "P"
2	Internal Mode Switch Signal "N"	12	"Not Used"
3	Output Speed Sensor (OSS)	13	Pressure Control Solenoid (+)
4	Internal Mode Switch Volts In	14	1-2 Shift Solenoid (A) Ground
5	4-5 Shift Solenoid (C) Ground	15	Input Speed Sensor (ISS)
6	Trans Fluid Temp (TFT) Sensor	16	Internal Mode Switch Signal "A"
7	Internal Mode Switch Signal "B"	17	Solenoid Power In
8	Pressure Control Solenoid (-)	18	Input Speed Sensor (ISS)
9	2-3 Shift Solenoid (B) Ground	19	Internal Mode Switch Signal "C"
10	Trans Fluid Temp (TFT) Sensor	20	TCC/PWM Solenoid Ground

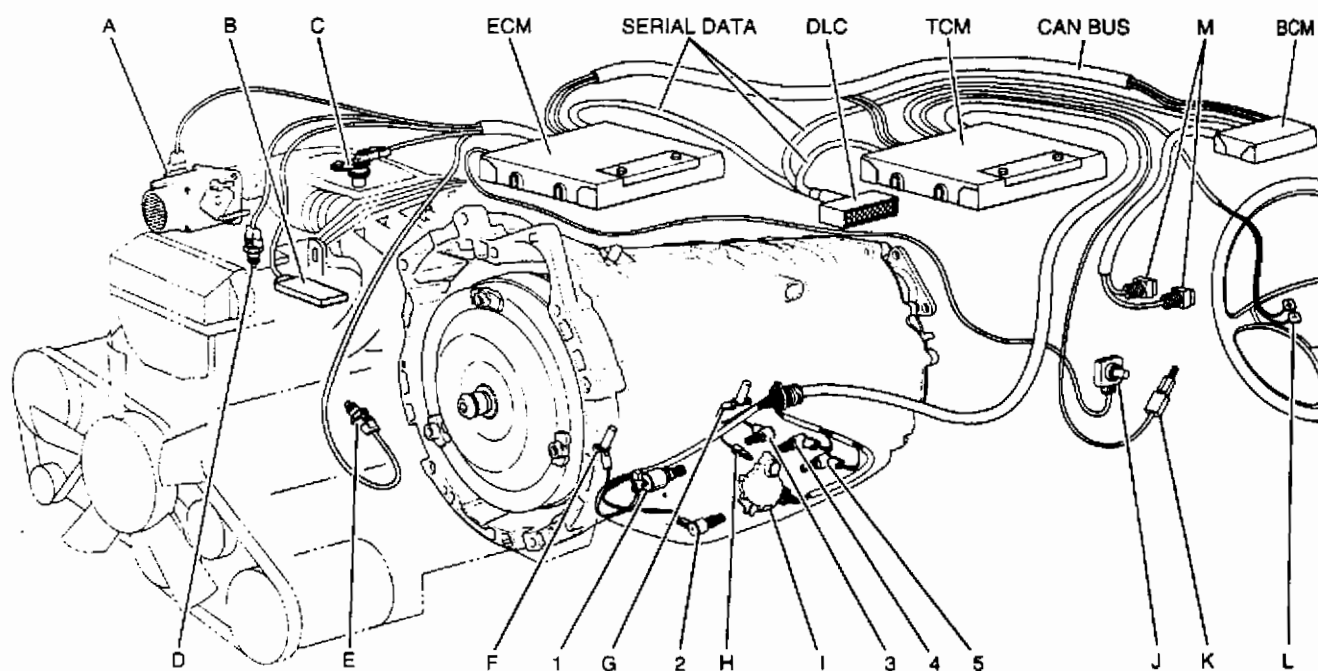
Electrical signals from various sensors provide information to the TCM or PCM, about vehicle speed, throttle position, engine coolant temp, range selector position, engine speed and converter turbine speed. The TCM or PCM uses this information to determine upshift and downshift speeds, apply or release of the TCC and what fluid pressure is needed to apply the clutch packs. This type of control provides consistent shift points and shift quality based on the operating conditions of the vehicle.

INFORMATION SENSORS

- A. THROTTLE POSITION SENSOR (TPS)
- B. MANIFOLD ABSOLUTE PRESSURE (MAP) SENSOR
- C. ENGINE SPEED SENSOR
- D. MANIFOLD AIR TEMPERATURE (MAT) SENSOR
- E. ENGINE COOLANT TEMPERATURE (ECT) SENSOR
- F. INPUT SPEED SENSOR (ISS)
- G. OUTPUT SPEED SENSOR (OSS)
- H. TRANSMISSION FLUID TEMPERATURE (TFT) SENSOR
- I. INTERNAL MODE SWITCH (IMS)
- J. ACCELERATOR PEDAL POSITION (APP) SENSOR
- K. TCC BRAKE SWITCH

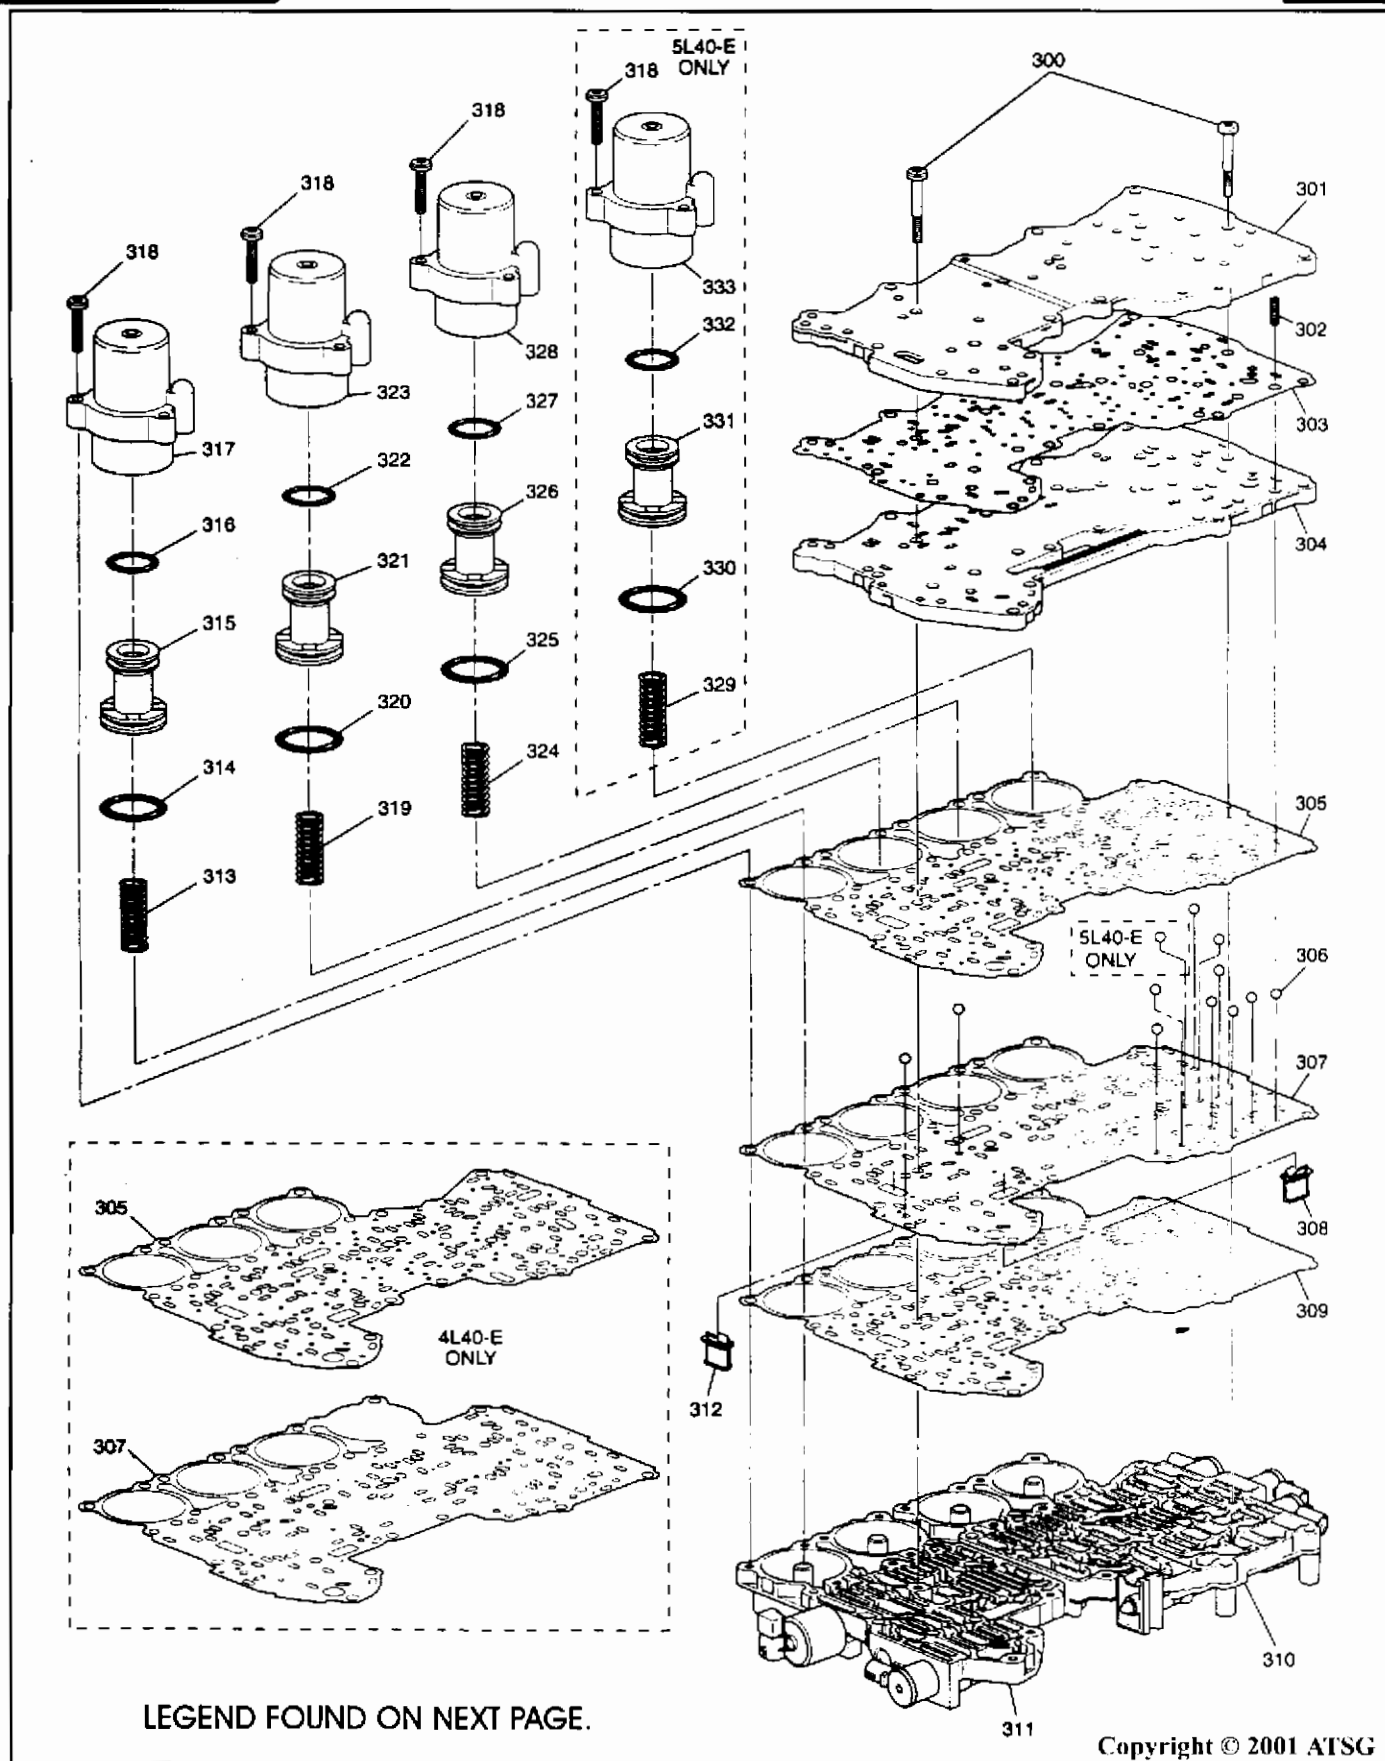
Figure 9

- 300 CONTROL VALVE BODY BOLT
- 301 CONTROL VALVE BODY "TOP" CHANNEL PLATE
- 302 NUMBER 7 CHECK BALL SPRING
- 303 CONTROL VALVE CHANNEL PLATE GASKET
- 304 CONTROL VALVE BODY "BOTTOM" CHANNEL PLATE

- 330 2ND CLUTCH ACCUMMULATOR PISTON LARGE SEAL RING
- 331 2ND CLUTCH ACCUMMULATOR PISTON
- 332 2ND CLUTCH ACCUMMULATOR PISTON SMALL SEAL RING
- 333 2ND CLUTCH ACCUMMULATOR HOUSING

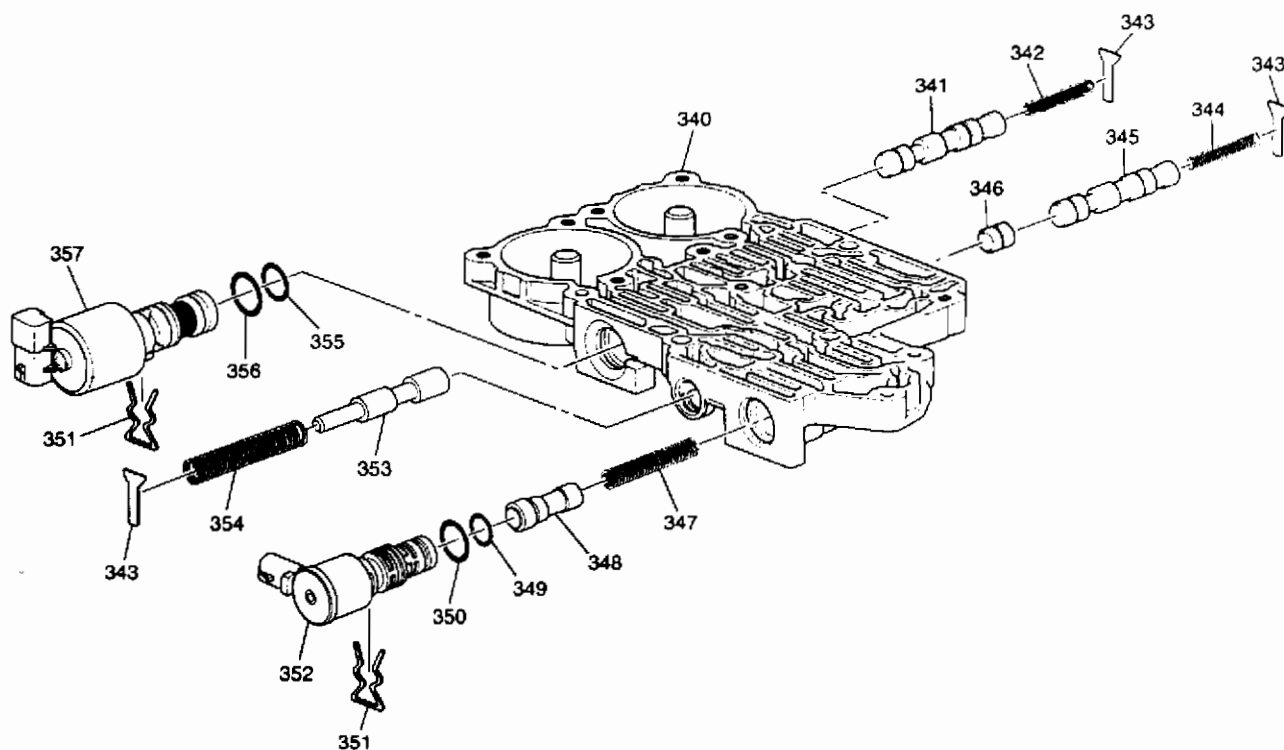
Figure 10

FRONT CONTROL VALVE BODY EXPLODED VIEW

- 340 FRONT CONTROL VALVE BODY CASTING
- 341 SAFETY MODE VALVE
- 342 SAFETY MODE VALVE SPRING
- 343 VALVE SPRING RETAINER
- 344 3-4 SHIFT VALVE SPRING
- 345 3-4 SHIFT VALVE
- 346 3-4 SHIFT CONTROL VALVE
- 347 TCC REGULATOR APPLY VALVE SPRING
- 348 TCC REGULATOR APPLY VALVE
- 349 TCC/PWM SOLENOID SMALL "O" RING SEAL
- 350 TCC/PWM SOLENOID LARGE "O" RING SEAL
- 351 SOLENOID RETAINING CLIP
- 352 TCC/PWM SOLENOID ASSEMBLY
- 353 FEED LIMIT VALVE
- 354 FEED LIMIT VALVE SPRING
- 355 PRESSURE CONTROL SOLENOID SMALL "O" RING SEAL
- 356 PRESSURE CONTROL SOLENOID LARGE "O" RING SEAL
- 357 PRESSURE CONTROL SOLENOID ASSEMBLY

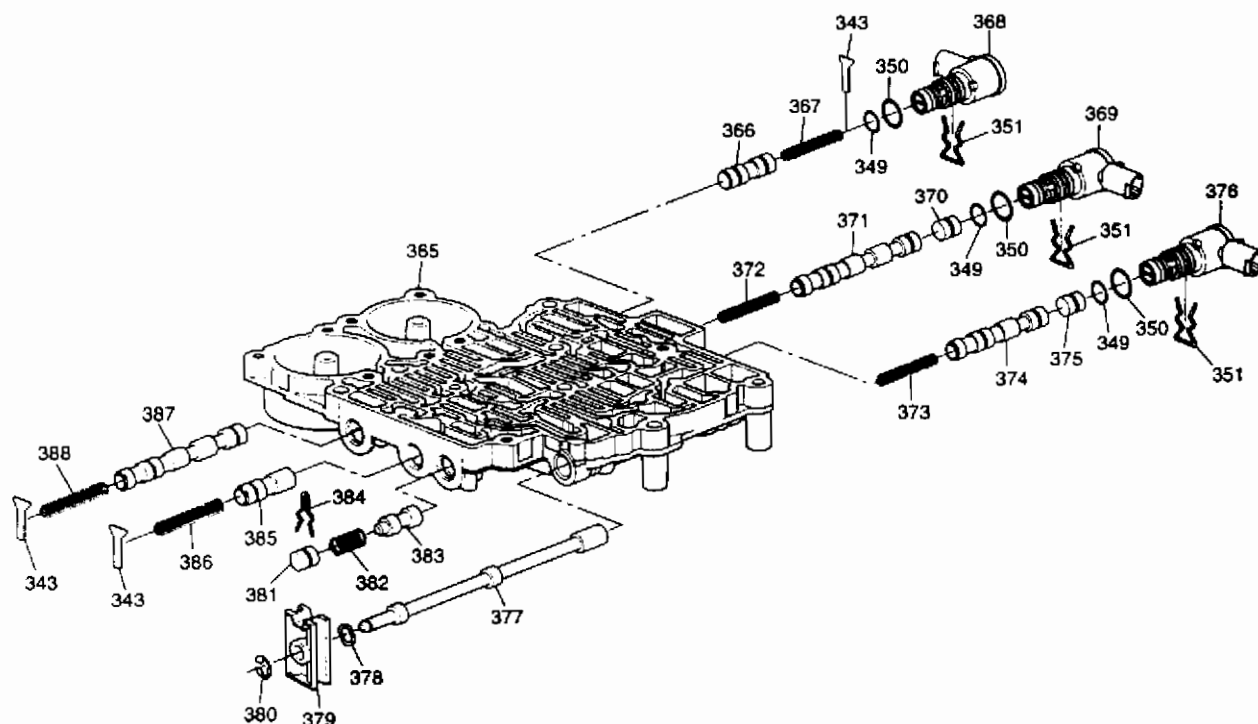
REAR CONTROL VALVE BODY EXPLODED VIEW

- 343 VALVE SPRING RETAINER
- 349 SHIFT SOLENOID SMALL "O" RING SEAL
- 350 SHIFT SOLENOID LARGE "O" RING SEAL
- 351 SHIFT SOLENOID RETAINER
- 365 REAR CONTROL VALVE BODY CASTING

- 366 1-2 SHIFT CONTROL VALVE
- 367 1-2 SHIFT CONTROL VALVE SPRING
- 368 1-2 (A) SHIFT SOLENOID ASSEMBLY
- 369 2-3 (B) SHIFT SOLENOID ASSEMBLY
- 370 2-3 SHIFT CONTROL VALVE

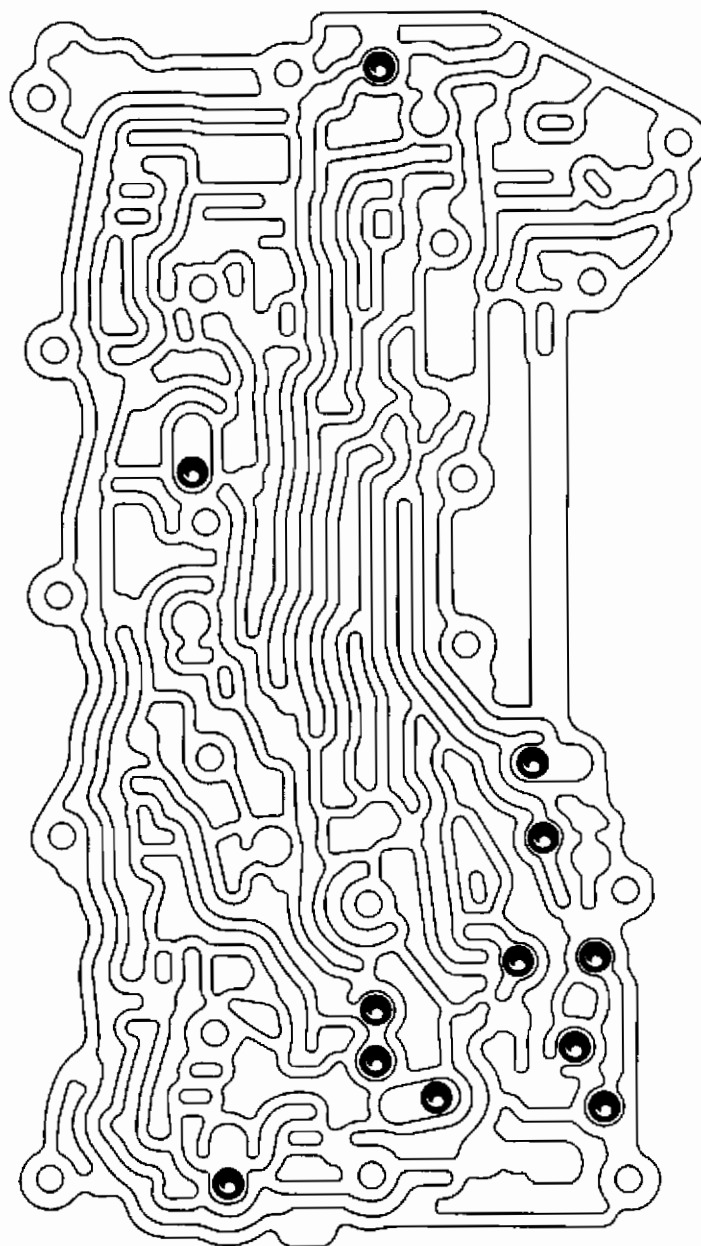
Figure 12

BOTTOM CHANNEL PLATE
(Control Valve Body Side)

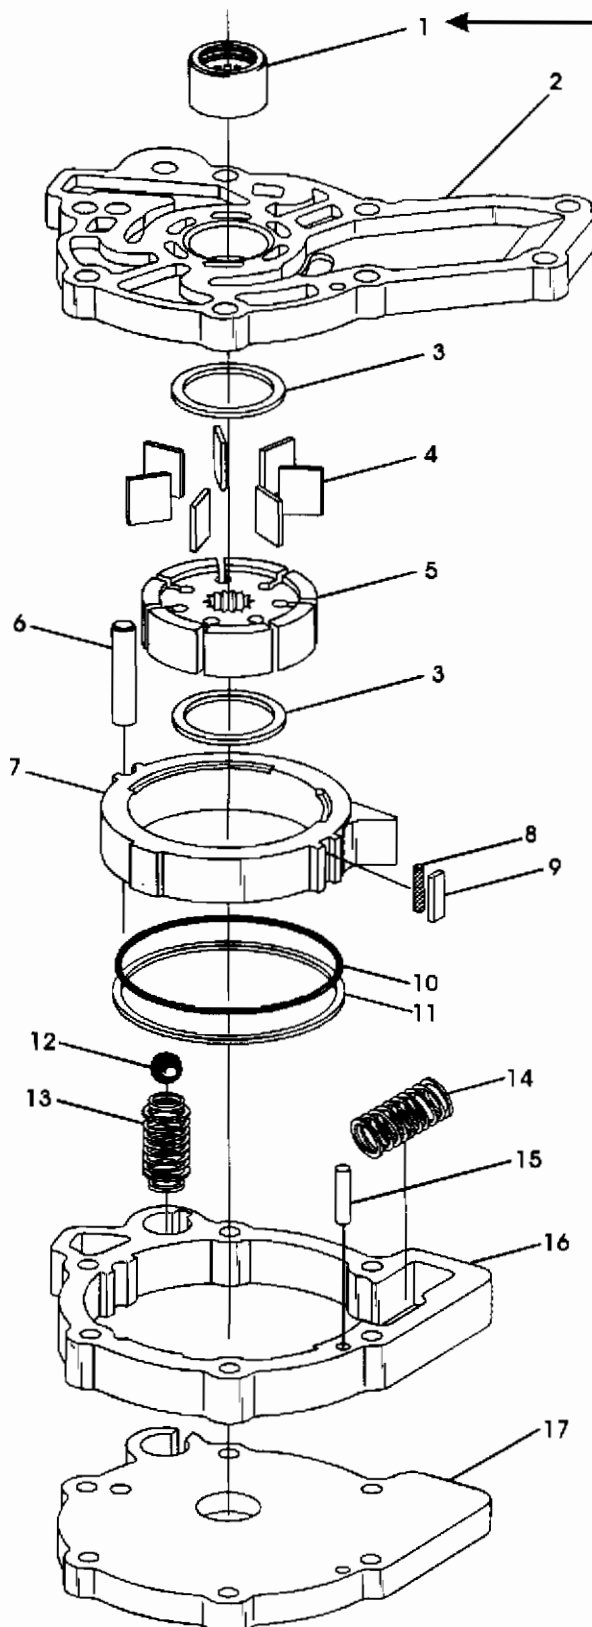
CAUSE: This is usually created by a leak of TCC release oil through the needle bearing and seal assembly located in the oil pump, as shown in Figure 1.

THM 4T40-E OIL PUMP ASSEMBLY

*This Needle Bearing and Seal Assembly
Is Now Available Under:
TRANSTAR Part No. 67922B or
SONNAX® Part No. 33000-01*

1. NEEDLE BEARING AND SEAL ASSEMBLY (NOT SERVICED)
2. OIL PUMP BASE
3. OIL PUMP VANE RING (2 REQUIRED)
4. OIL PUMP VANES (7 REQUIRED)
5. OIL PUMP ROTOR
6. OIL PUMP SLIDE PIVOT PIN
7. OIL PUMP SLIDE
8. OIL PUMP SLIDE SEAL SUPPORT
9. OIL PUMP SLIDE SEAL
10. OIL PUMP SLIDE SEAL "O" RING
11. OIL PUMP SLIDE TO COVER SEAL
12. PRESSURE RELIEF BALL
13. PRESSURE RELIEF SPRING
14. OIL PUMP SLIDE PRIMING SPRING (SAME AS 125C)
15. LOCATING DOWEL
16. OIL PUMP BODY
17. OIL PUMP COVER

CORRECTION: This needle bearing and seal assembly is now available under TranStar part number 67922B, which is a 2000 and later AX4N pump bearing and seal assembly. The AX4N bearing is not available from Ford Motor Co. The bearing is also available from Sonnax® under part number 33000-01. In some instances, because of the bearing failure, the entire pump assembly will have to be replaced and is available under OEM part number 24208987.

This Needle Bearing and Seal Assembly has been such a high failure item that ATSG recommends the needle bearing and seal assembly be replaced on every rebuild.

Needle Bearing And Seal Assembly (TranStar Number)	67922B
Needle Bearing And Seal Assembly (Sonnax® Number)	33000-01
Oil Pump Assembly Complete	24208987

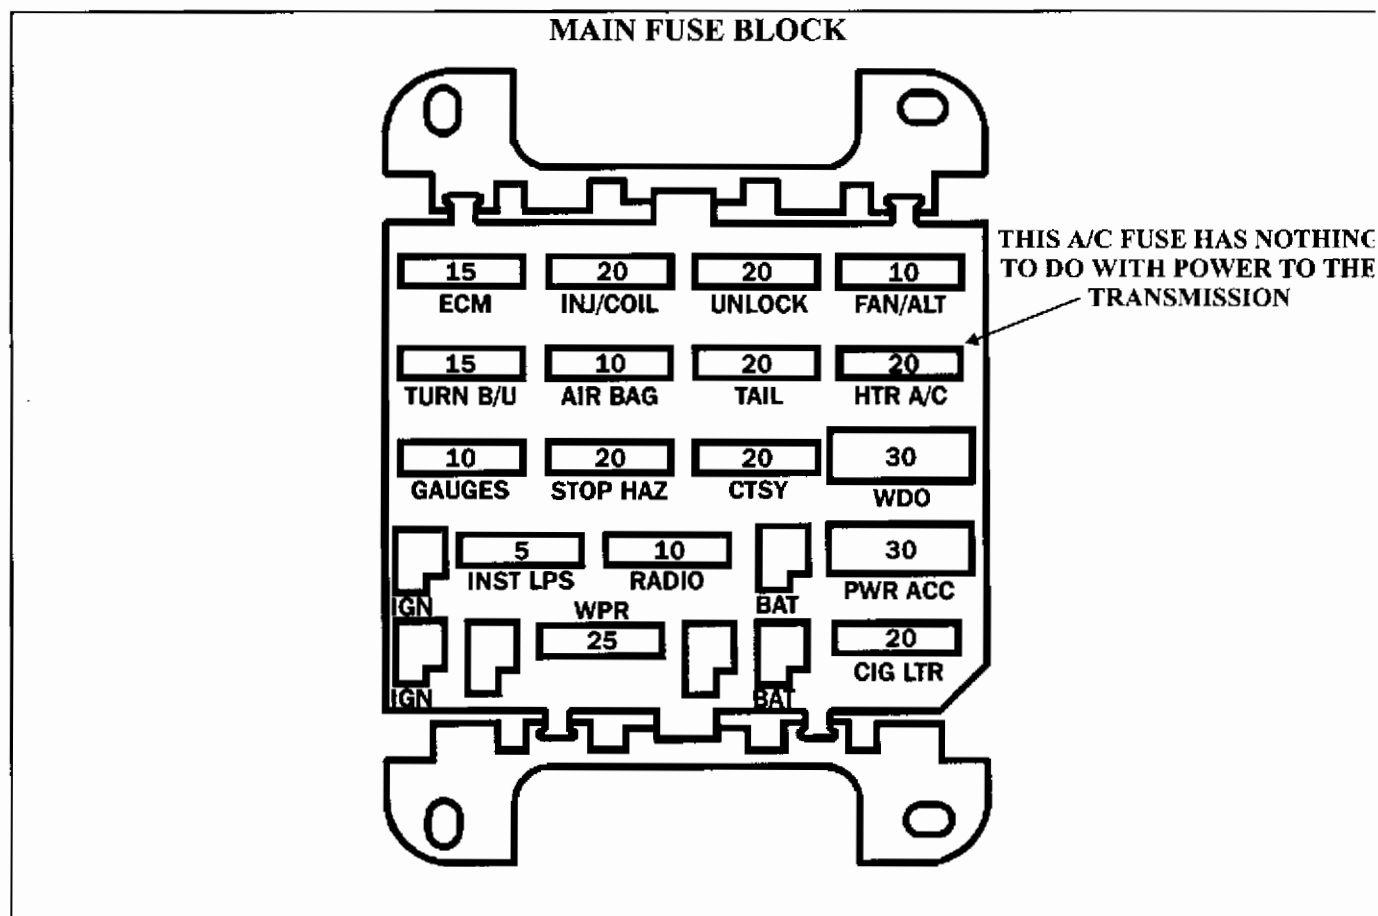
Figure 1

COMPLAINT: Some 1995-1996 Buick Century and Oldsmobile Ciera vehicles, equipped with the 3.1L (VIN "M") engine, may exhibit a 3rd gear start condition and the air conditioner not working. Since the vehicle came into a transmission shop we immediately check for voltage at terminal "E" at the case connector, and find 0 volts. After inspecting the fuse block, you discover that there are NO blown fuses even though there is a fuse identified as A/C as shown in figure 1.

CORRECTION: Remove the glove compartment for access to the "In-Line" fuses which are towards the passenger side of the main fuse block and are taped in a bundle which makes them hard to find. Remove some of the tape and replace the A/C fuse, as shown in Figure 2. A wire diagram is provided in figure 3 which shows why power to the transmission is lost when this in-line fuse is blown.

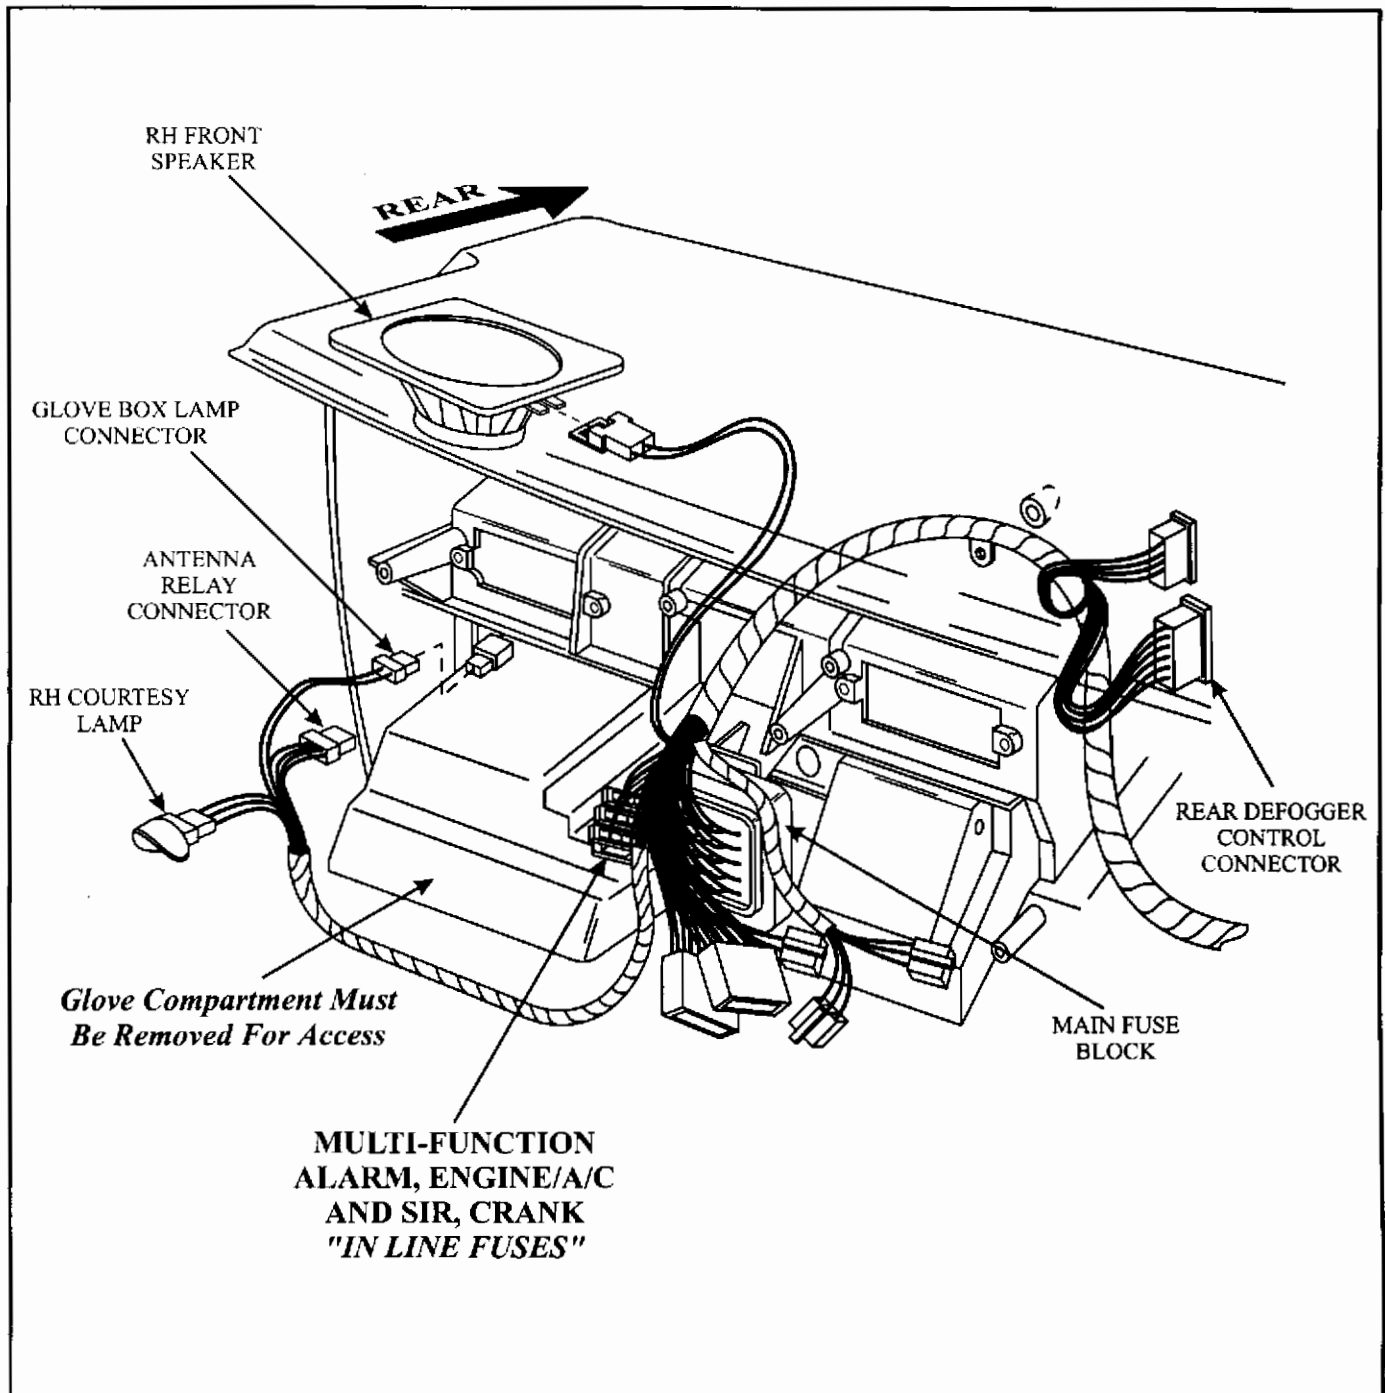
Figure 2

CAUSE: The cause may be, a blown *"In-Line"* fuse behind the instrument panel as illustrated in Figure 2, that also controls voltage to terminal "E" at the transaxle.

THM 4T60-E
3RD GEAR STARTS, NO A/C,
NO VOLTAGE TO "E" TERMINAL

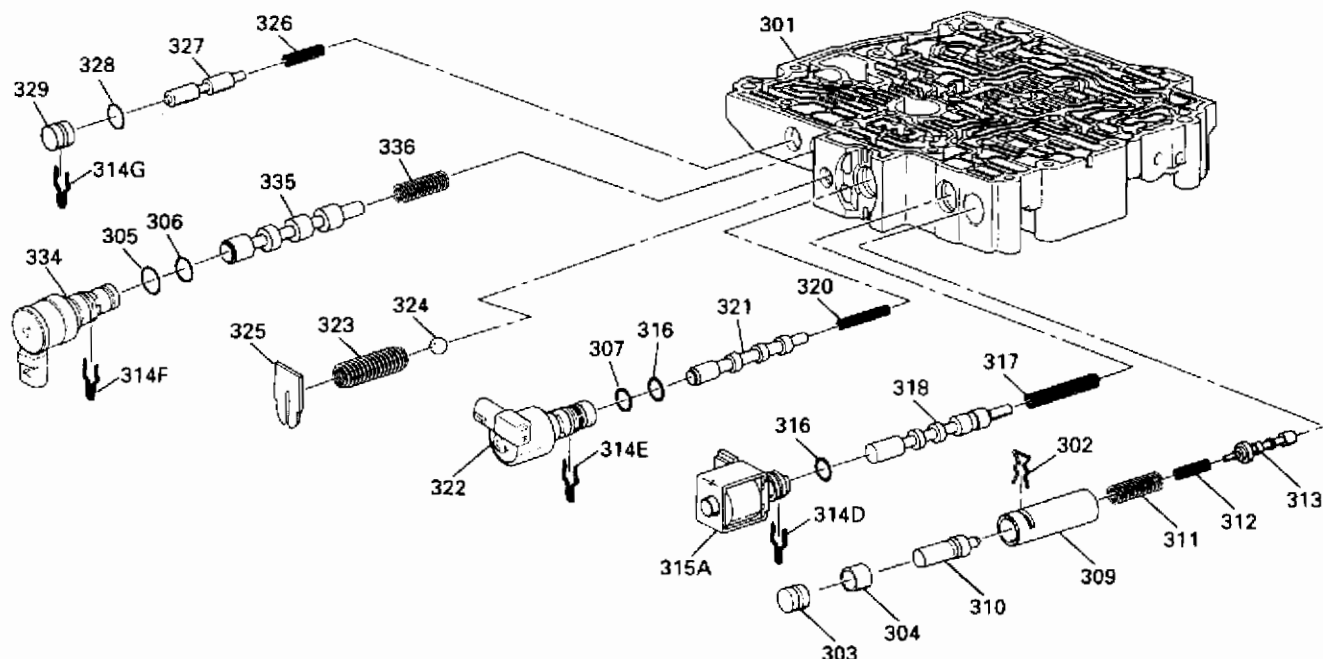
Figure 1

OEM Boost Valve And Sleeve Assembly
